## Arborist Report

749 West El Camino Real

**April 22, 2021**  
**Revised April 2022**  
**& September 2022**

**Arborist Report  
749 W El Camino Real  
Mountain View, CA**

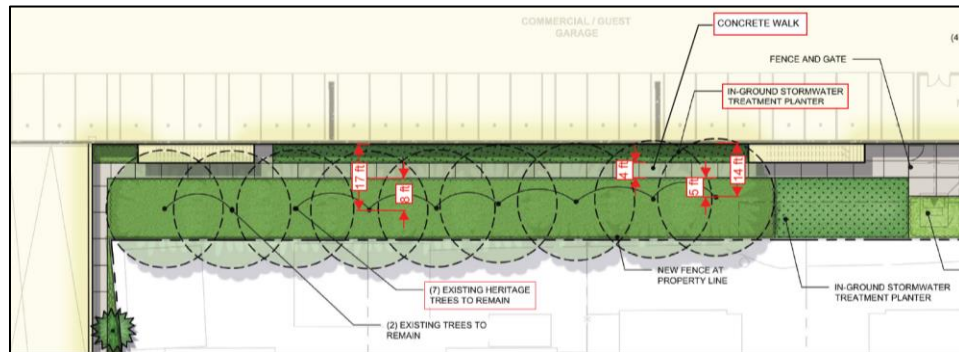
Coast redwoods #36-41 can be preserved with meticulous adherence to the tree preservation guidelines. The walkway is planned between 5 to 8 feet away from the trunks of the trees the existing pavement is around the same distance from the trunks (Sheet L-1 screenshot 1 below). To enable preservation, I recommend reducing the extent of the excavation required for the adjacent concrete walkway. Permeable pavers will be used to enhance water flow in the root zone.

The in-ground stormwater treatment planter is located where the existing parking lot is located. Root loss in this area is expected to be minimal. Excavation within the tree protection zone should be done by hand and should seek to preserve roots 2-inches in diameter and larger. Once roots are severed, they should be covered. The trees should be irrigated regularly with potable water before, during, and after construction to help the trees tolerate and recover from construction impacts better. Tree protection fencing should also be installed between the trees and the edge of the proposed work area. Fencing should remain in place for the duration of the project.
