266 & 272 Tyrella Ave Mountain View, CA Arborist Report 2024

Site: 266 & 272 Tyrella Ave
Mountain View, CA 94043

Date: May 30th, 2024

Subject: Tree protection plan for 266 & 272 Tyrella Ave, Mountain View, CA 94043

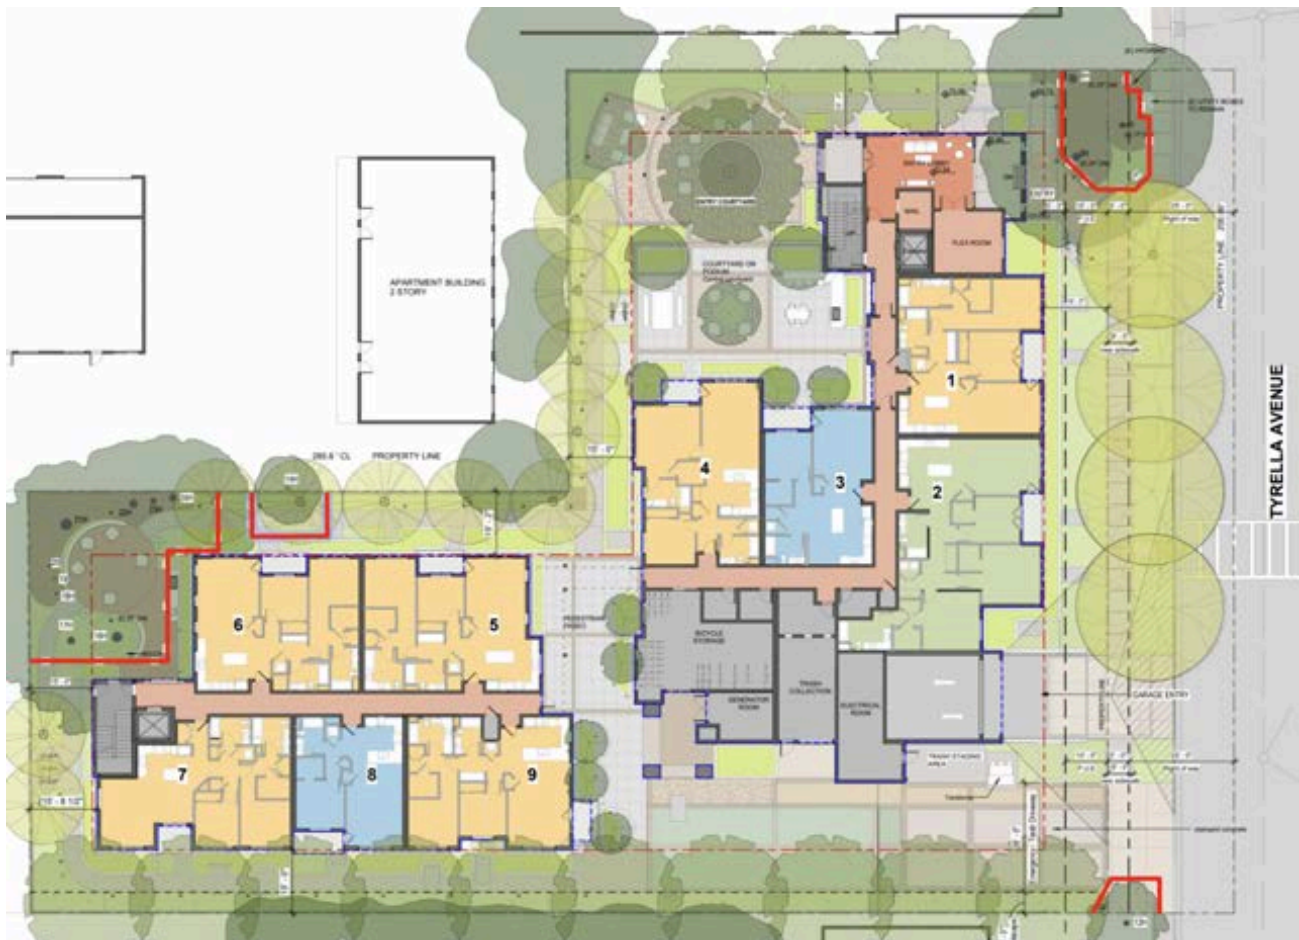
Red lines showing the recommended tree protection zones.**Staging**
