Arborist Report

515 – 525 N. Whisman Road
Mountain View, CA

January 2026

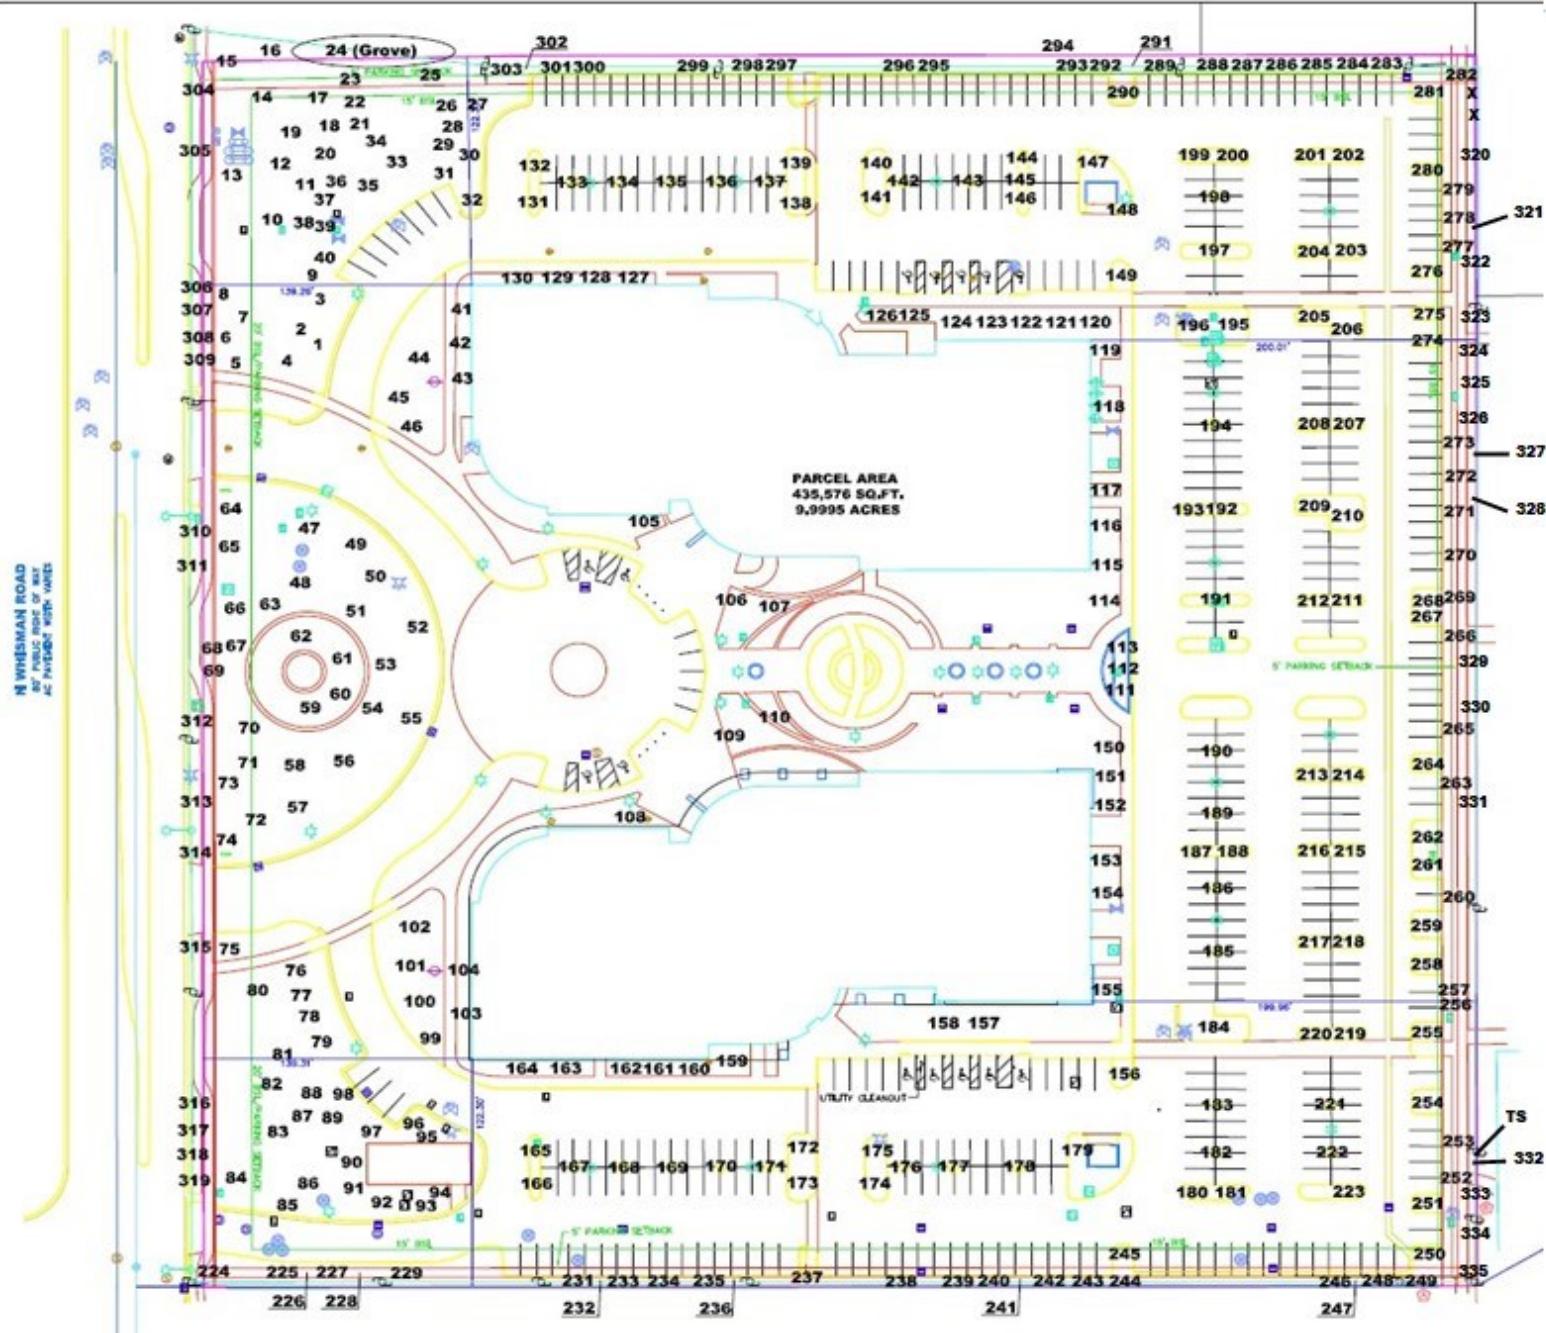
Tree Assessment Map

Descriptions of each tree can be found in the **Tree Assessment Form**, and approximate locations are shown on the **Tree Assessment Map** (see Exhibits).
