Request Name: A Plus Tree is removing 1 Heritage Tree

Heritage Tree Removal Permit Application

Arborist Report for:

**Willow Park Mountain View HOA / Common Interest
500 W Middlefield Rd, Mountain View, CA 94043**

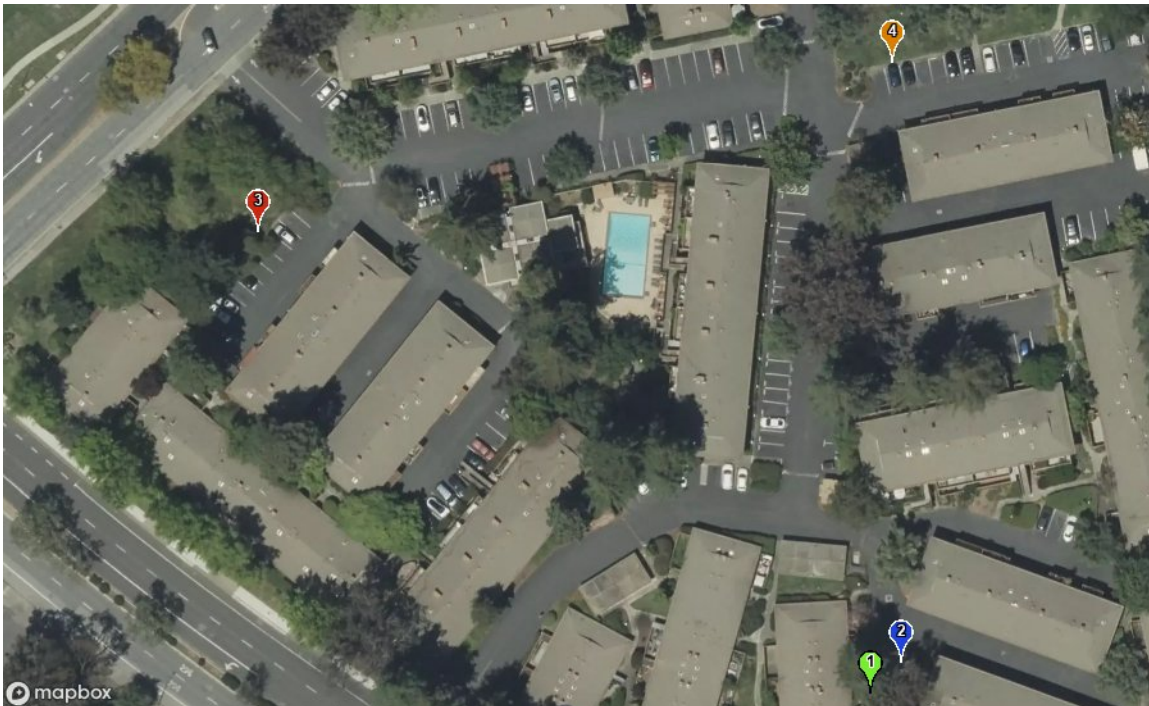
Trees

1	<p>Coast Redwood (Sequoia sempervirens) [1026048] 📏 30-36" 🍷 Fair</p> <p>Building 20, Unit 149. 30" DBH - rooted against the patio fence. — removal requires a HERITAGE TREE permit and (1) 15-gallon replacement tree. *** crane needs to be small enough to make difficult turns *** stump cannot be fully ground down because of the slope and proximity to the fence</p>	<p>Removal</p> <hr/> <p>Grind Stump (Description at Bottom of Estimate) Notes : stump cannot be fully ground down because of the slope and proximity to the fence</p> <hr/> <p>Permit Needed - Removal</p> <hr/> <p>Crane Needed Notes : crane needs to be small enough to make difficult turns</p> <hr/> <p>Log Loader Needed Notes : Trunk sections larger than 18" diameter cannot be chipped</p>

3	<p>Autumn Blaze Red Maple (Acer X freemanii 'Jeffsred') [1002634086] 📏 0-3" 🍷 Fair</p> <p>Building 1, Unit 1. Recommended planting site for replacement tree for the redwood removal</p>	<p>Tree Installation - 15 Gal (Irrigation not included) Notes : Building 1, Unit 1. Recommended planting site for replacement tree for the redwood removal</p>
