PAGE&TURNBULL

MEMORANDUM

REGARDING 415 Bush Street, Mountain View – Secretary of the Interior's Standards for

Rehabilitation Compliance Analysis

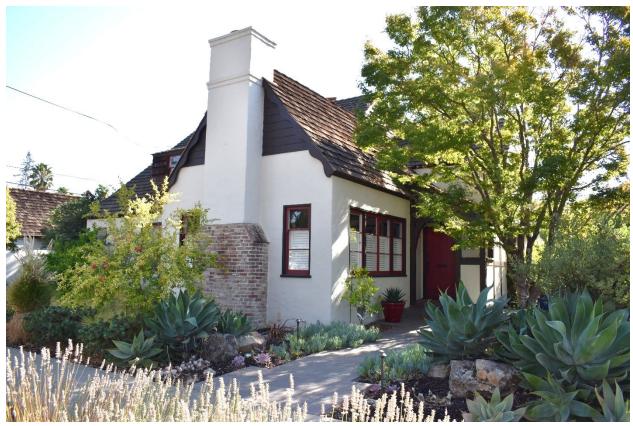
The property is set back on a rectangular parcel at the northeast corner of Bush and Velarde Streets, and consists of a residence, detached garage, and detached rear Accessory Dwelling Unit (ADU) (Figure 1). The residence is approximately L-shaped in plan and constructed of wood frame with stucco, half-timbering, horizontal wood clapboard, and wood shingle cladding. It is capped with a cross-gabled roof and cedar shake shingles, with a boxed eave and curved bargeboard at the gable end facing Bush Street. Typical windows are original one-over-one double-hung with wood sash, unless noted otherwise.

Figure 1. Context view of 415 Bush Street, looking east.

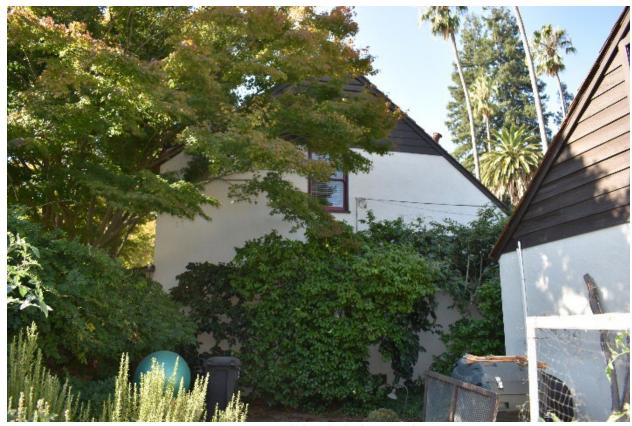
The north side façade features a typical window at each story, with stucco cladding and horizontal wood siding at the gable end **(Figure 6).** Fenestration on the first floor is partially obscured by vegetation.

Figure 6. North facade, looking south.

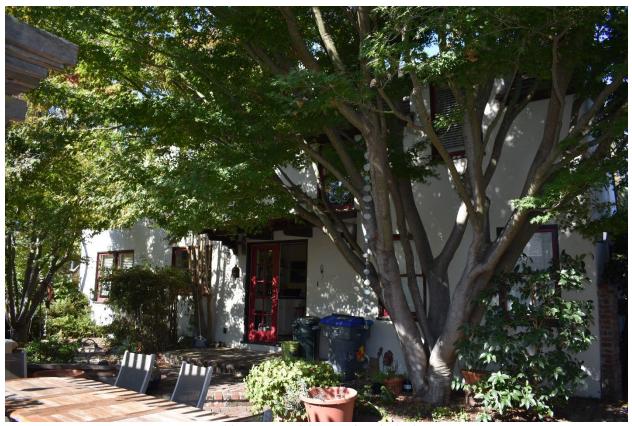
The rear, east façade faces a small enclosed backyard. The fenestration is arranged asymmetrically, and the façade is capped by a side gable roof. The first floor is accessed through a non-original set of wood French doors with a brick masonry stoop and wood canopy and features four typical windows and one non-original window on the first floor aligned to the left (south) side of the French doors. The fenestration of the second story includes five typical windows, with groupings of one and three within two wall dormers, each with shed roofs.

Figure 7. Oblique view of the rear façade, looking west.

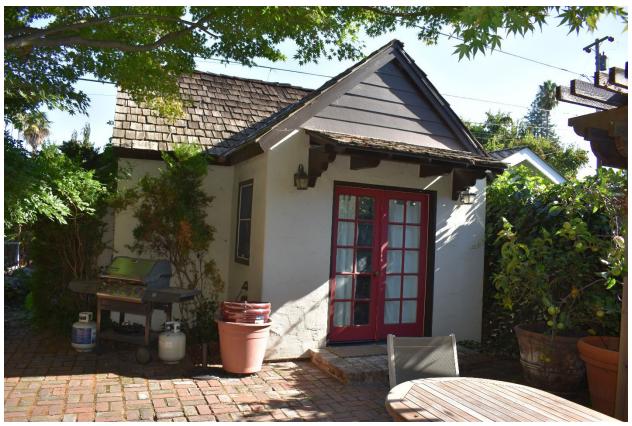
The rear ADU is set back at the northeastern corner of the parcel. It has a T-shaped plan with a cross-gabled roof, and is accessed through a set of wood French doors beneath a wood canopy with carved brackets and wood shake roofing. It is compatible with the main residence and features similar architectural characteristics and materials including stucco and horizontal wood siding, wood-sash windows, and wood shake roofing (Figure 13 through Figure 15).

Figure 13. Context view of the rear ADU, looking northeast.

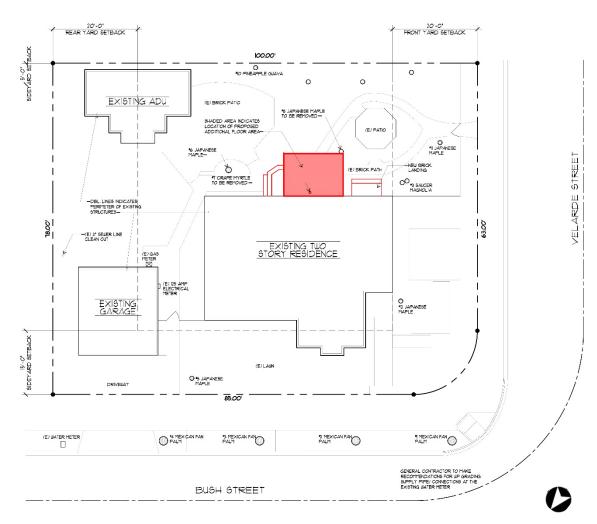
- A one-story, 136-square-foot addition would be constructed at the rear (east) side of the
 residence, with stucco siding, wood siding at the gable end, and standing seam metal roof
 cladding.
 - An existing French door; non-original wood canopy; masonry stoop, and non-original wood sash double-hung window would be removed
 - o A new masonry stoop and double-hung wood sash window would be installed at the right (north) side of the new addition
- A pair of original double-hung wood sash windows at the leftmost (south) side of the east façade would be removed and replaced with a new set of French doors, wood canopy, and brick stoop.

Figure 16. Proposed site plan. Rear addition and alterations indicated by red shading and outline. Source: "Proposed Remodel For: The Bettman Residence" prepared by Flury Bryant Design Group, Inc. (dated July 16, 2024), Sheet 2. Edited by Page & Turnbull.

The proposed description is based on the scope of work described and illustrated in the drawing set for 415 Bush Street, titled "Proposed Remodel For: The Bettman Residence" prepared by Flury Bryant Design Group, Inc. (dated July 16, 2024). (included in **Appendix B** of this memorandum). The proposed project includes the following alterations (**Figure 16 - Figure 19**):

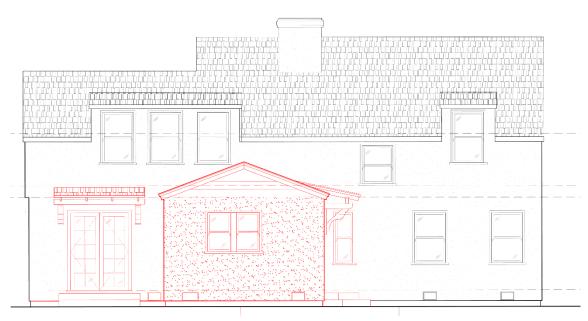
Figure 17. Rear east elevation drawing illustrating areas of new construction and alterations in red. Source: "Proposed Remodel For: The Bettman Residence" prepared by Flury Bryant Design Group, Inc. (dated July 16, 2024), Sheet 7. Edited by Page & Turnbull.

The proposed project includes a one-story, 136-square-foot addition at the rear (east) side of the residence. The addition would replace and relocate a non-original set of French doors with wood canopy to another location on the same façade in the place of a pair of existing original wood sash double-hung windows. The addition and alterations are proposed for the rear east façade, which is not visible from the public right-of-way, despite the property being a corner lot. Thus, the location and design of the addition and alterations would affect a minimal amount of historic material and would not diminish the historic character of the residence. The new addition would be clad in stucco and horizontal wood siding to match the existing residence, and the standing seam metal roofing would sufficiently distinguish it as an addition. The new set of French doors would feature a wood canopy with curved brackets that would be differentiated from existing wood brackets elsewhere on the building and would not introduce a sense of false historicity.

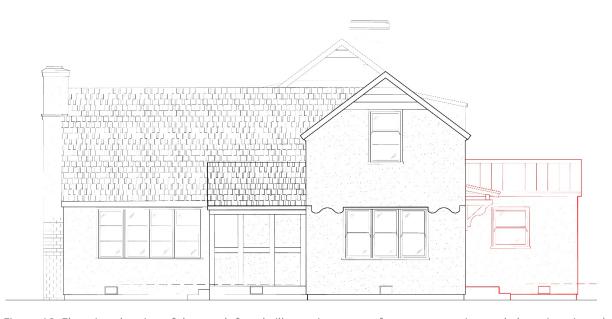
Figure 18. Elevation drawing of the south facade illustrating areas of new construction and alterations in red. Source: "Proposed Remodel For: The Bettman Residence" prepared by Flury Bryant Design Group, Inc. (dated July 16, 2024), Sheet 7. Edited by Page & Turnbull.

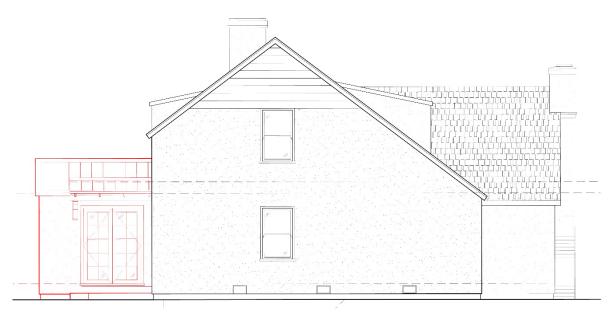
Figure 19. Elevation drawing of the north facade illustrating areas of new construction and alterations in red. Source: "Proposed Remodel For: The Bettman Residence" prepared by Flury Bryant Design Group, Inc. (dated July 16, 2024), Sheet 7. Edited by Page & Turnbull.

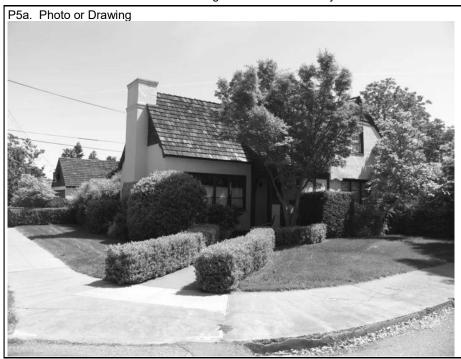
P5b. Description of Photo:

View of the southwest and northwest façades; April 26, 2007
