Logistics technical memo

Project title	North Bayshore Logistics Masterplan	Job number
		282535-00
cc	City of Mountain View Public Works	File reference
		TN-02
Prepared by	Spencer Paret Melody Ablola	Date
		March 15, 2023
Subject	Delivery & Loading Requirements

Figure 1.1. NORTH BAYSHORE MASTER PLAN - PHASING PLAN

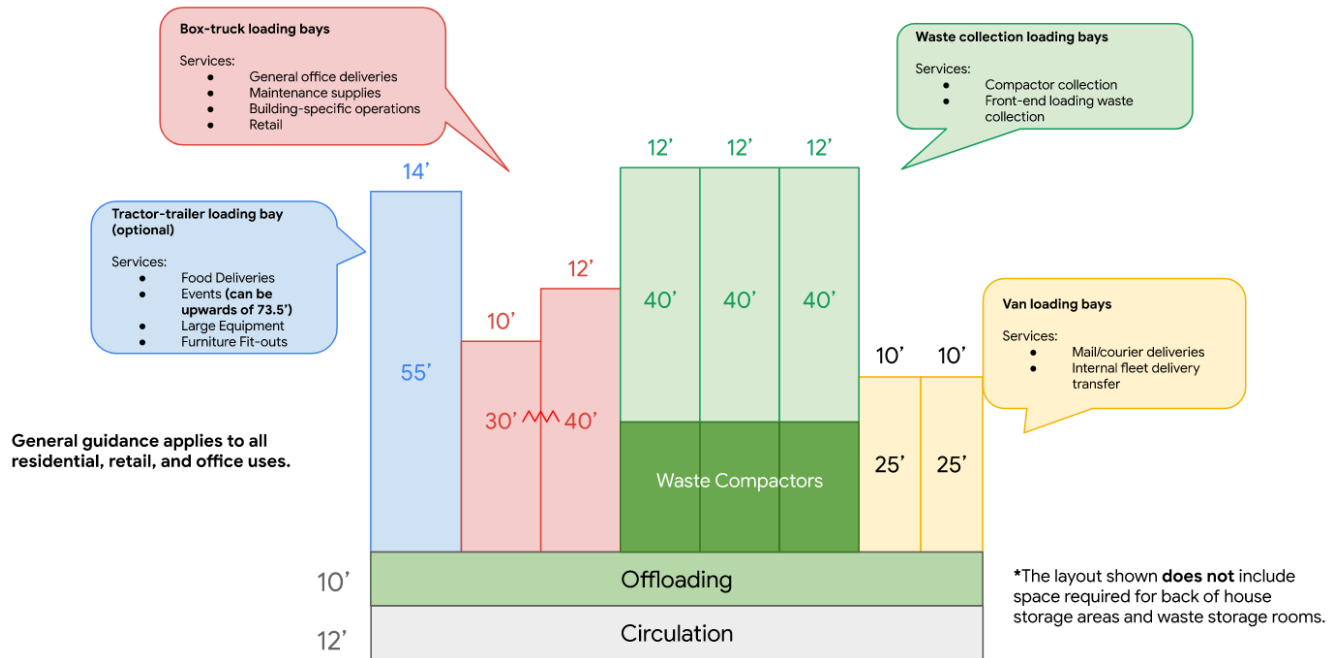
Figure 1: Example Loading Dock Layout

A 40' long box truck (SU-40) is proposed as the design vehicle for the site. To accommodate this vehicle, loading bays will be sized at 12' W x 40' L with 15' of vertical clearance. Per City of Mountain View Municipal Code [Section 36.32.75](#), minimum required dimensions for a loading space set by the City of Mountain View: 10' W x 25' L with 12' of vertical clearance. An example loading dock layout at a typical building is shown in **Figure 1**. Section 3.3.11 of the [North Bayshore Precise Plan](#) and [Section 36.32.75](#) of City of Mountain View Municipal Code further prescribe location, screening, and other off-street loading design requirements.

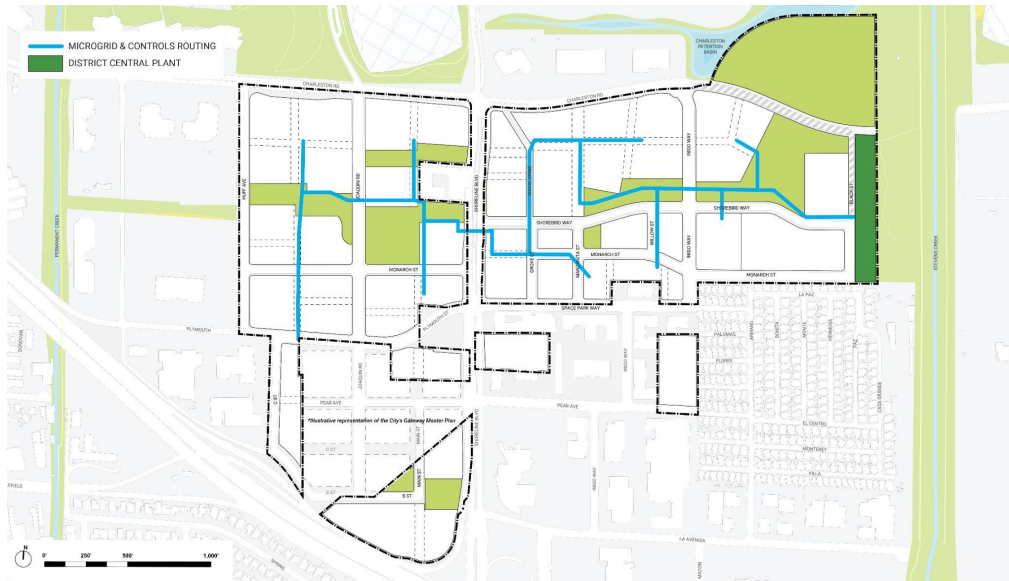
Figure 3.1. CONCEPTUAL MICROGRID & CONTROLS LAYOUT. ILLUSTRATIVE DIAGRAM SUBJECT TO CHANGE.

If a Community Microgrid arrangement is selected, connections to each building will be provided by PG&E from distribution lines located within PG&E's existing easements. This microgrid option includes private fiber distribution for controls. The microgrid operation control location(s) shall be determined by PG&E islanding sections.

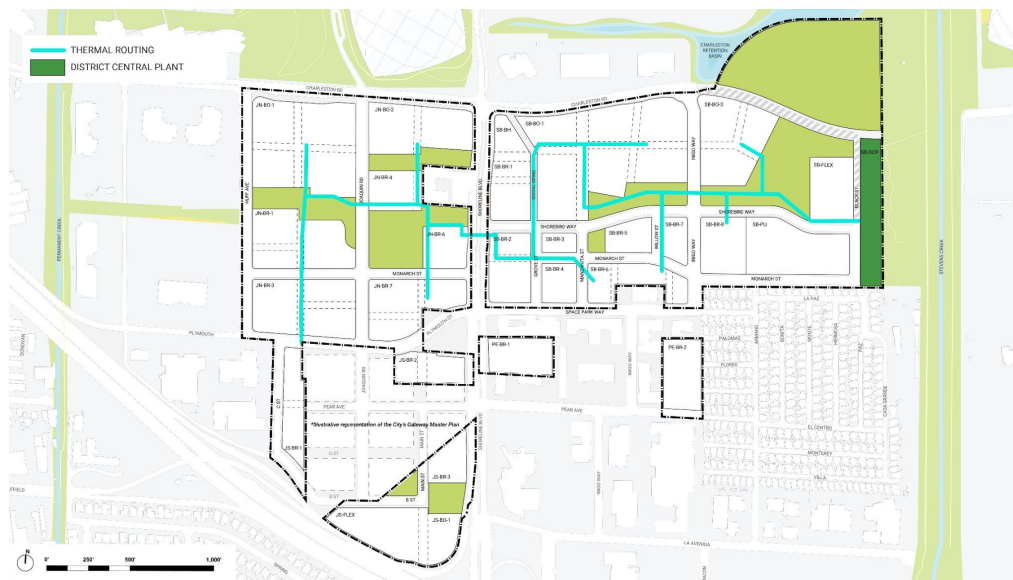
Figure 3.2. CONCEPTUAL THERMAL ENERGY LAYOUT. ILLUSTRATIVE DIAGRAM SUBJECT TO CHANGE.

There is no existing heating hot water or chilled water system serving the site. Thermal energy for the Project is proposed to be served from the DCP. The DCP would provide heating hot water and chilled water to the all of the buildings within the Project Area except the ones with any of the constraints described above, via underground heating hot water and chilled water pipes located within the District Systems Corridor and/or direct-buried, as shown in Figure 3.2. Buried district piping would be fused-joint virgin high density polyethylene or equivalent.

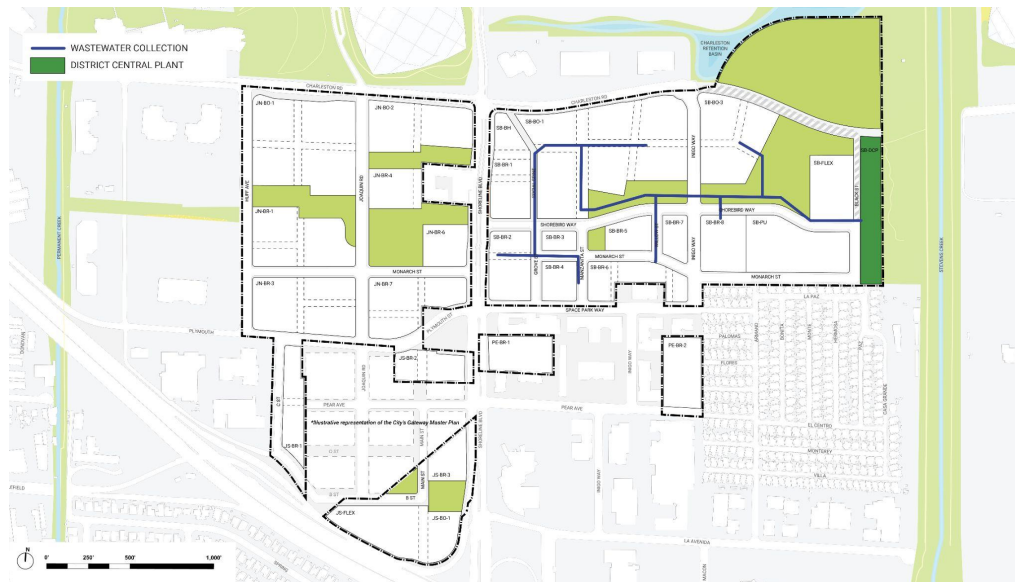
Figure 3.4. CONCEPTUAL DISTRICT WASTEWATER COLLECTION NETWORK (SHOREBIRD ONLY). ILLUSTRATIVE DIAGRAM SUBJECT TO CHANGE.

The proposed design for the wastewater collection system includes a private, low-pressure sanitary sewer (SS) collection network which would be integrated into the proposed District Systems Corridor alignment, as shown in Figure 3.4.

A PSS operates through a sealed system, eliminating leakages (exfiltration) and stormwater inflow and infiltration (I/I) while also reducing odor issues. Additionally, a PSS allows for system optimization, as the operator can program the system's operating periods and stagger peak loads. This flexibility could potentially reduce the discharge volume that would be sent to the City SS.

The in-building pump station wet wells associated with the PSS will be vented as required by California Plumbing Code (CPC) to prevent odorous conditions. If needed, air blowers and odor control units (eg. carbon filters) may be incorporated into the pump station design.

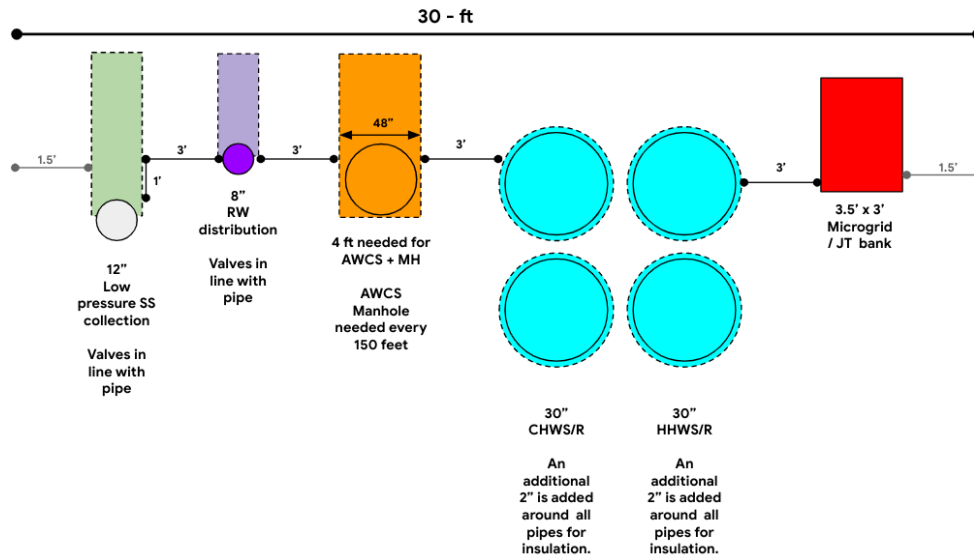
Figure 3.8. CONCEPTUAL DISTRICT SYSTEMS CORRIDOR SECTION - TYPICAL EXTERIOR ROUTING. ILLUSTRATIVE DIAGRAM SUBJECT TO CHANGE.

Figure 3.8 shows the typical section of the District Systems Corridors, when they are directly buried. This section proposes that all District Systems would be buried in a “joint trench” and share the same alignment, but maintain a constant separation as shown. Exceptions to the separation requirements are likely to occur, when access or appurtenances for these District Systems are needed.

The District Systems Corridor sections in Figures 3.7 to 3.9 are for illustrative purposes only and are subject to change as the District Systems design advances.

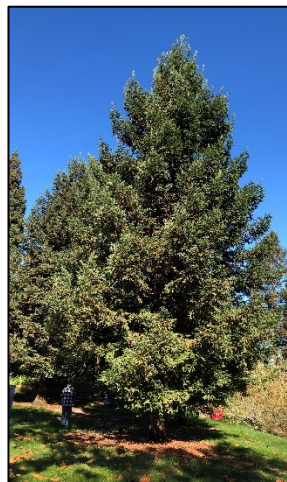
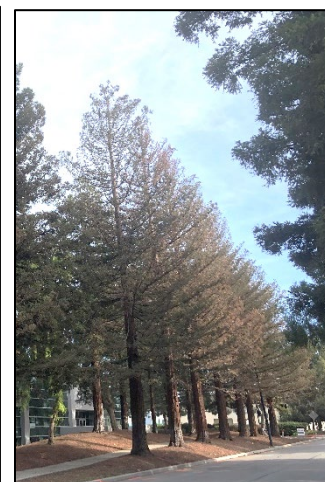
Photos 1 & 2: The coast redwood in good condition on the left had a dense, dark green crown. The coast redwoods on the right irrigated with recycled water were in poor condition and dying.

Coast redwood accounted for 21% of the population with 849 trees. The coast redwoods were mostly in good condition (55% of population) with 29% in fair condition, 13% in poor condition, and 2% dead. There was a wide range in trunk diameter from 4 to 58 inches with an average trunk diameter of 26 inches. The largest trees on the site were redwoods; tree #2489 was 55 inches in diameter, and tree #4 was 58 inches. Redwoods in good condition had dense canopies, good color, and new growth in the top of the crown. Redwoods in poor condition had thin canopies, brown foliage, and visible trunk exposed (Photos 1 & 2).

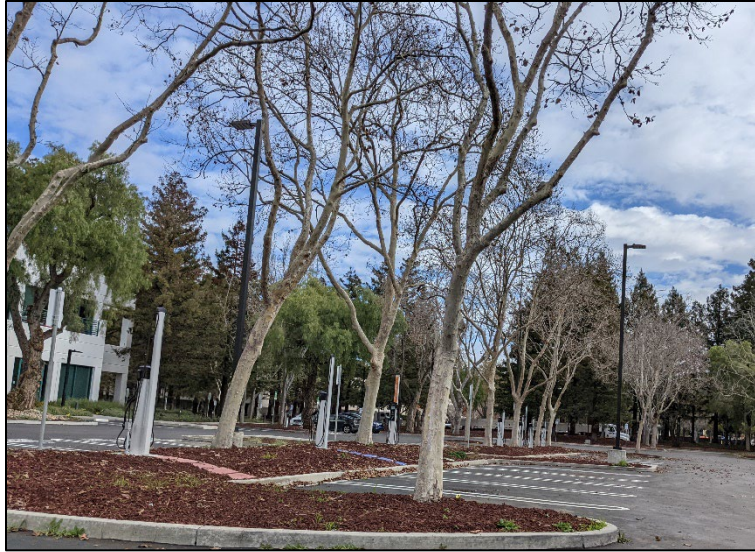
Photo 3: London plane was the dominant species growing in parking lots on the site.

London plane comprised 15% of the tree population with 617 trees. The London planes were generally in good condition (59% of population) with 38% in fair and 3% in poor condition. Most planes were semi-mature (11-inch average trunk diameter) with trunk diameters ranging from 1 to 31 inches. London planes are generally tolerant of difficult growing conditions and were one of the more successful species in parking lots (Photo 3).

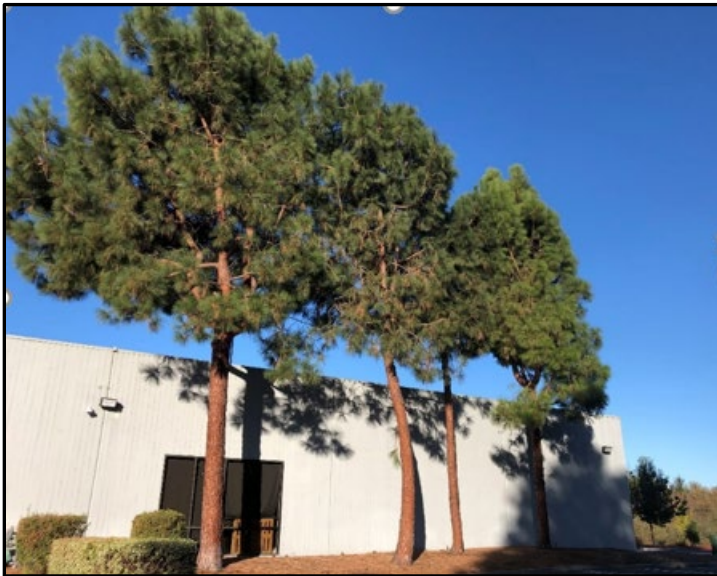
Photo 4: Many of the Canary Island pines (#24-27 shown above) had lower branches removed, creating a low live crown ratio.

diameter of 21 inches. Many of the Canary Island pines had low live crown ratios with foliage concentrated at the top since lower branches had been removed (Photo 4).

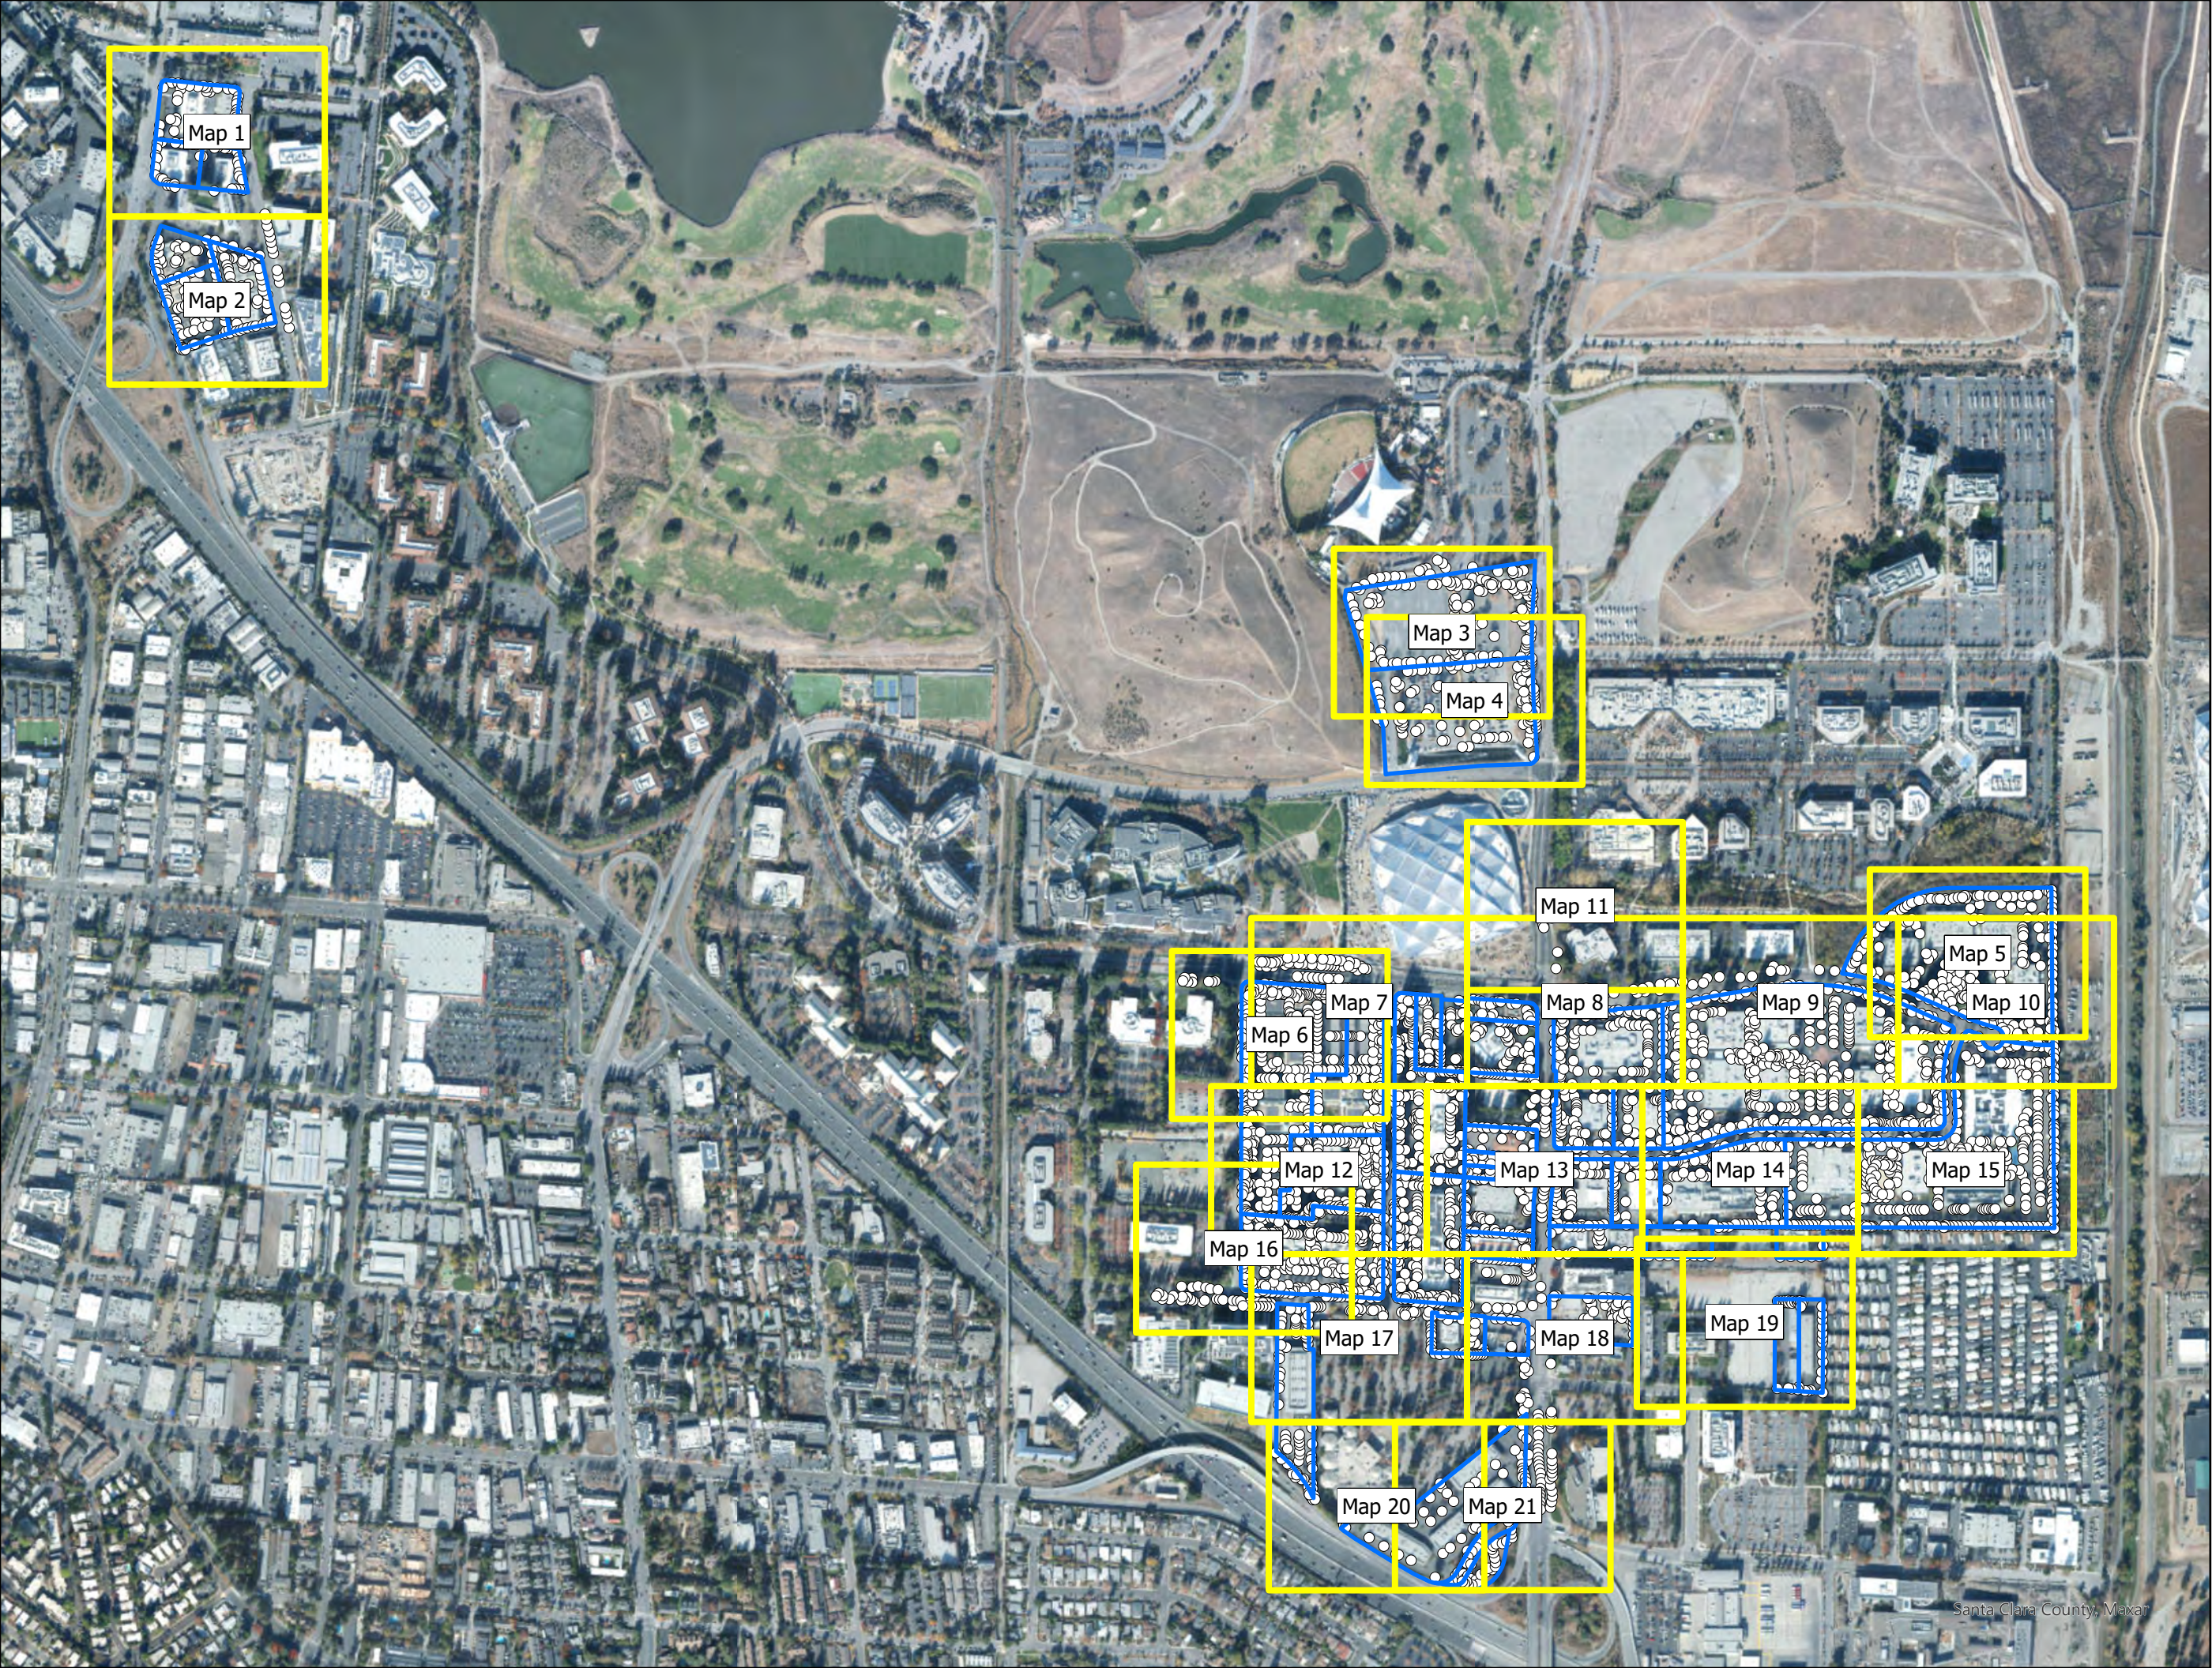
Map 1 of 21
North Bayshore
Mountain View, CA

Tree Assessment Map

Each tree was rated for suitability for preservation based upon its age, health, structural condition and ability to safely coexist within a development environment (see **Tree Assessment** in Exhibits, and Table 2). We consider trees with high suitability for preservation to be the best candidates for preservation. We do not recommend retention of trees with low suitability for preservation in areas where people or property will be present. Retention of trees with moderate suitability for preservation depends upon the intensity of proposed site changes.

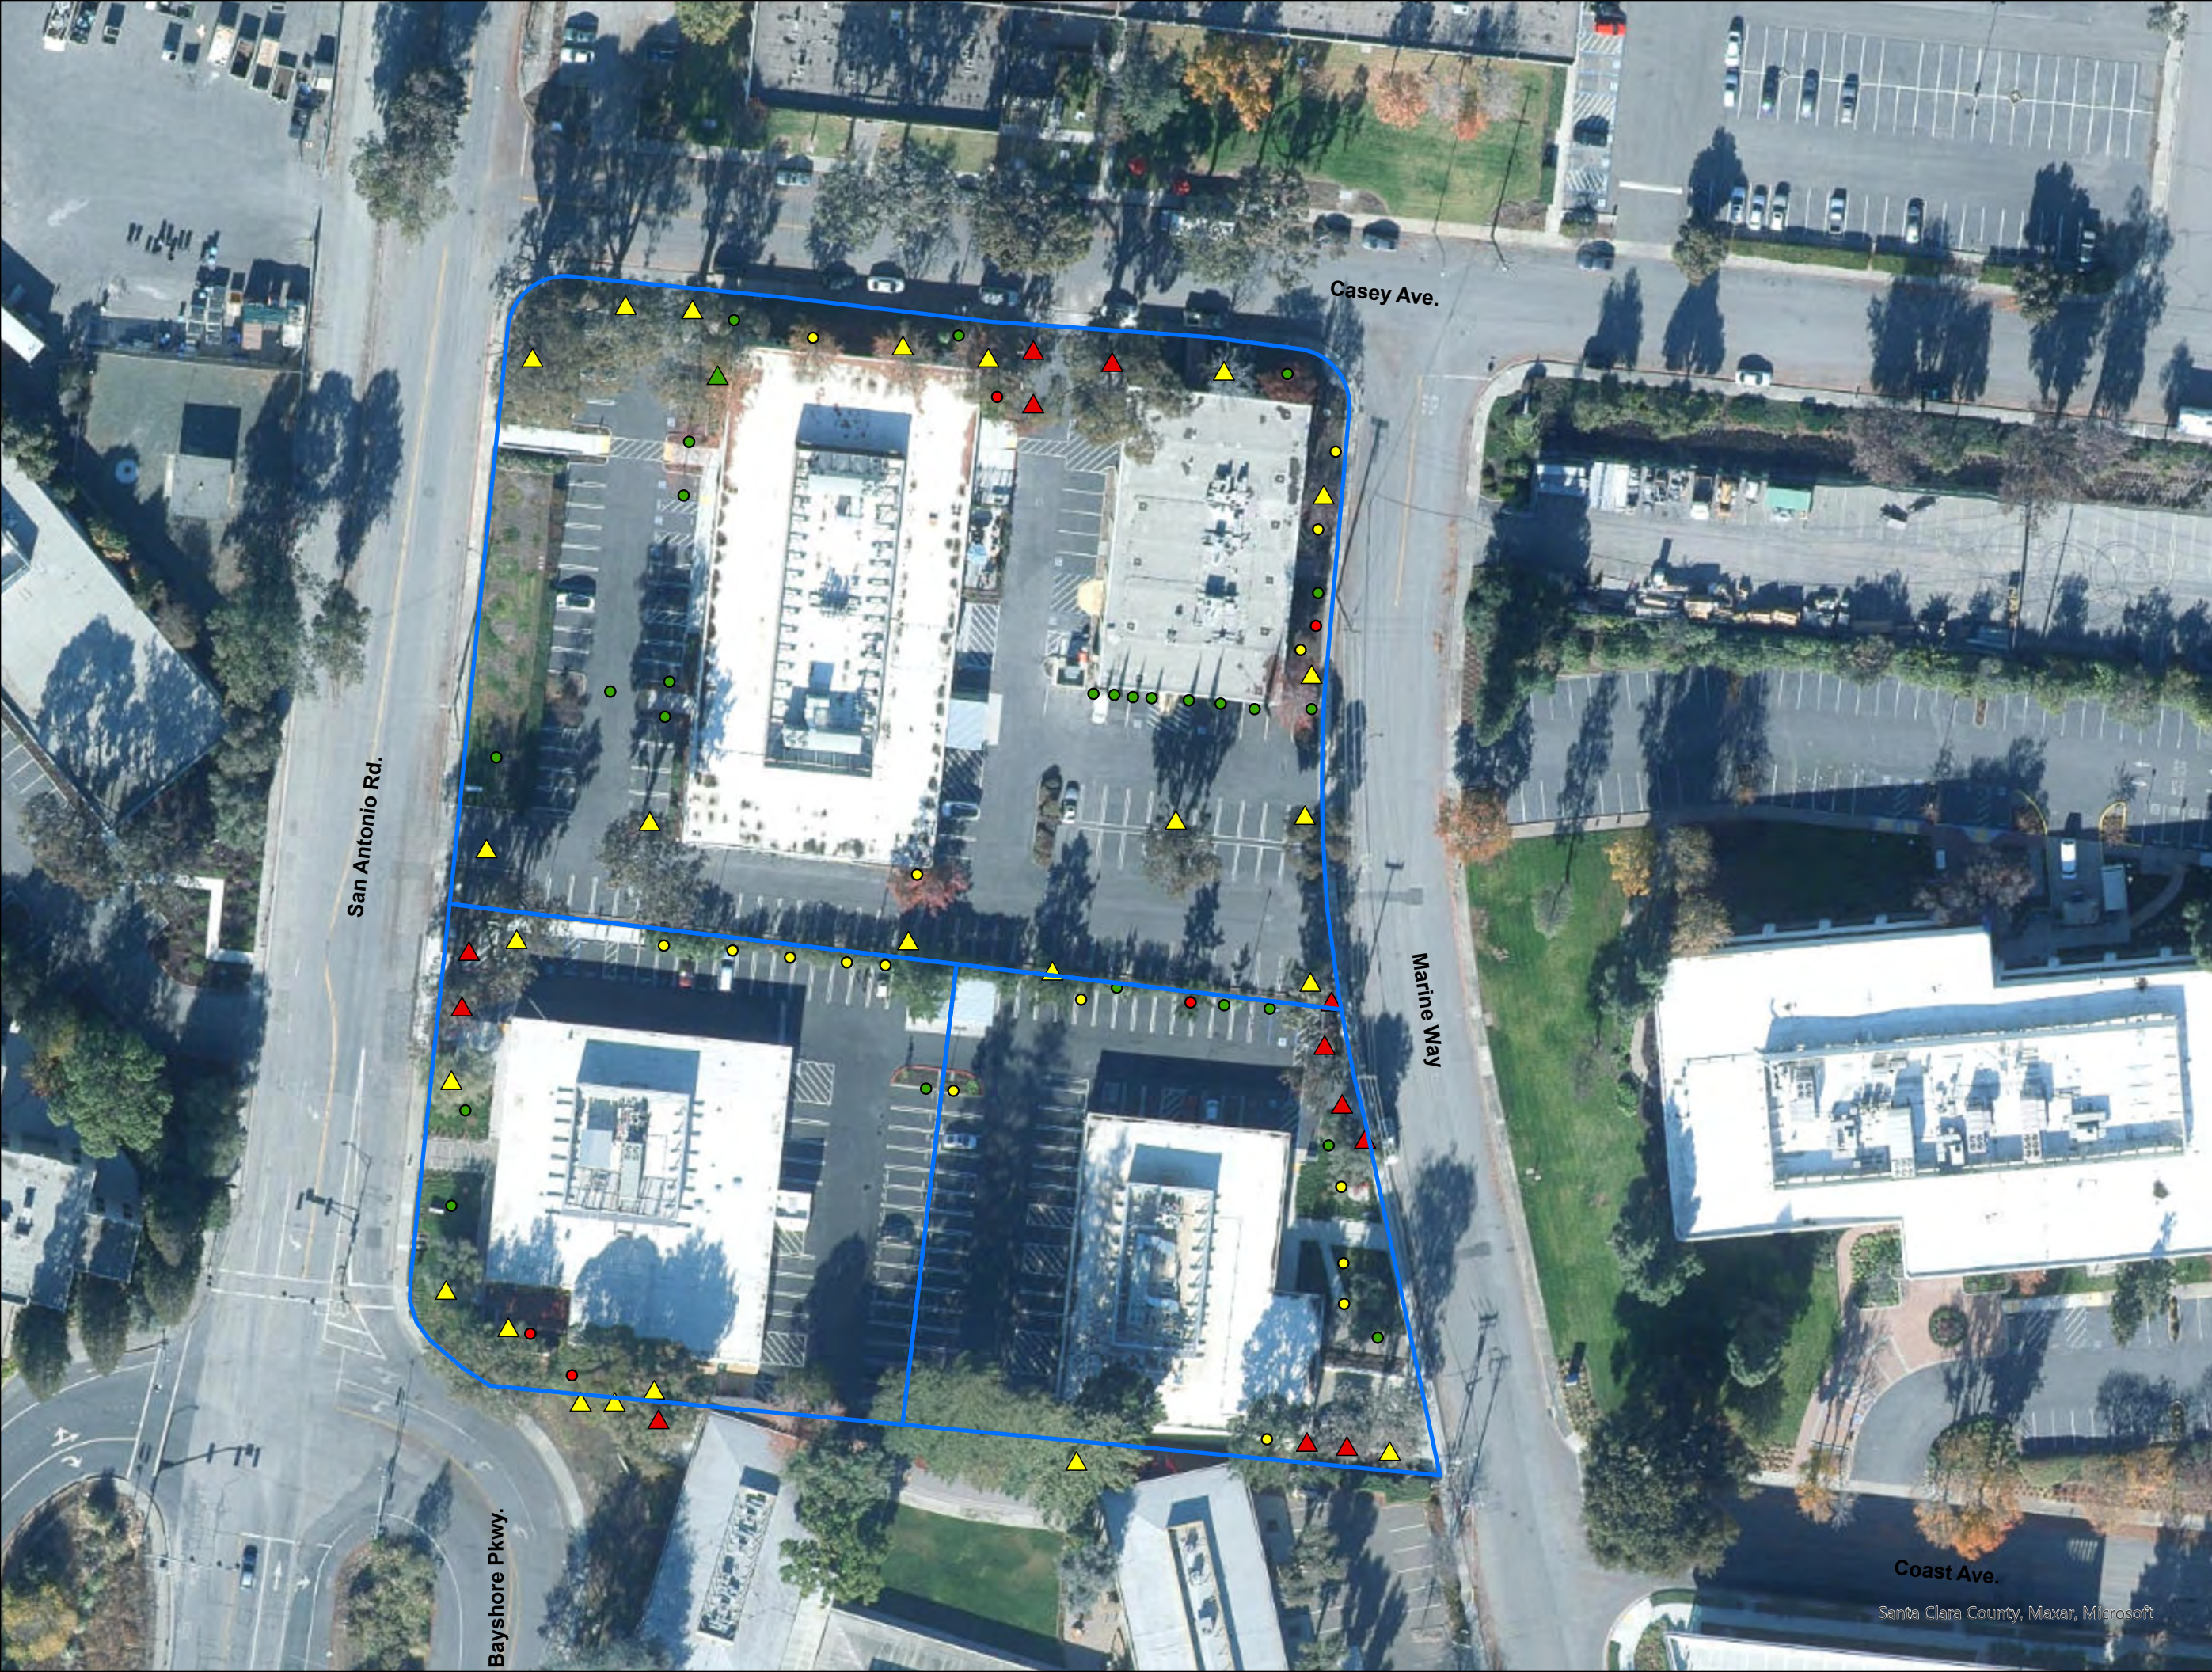
Map 1 of 21
North Bayshore
Mountain View, CA

Tree Condition Map

Four thousand one hundred four (4,104) trees were assessed representing 115 species (Table 1). Among all species, 46% of trees were in good condition, 42% were in fair condition, and 12% of trees were in poor condition. Descriptions of each tree are provided in the *Tree Assessment*, and locations are plotted on the **Tree Assessment Maps** (see *Exhibits*). **Tree Condition Maps** provide color-coded condition ratings for each tree.
