Council Transportation Committee Member Questions April 20, 2021 CTC Meeting

Item 5.1 Grant Road and Sleeper Avenue Intersection Study

Item 5.2 AccessMV: Comprehensive Modal Plan

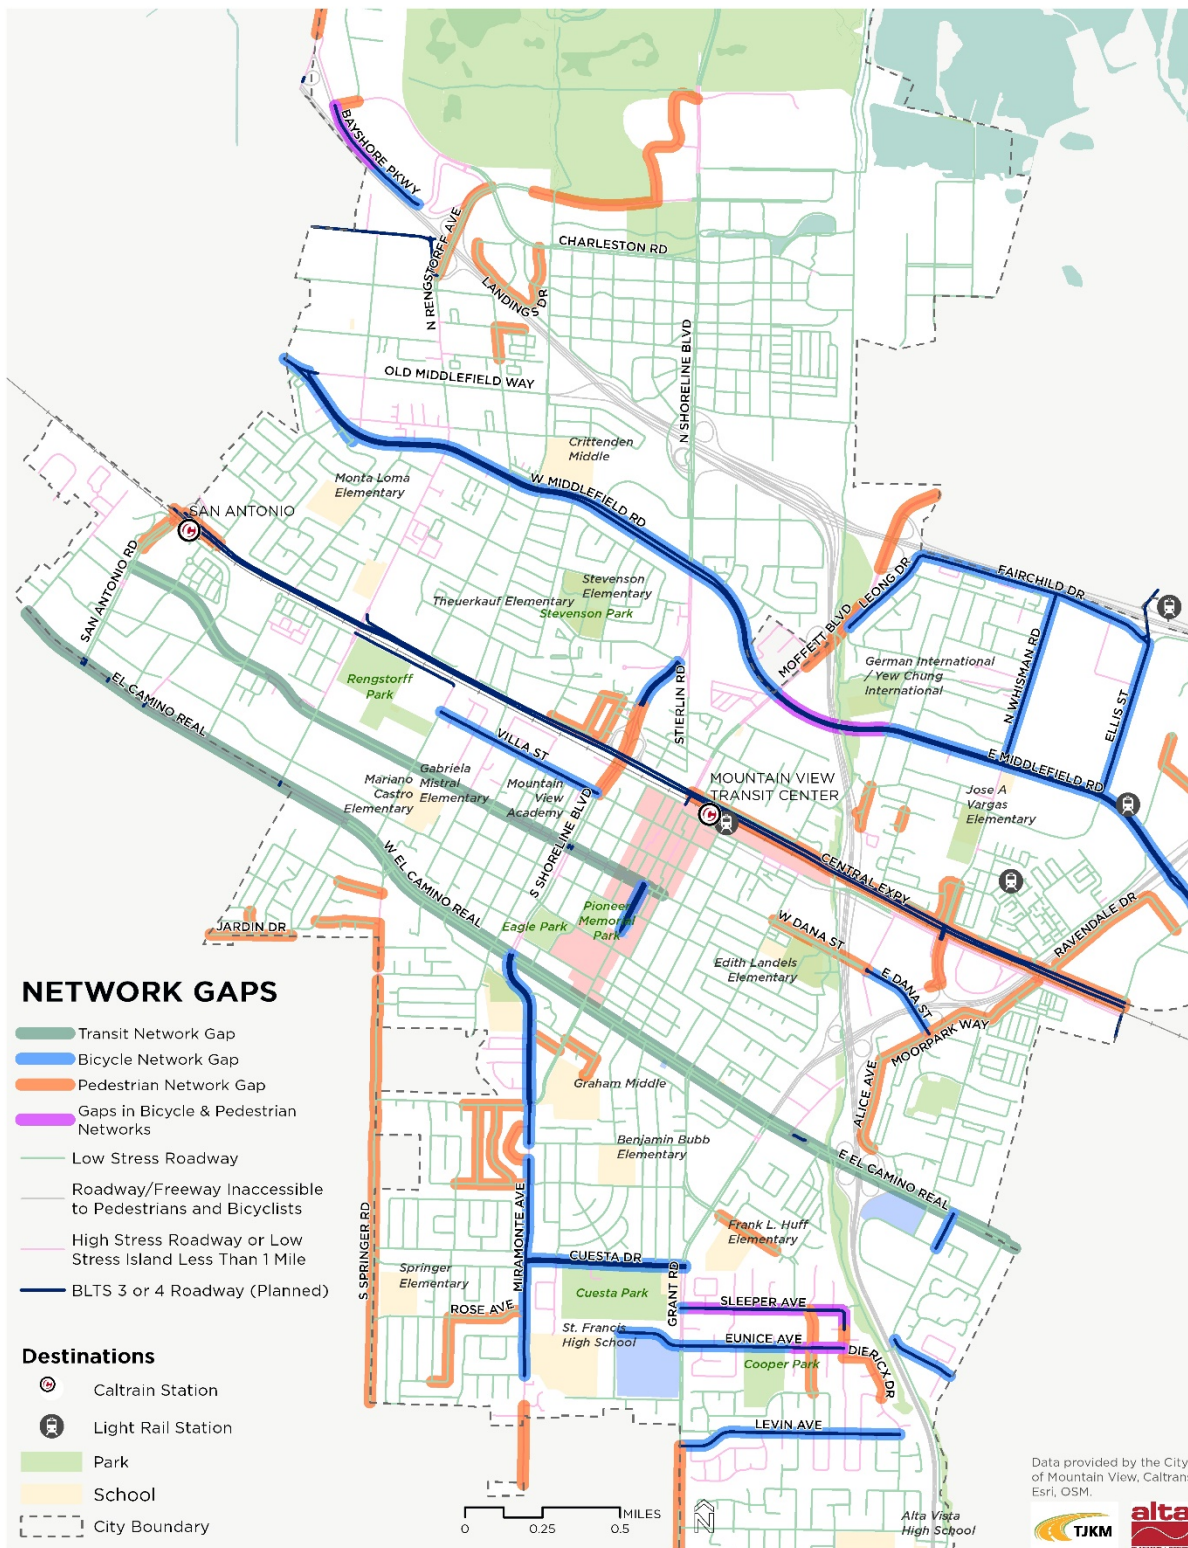
There was a glitch in importing the map into the document. Attached is the full map for Figure 4-3 Network Gaps on page 95. Page 96 is intentionally blank for pagination purposes.

Page 95 of the Draft Access MV plan is missing the lower 2/3 of the page. Where can I find the complete map? Page 96 is blank. Is it supposed to be?
