Typical soft story retrofit elements

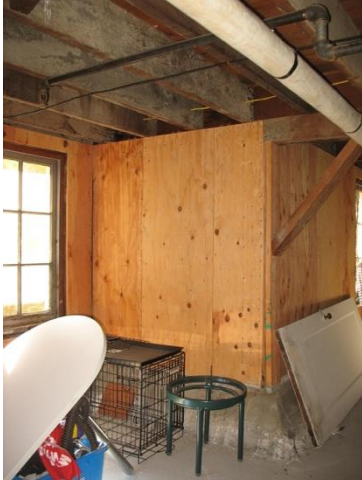
Wood sheathing applied over existing studs, using the existing concrete foundation

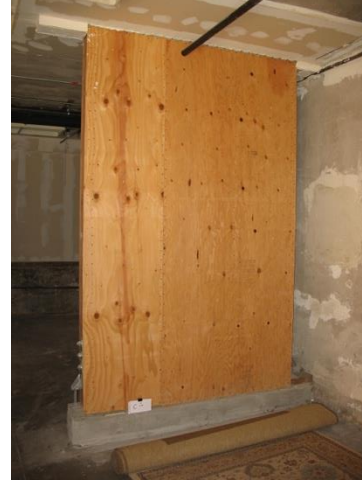
New stand-alone wood shear wall with new concrete footing

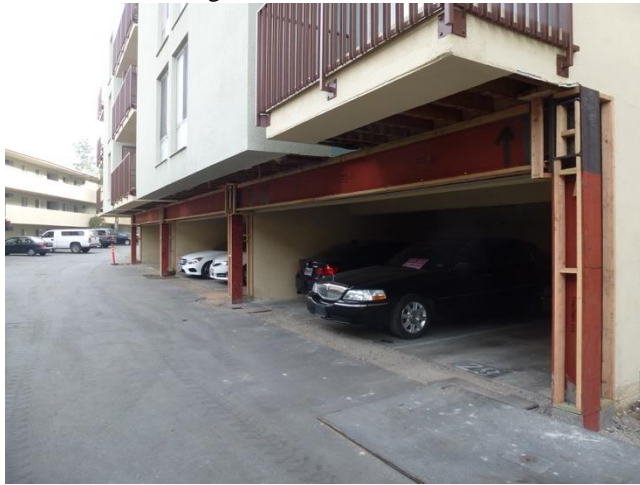
Three-bay steel moment frame installed around garage door openings, with new concrete footing (Credit: Degenkolb Engineers)

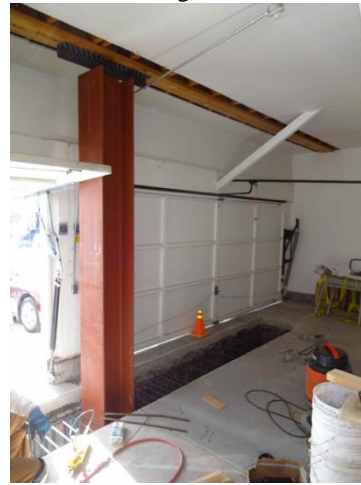
Cantilever column installed with new concrete footing (awaiting concrete) (Credit: Thor Matteson)

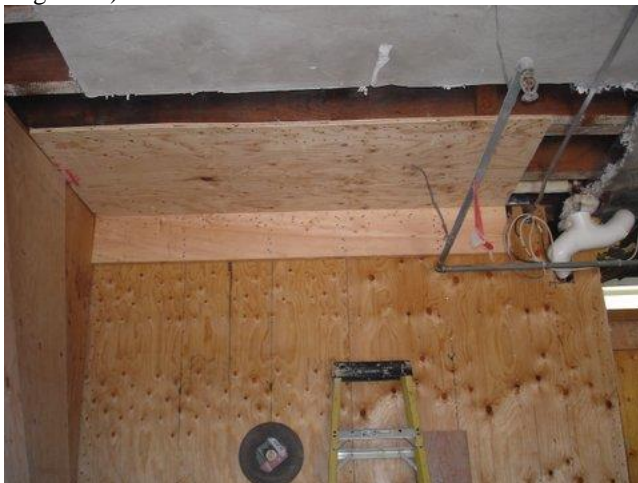
Local strengthening of the second floor diaphragm (Credit: Anthony DeMascole)
