**MEMORANDUM**

Community Services Department

**SUBJECT:** Heritage Tree Appeal – 1866 Golden Way

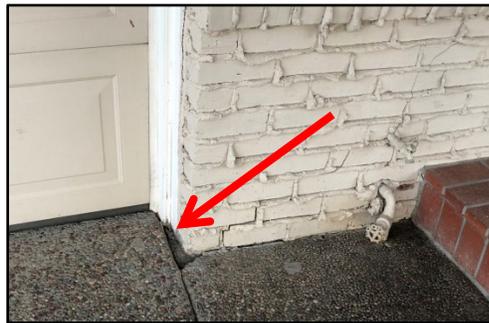
- The front-middle section of the garage pad appears to be cracked and lifted, possibly due to a current or past root issue. When the driveway was removed, it would have been a good time to review the surrounding conditions and roots impacting the driveway, porch, and garage floor. At that time, the area could have been excavated to a depth for new base rock, and roots could be evaluated for removal or shaving. It is possible that roots are lifting the center of the driveway and contributing to issues, but the garage door trim is below the concrete pour at the bottom edge of the door. This indicates that the driveway grade changed with the new driveway and they raised the section of concrete next to the garage trim. (See photo below.)

- Due to the complexities of the issues in relation to construction details and grading, staff suggested the homeowner consult with a contractor or structural engineer that could help determine any construction and grading issues that may be contributing to shifting and grade changes. Staff does not know what was done in regard to roots when the original driveway was replaced and can only offer guidance on mitigation efforts when they are available. It is possible to scan the area using ground-

- In staff's opinion, mitigation should be possible when combined with the corrective work needed to repair the areas noted above. Removing the tree without consideration for preservation is premature given that additional information is needed to determine whether the Southern magnolia tree's roots are actually causing the damage to the areas noted above and, if so, to what degree.

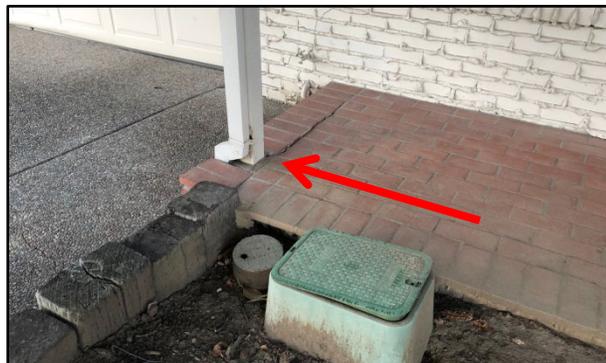
- The porch has been overlaid with a brick veneer and a section appears to have shifted, creating a lip and crack between the support post and the wall. Staff suspects that this could be a root issue but could also be a part of the construction detail or settling of the area. Again, the porch area near the post could be excavated to see if roots are impacting this location. (See photo below.)
