Appeal for 2420 Villa Nueva Way

RE: Appeal for HTR-9901

This is an appeal to the Urban Forestry Board's denial of permit HTR-9901 to remove a California Coastal Redwood tree affecting my property at 240 Chatham Way.

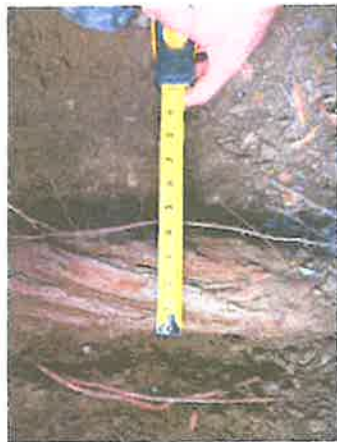
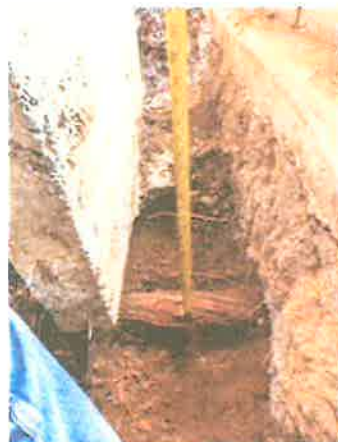
**FIG 3:** 4" inch root found 24" directly below the concrete footing of the property line retaining wall (**FIG 4**), which has been uplifted nearly 2' by the roots.

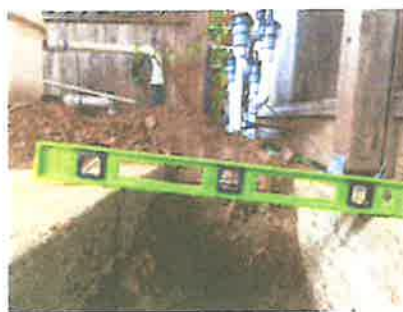
**FIG 5:** Concrete slab where pool equipment is at 240 Chatham Way. The property line retaining wall on the right is the property ground level. Level shows the elevation change caused by the redwood tree roots uplifting the ground underneath the slab.

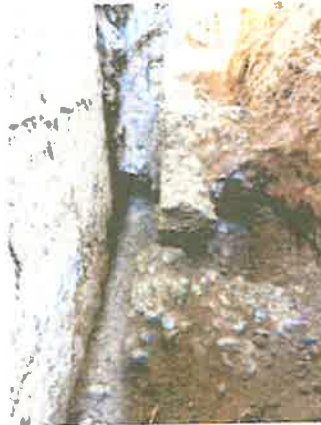
**FIG 6:** Damage to the property line retaining wall and footing.

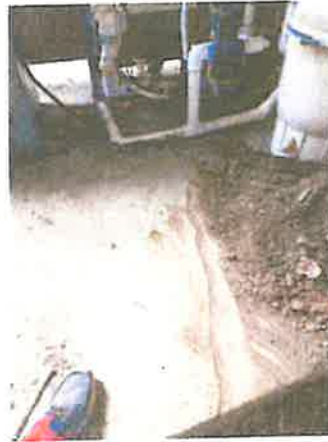
**FIG 7:** Proximity to pool equipment with crack extending precariously underneath the plumbing and pumps. Repairs estimated at \$15,000.

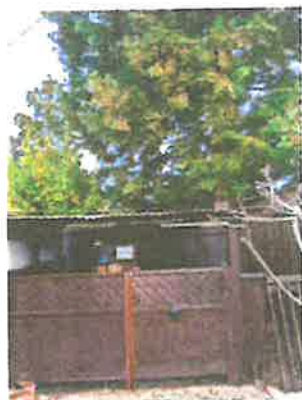
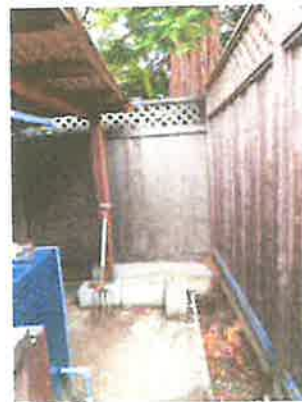
**FIG 8:** View of the pool equipment area with the redwood tree on the back. **FIG 9:** This photo shows the elevated property line retaining wall, which should be at ground level and the corner of the slab being pushed up by underground roots.

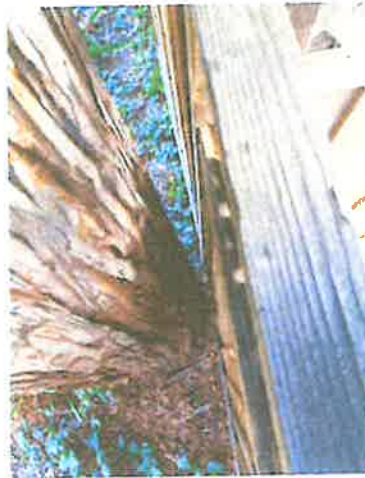
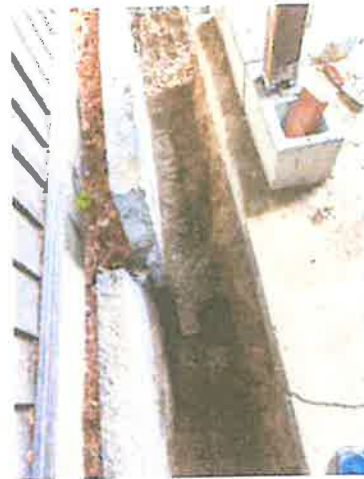
**FIG 1:** Top view of fence showing proximity to tree. **FIG 2:** Other side showing foundation damage already caused. Pool equipment sits on the concrete slab, and shows the start of a crack on the bottom right. Current estimated cost of repairs is \$15,000.
