Re: Heritage Tree Removal location: 2415 Benjamin Dr.

# HERITAGE TREE REMOVAL ACTION PENDING

Location: 2415 BENJAMIN DR

Type of Tree: PODOCARPUS

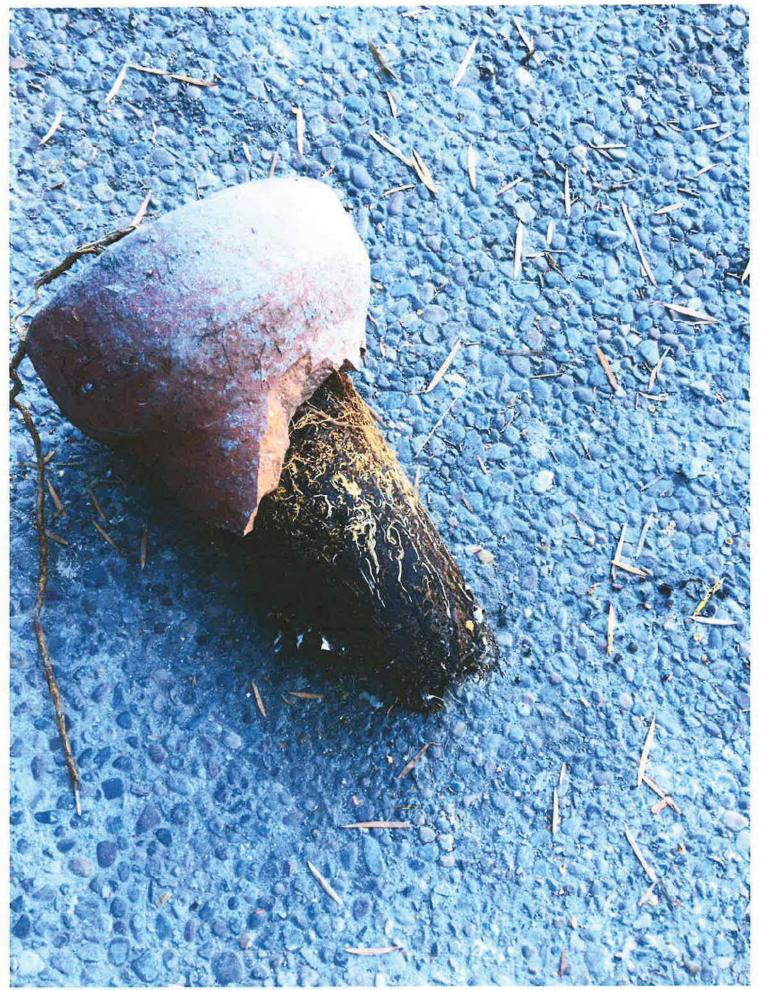
- 1) The tree damaged my sewer line (see attached invoices totaling \$58,789.00 & letter from EJ Plumbing stating the damage was caused by the above referenced tree, and picture of the damaged sewer line).
- 2) Impact on gas supply line to our house (see attached photo of PG&E mark on the tree root/stump indicating location of gas supply line)
- 3) The tree has raised the floor & driveway on the right side of our garage. Interfering with operation of our right side garage door.
