## 881 Castro Street Mixed-Use Project

### Class 32 Categorical Exemption Report

**September 2025**

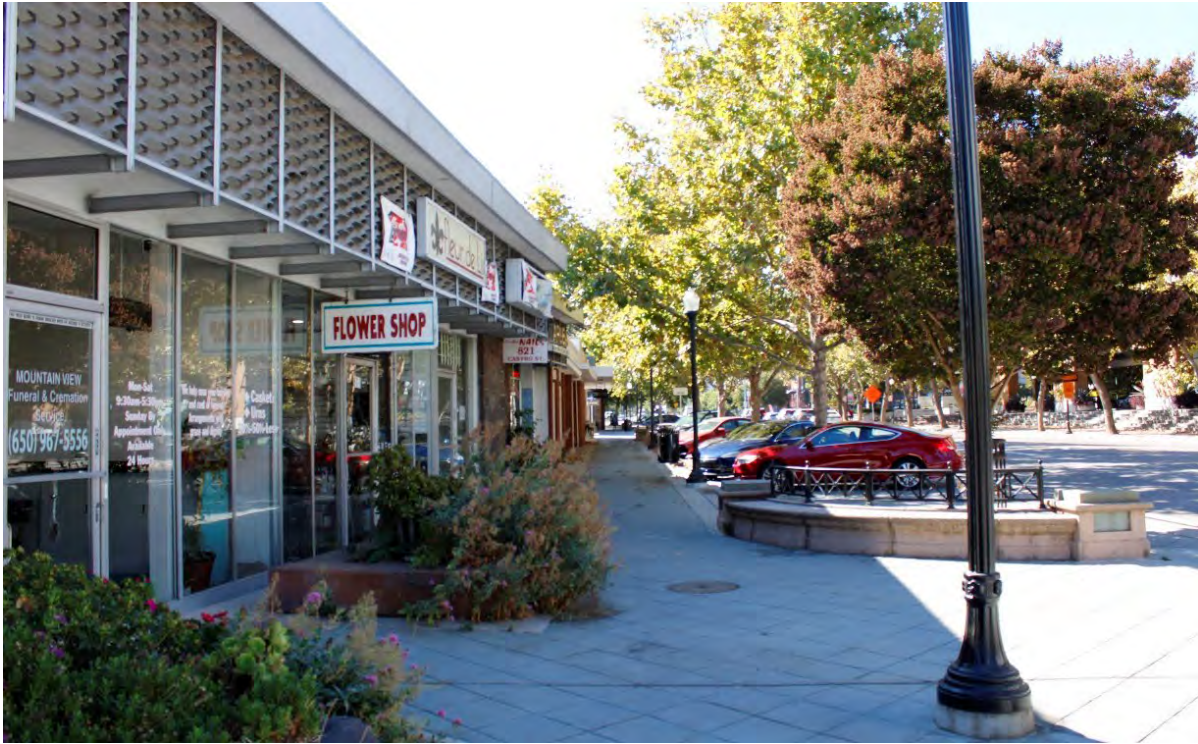
**Photograph 1.** Southerly view from near the intersection of Castro Street and Yosemite Avenue. The project site is visible to the left side of the photo, characterized by retail buildings.

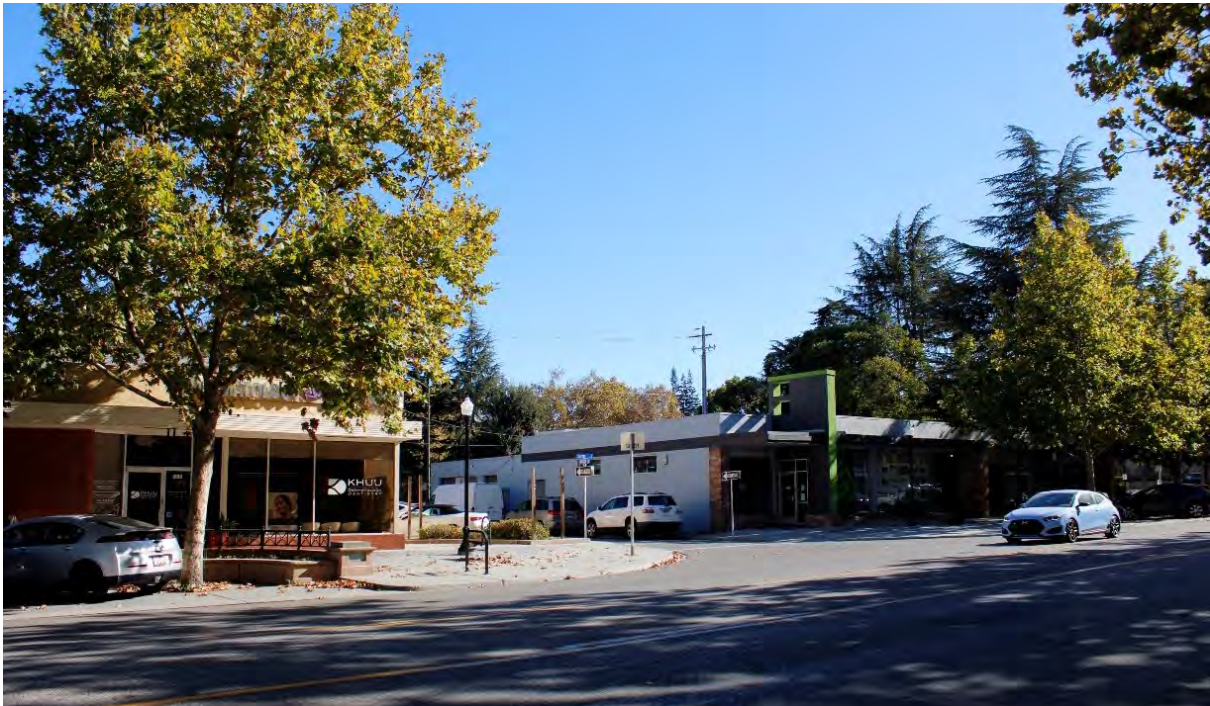
**Photograph 2.** Easterly view of project site from Castro Street. This photo shows the area of the project site characterized by retail buildings and Fairmont Avenue.

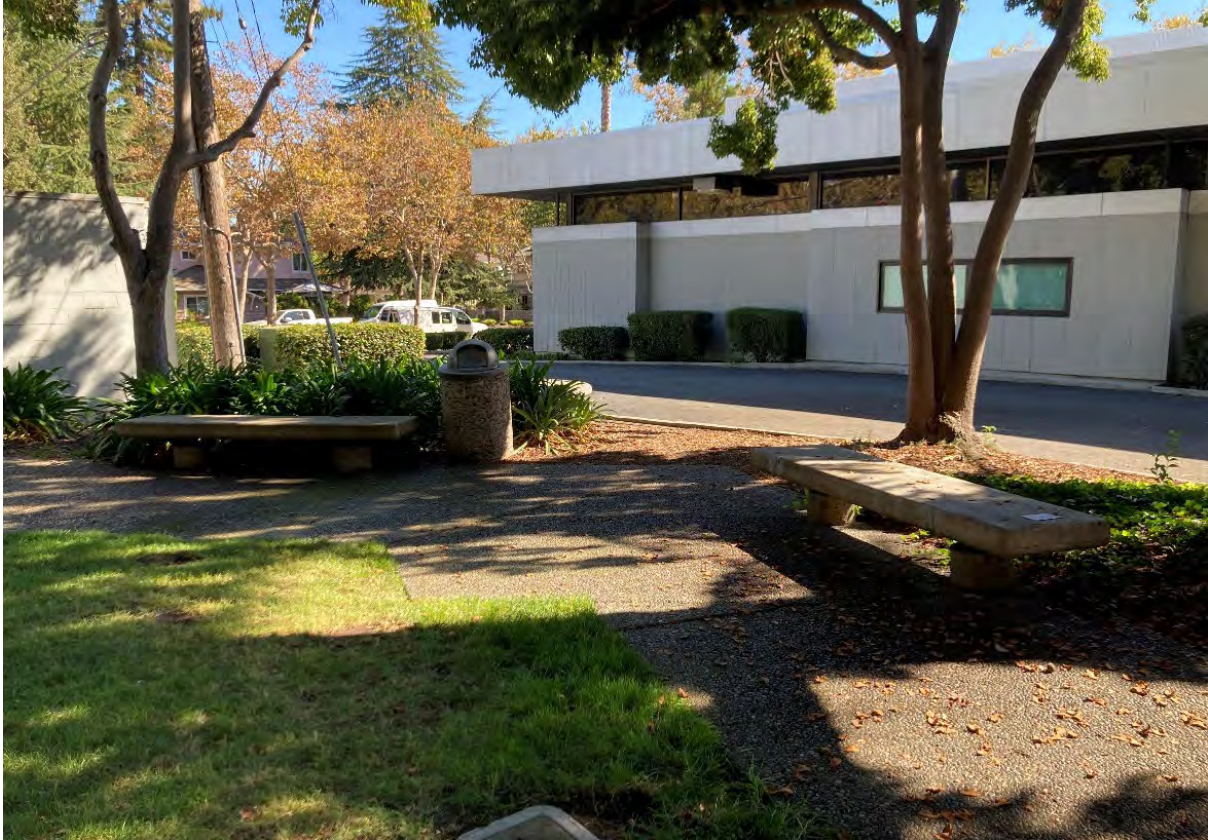
**Photograph 3.** Easterly view of the project site from Gateway Park. This area of the project site is characterized by the existing bank and office building.

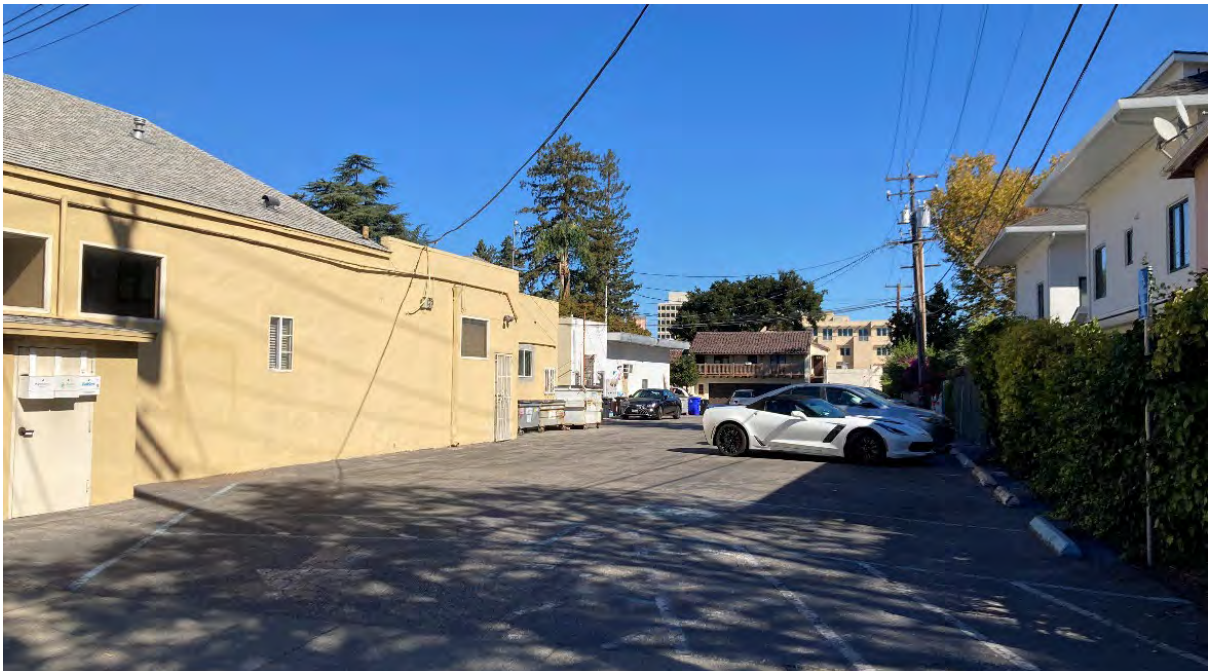
**Photograph 4.** Northerly view from internal to the project site near Fairmont Avenue. This area of the project site is characterized by surface parking for existing businesses on-site.

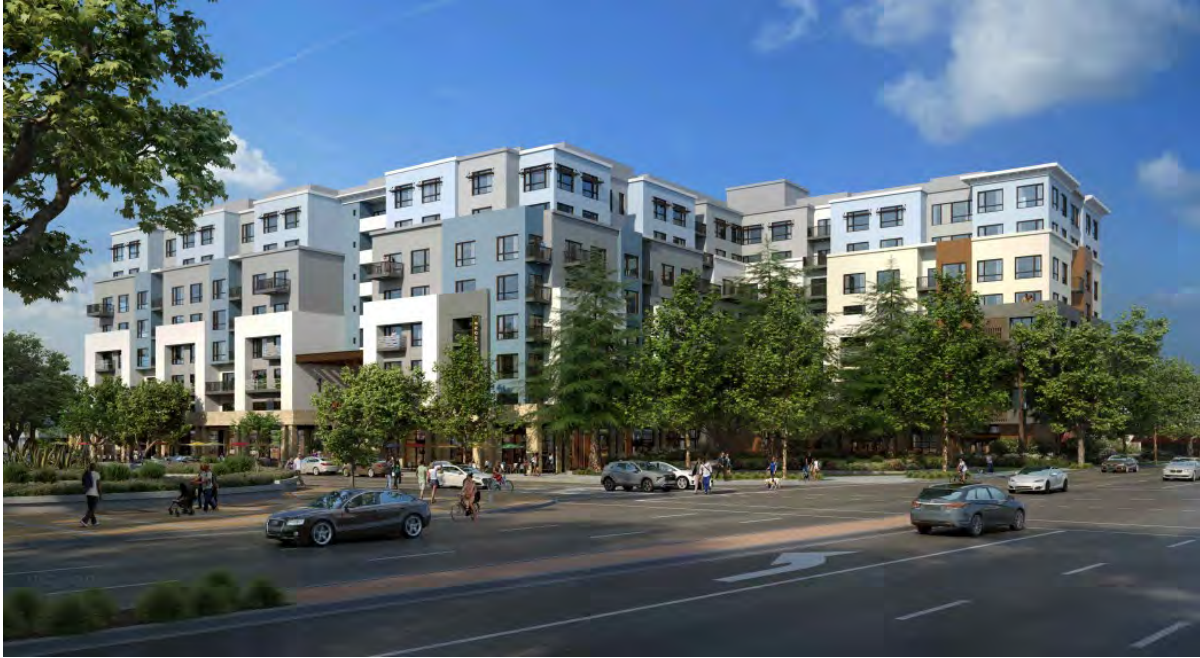
Proposed building from the intersection of Castro Street and El Camino Real

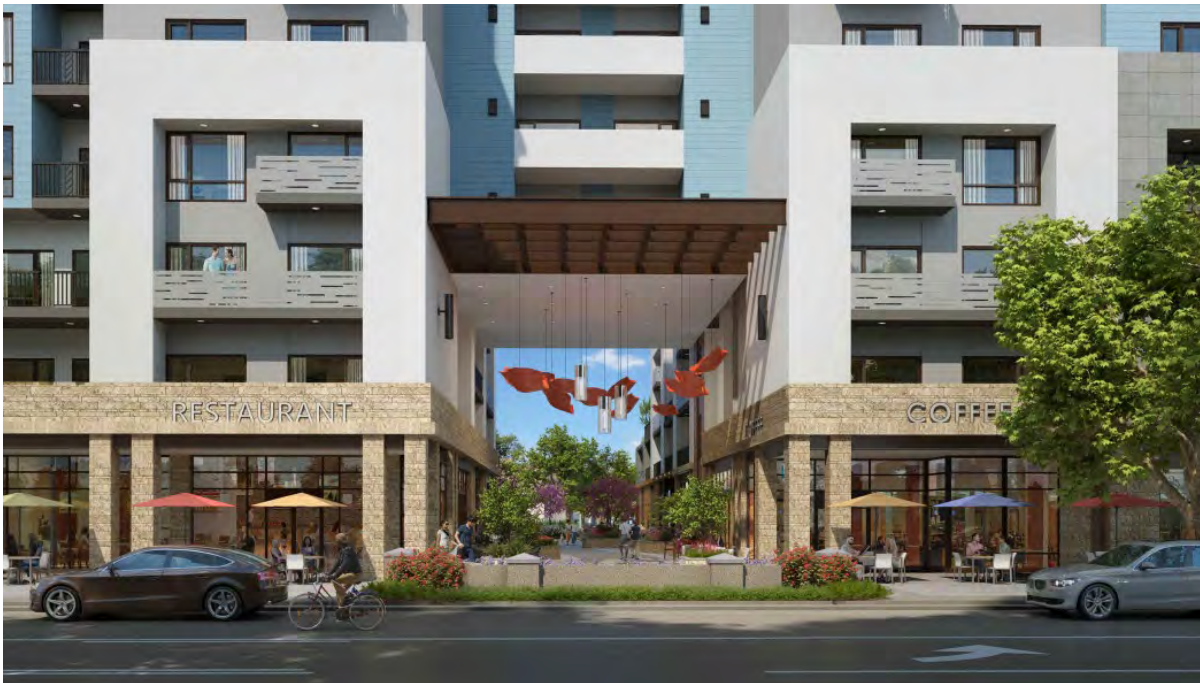
Paseo of proposed building from Castro Street

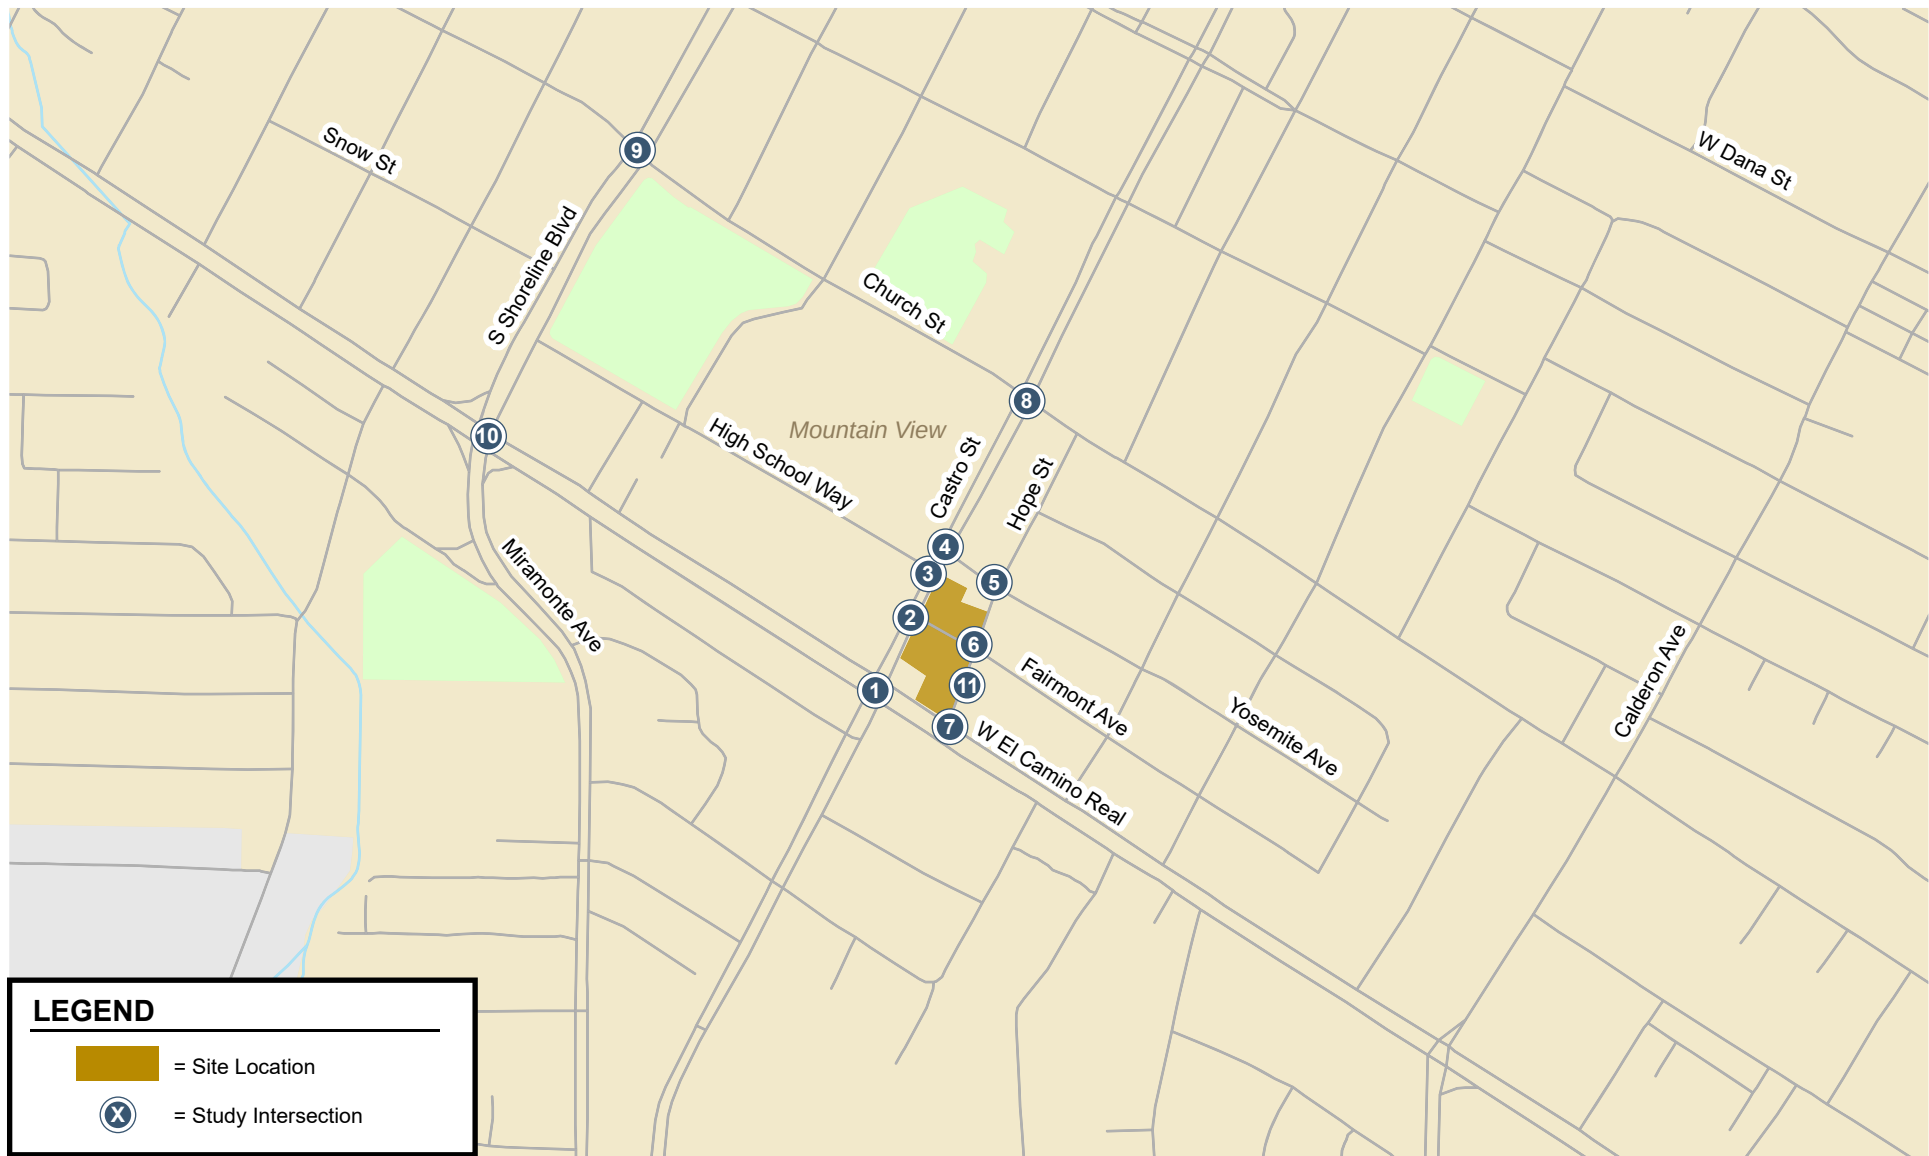
**Figure 1**  
**Site Location and Study Intersections**

The study intersections were selected in accordance with the City's *MTA Handbook*, VTA's *Transportation Impact Analysis (TIA) Guidelines* (October 2014), and in consultation with Mountain View staff. The study includes those intersections that would experience a traffic increase of 10 or more peak-hour trips per lane. The study intersections are listed below and shown on Figure 1. Two study intersections are designated as CMP intersections.

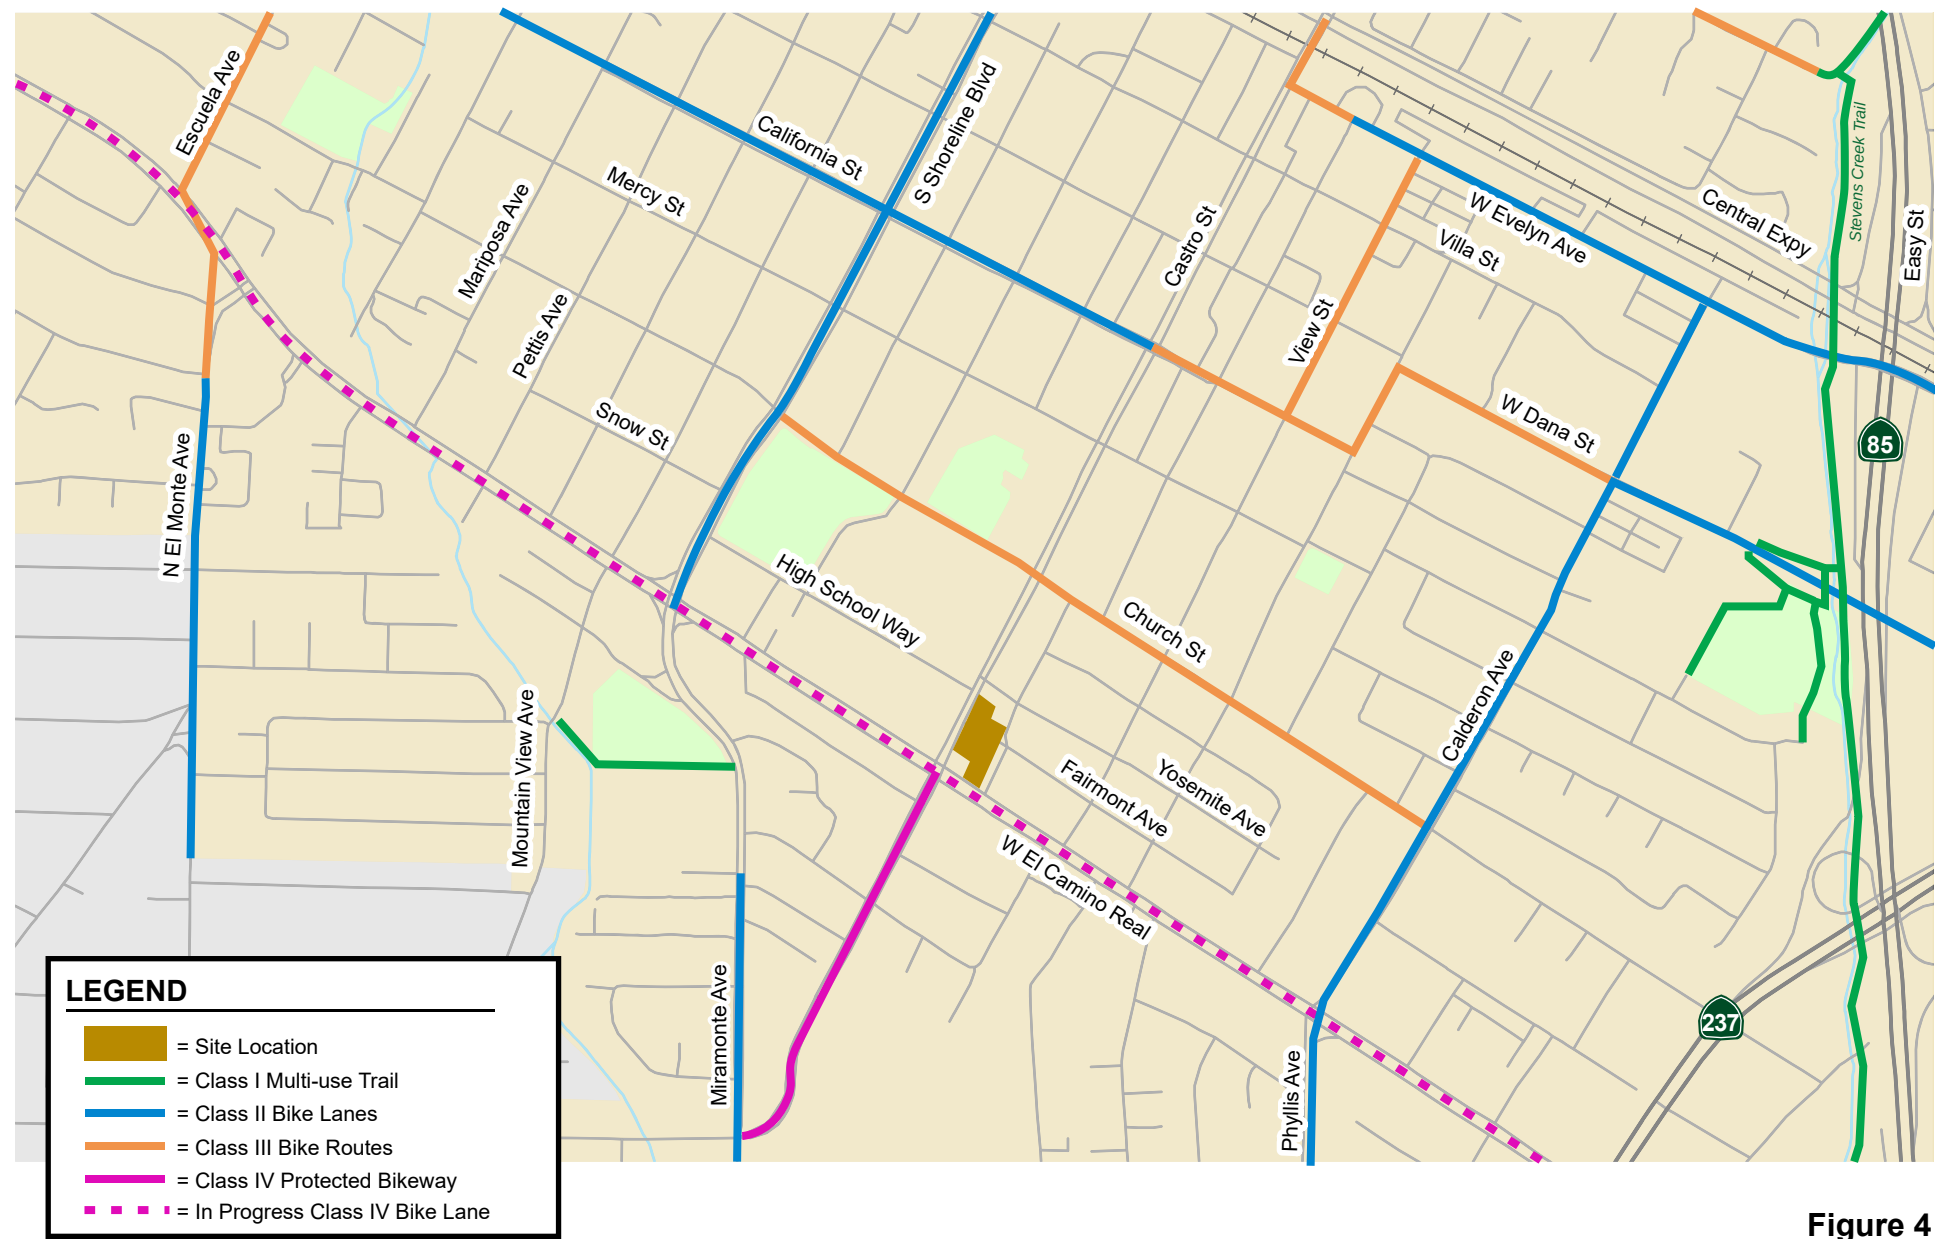
Figure 4  
Existing Bicycle Facilities

The bicycle facilities that exist within one mile of the project site (see Figure 4) include a multi-use trail (Class I bikeway), striped bike lanes (Class II bikeway), shared bike routes (Class III bikeway), and protected bike lanes (Class IV bikeway). Bike paths or multi-use trails are shared between pedestrians and bicyclists and separated from motor vehicle traffic. Bike lanes are lanes on roadways designated for use by bicycles with special lane markings, pavement legends, and signage. Bike routes are streets with signage and pavement markings where bicyclists share a travel lane with motorists. Protected bike lanes are lanes on roadways that provide separation between bicyclists and vehicles through posts, parked cars, planters, etc.

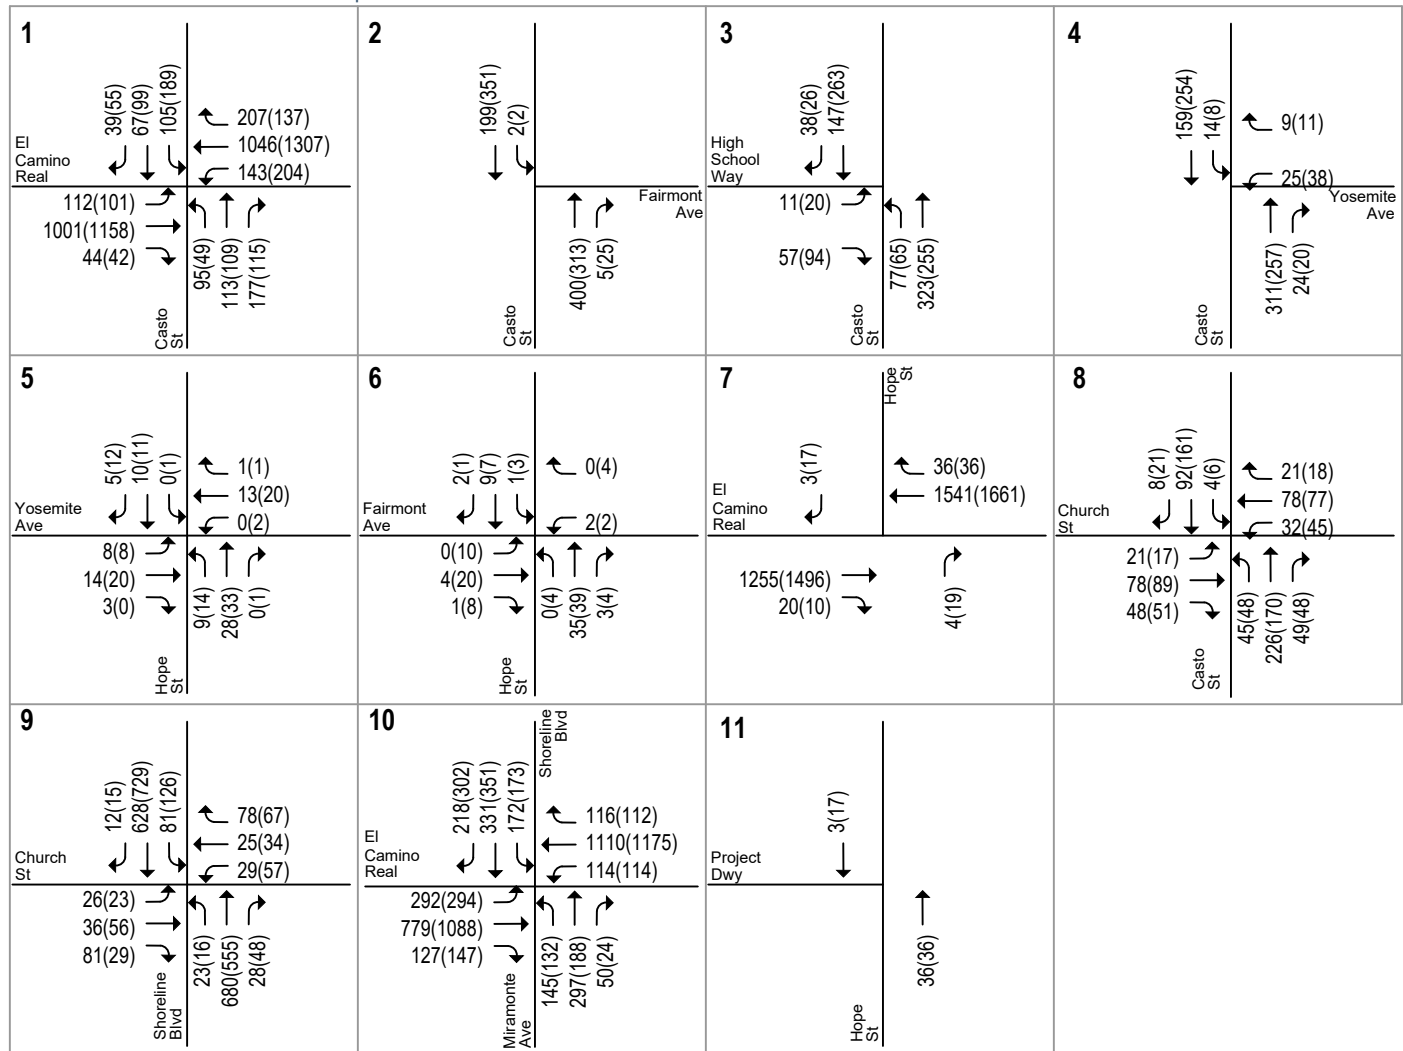
Existing traffic volumes were obtained from turning movement counts collected on a typical weekday, Thursday, September 12, 2024, between 7:00 and 10:00 AM and between 4:00 and 7:00 PM (see Figure 6). The intersection turning-movement counts conducted for this analysis are presented in Appendix A.

XX(XX) = AM(PM) Peak-Hour Traffic Volumes

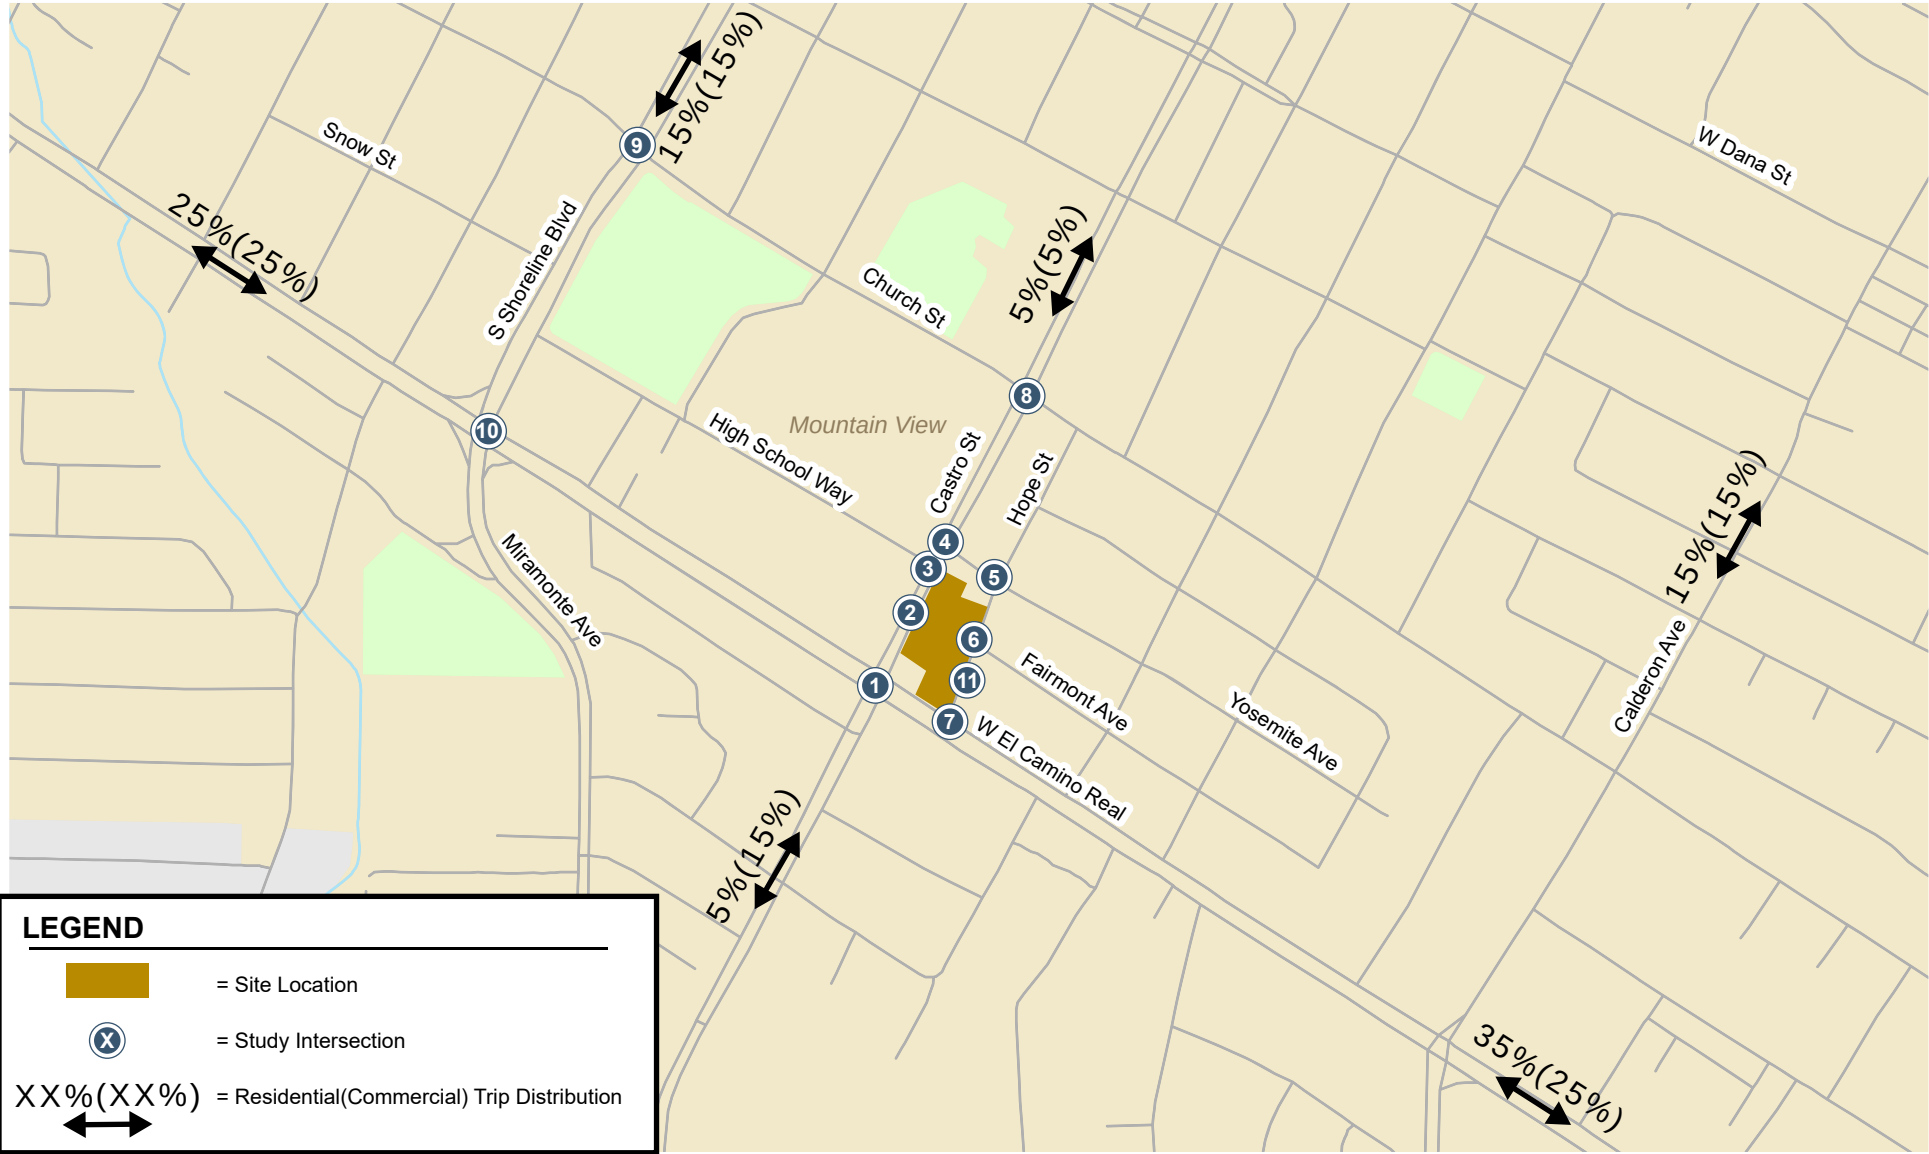
Figure 7  
Project Trip Distribution

There are some movements with negative trips due to existing credits. Some movements, such as inbound and outbound movements to/from Fairmont Avenue, would not exist anymore. In addition, due to the different access points between the existing developments and the proposed development, some movements would not be replaced with project traffic.

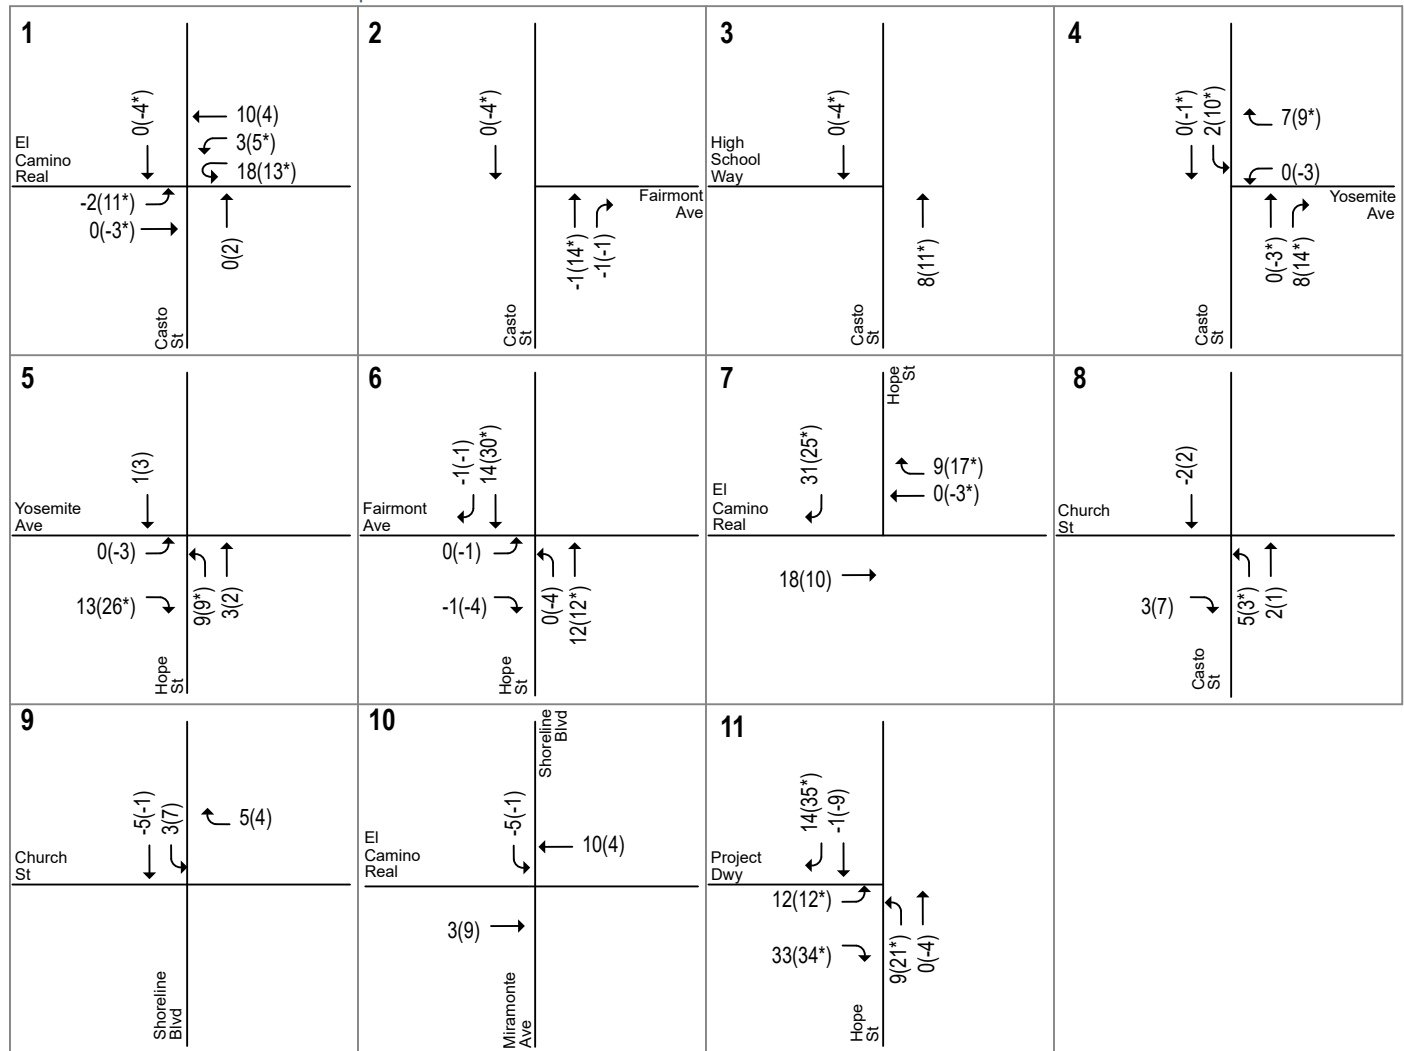
The trip distribution for the project was estimated based on existing travel patterns on the surrounding roadway network and the locations of complementary land uses (see Figure 7). Although Castro Street is closed to vehicular traffic north of California Street, motor vehicle trips to/from the Downtown area are expected to use Castro Street as the connecting road between the project site and the Downtown, and the trip distribution is taking into account overall Downtown access.

XX(XX) = AM(PM) Peak-Hour Trips

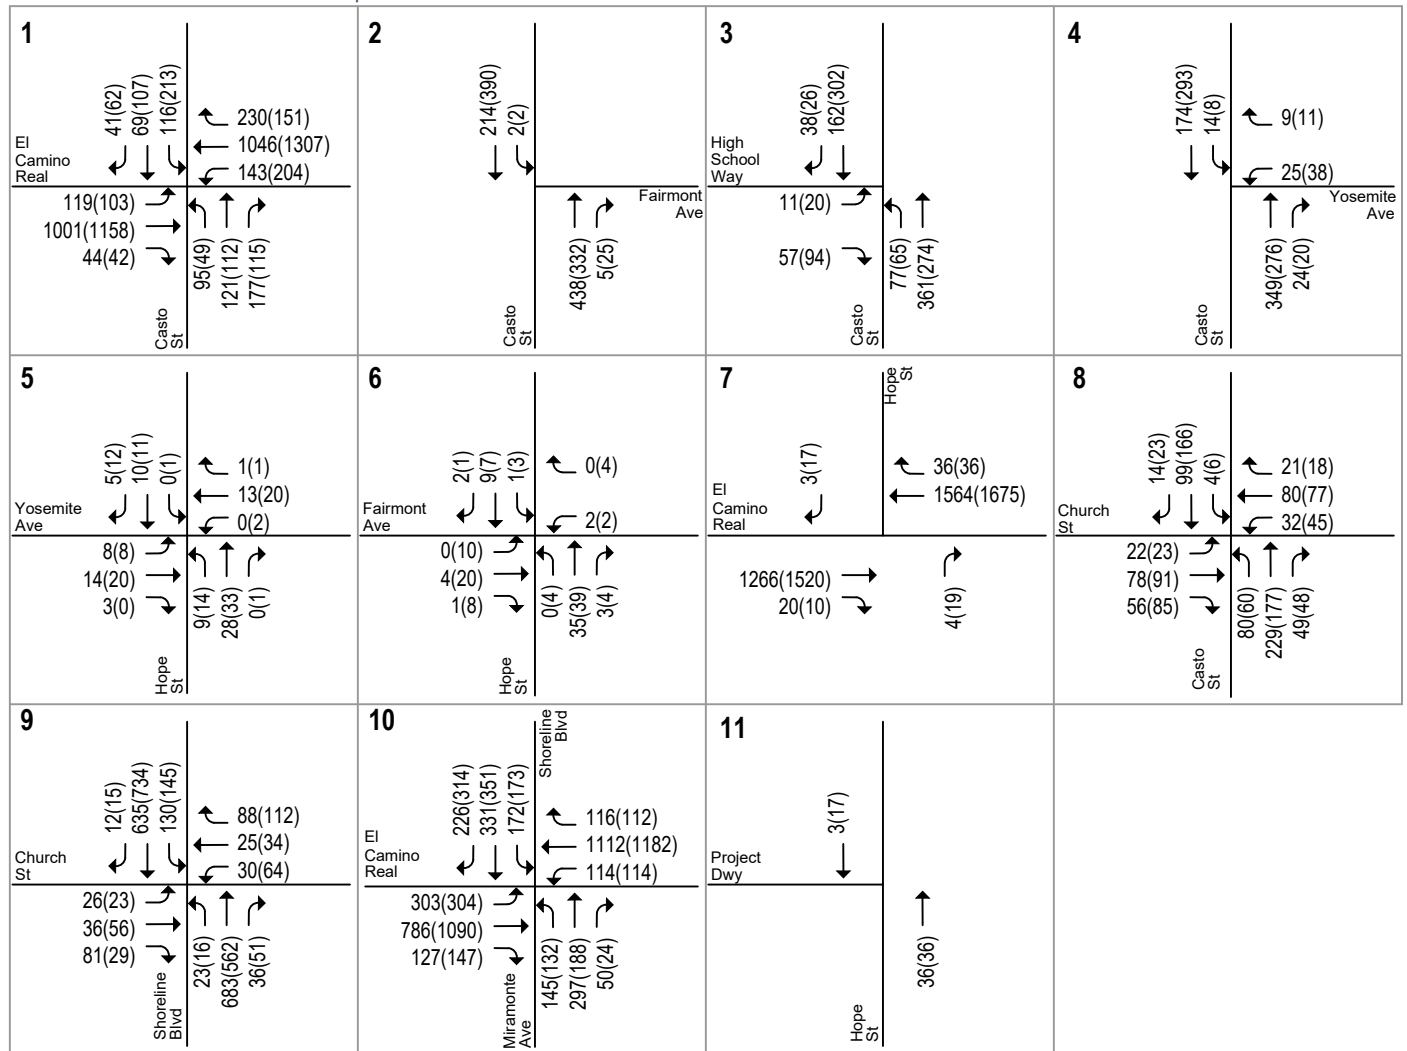
It is expected that the traffic traveling southbound and northbound on Castro Street and turning onto eastbound Fairmont Avenue would be relocated to Yosemite Avenue and El Camino Real, respectively. There are surface parking spaces behind the existing commercial buildings on Castro Street between Yosemite Avenue and Fairmont Avenue. Traffic associated with these parking spaces currently enters Yosemite Avenue and exits through Fairmont Avenue. The project would demolish the southern part of the area (buildings and surface parking), so the traffic associated with the remaining parking spaces would need to exit through Yosemite Avenue with the project. The project should work with the adjacent property to reconfigure the remaining surface parking area, so that traffic can enter and exit the parking area via Yosemite Avenue. Figure 9 shows the estimated diverted traffic from Fairmont Avenue during the AM and PM peak hours.

XX(X) = AM(PM) Peak-Hour Traffic Volumes

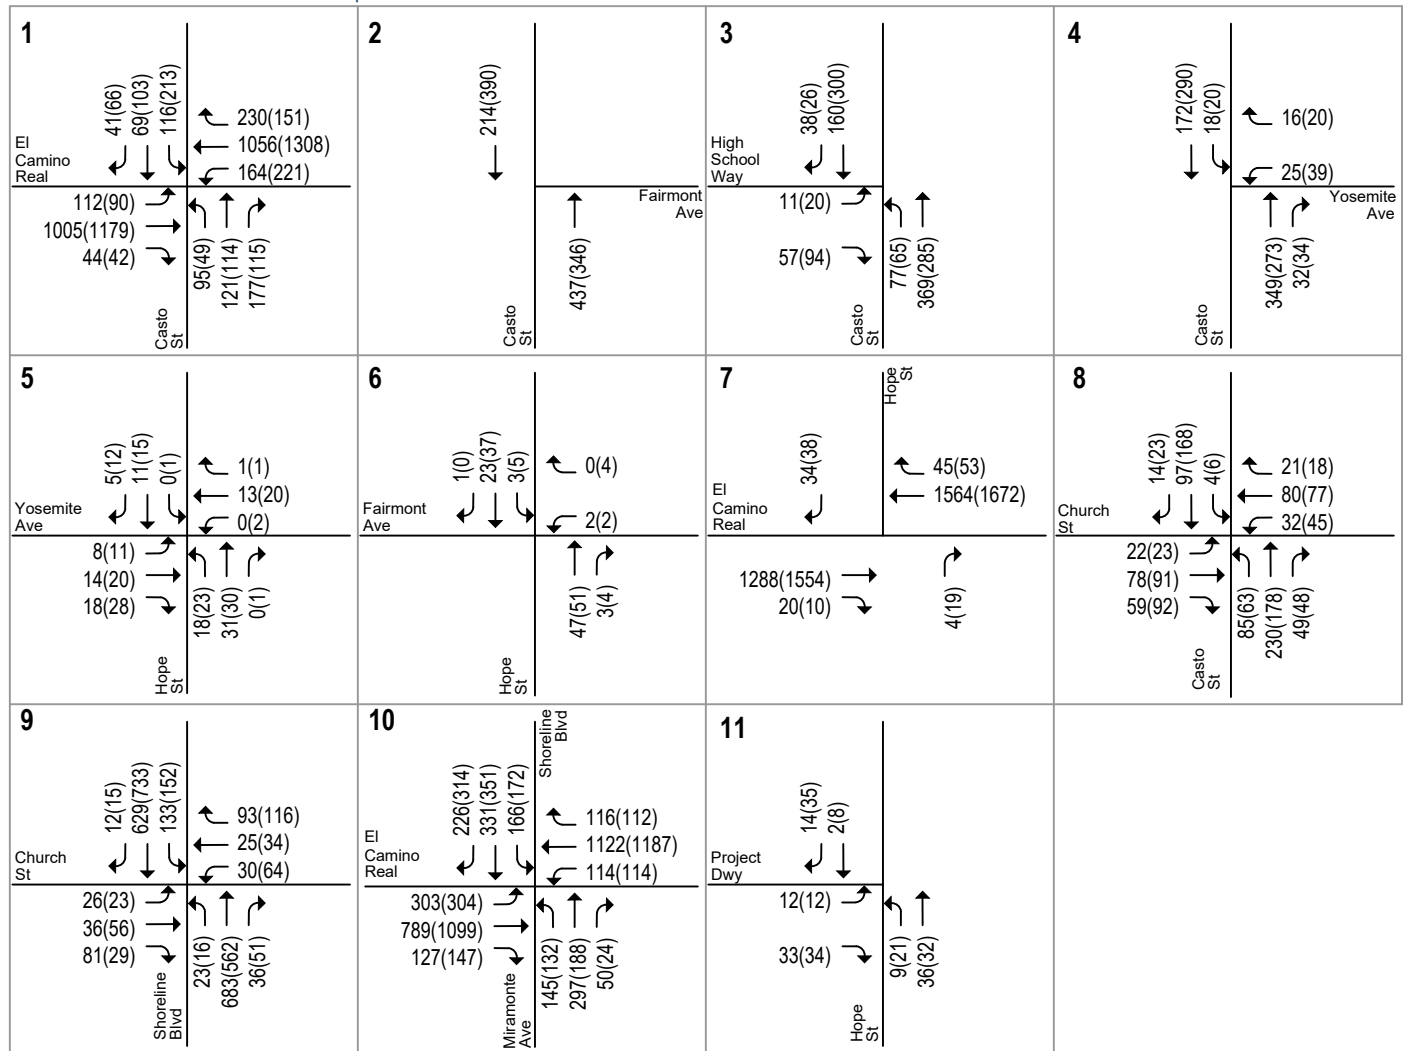
**Figure 10**  
**Background Traffic Volumes**

Background traffic volumes for the study intersections (see Figure 10) were estimated by adding to the existing traffic volumes the trips generated by nearby approved projects that have not been constructed or occupied.

XX(XX) = AM(PM) Peak-Hour Traffic Volumes

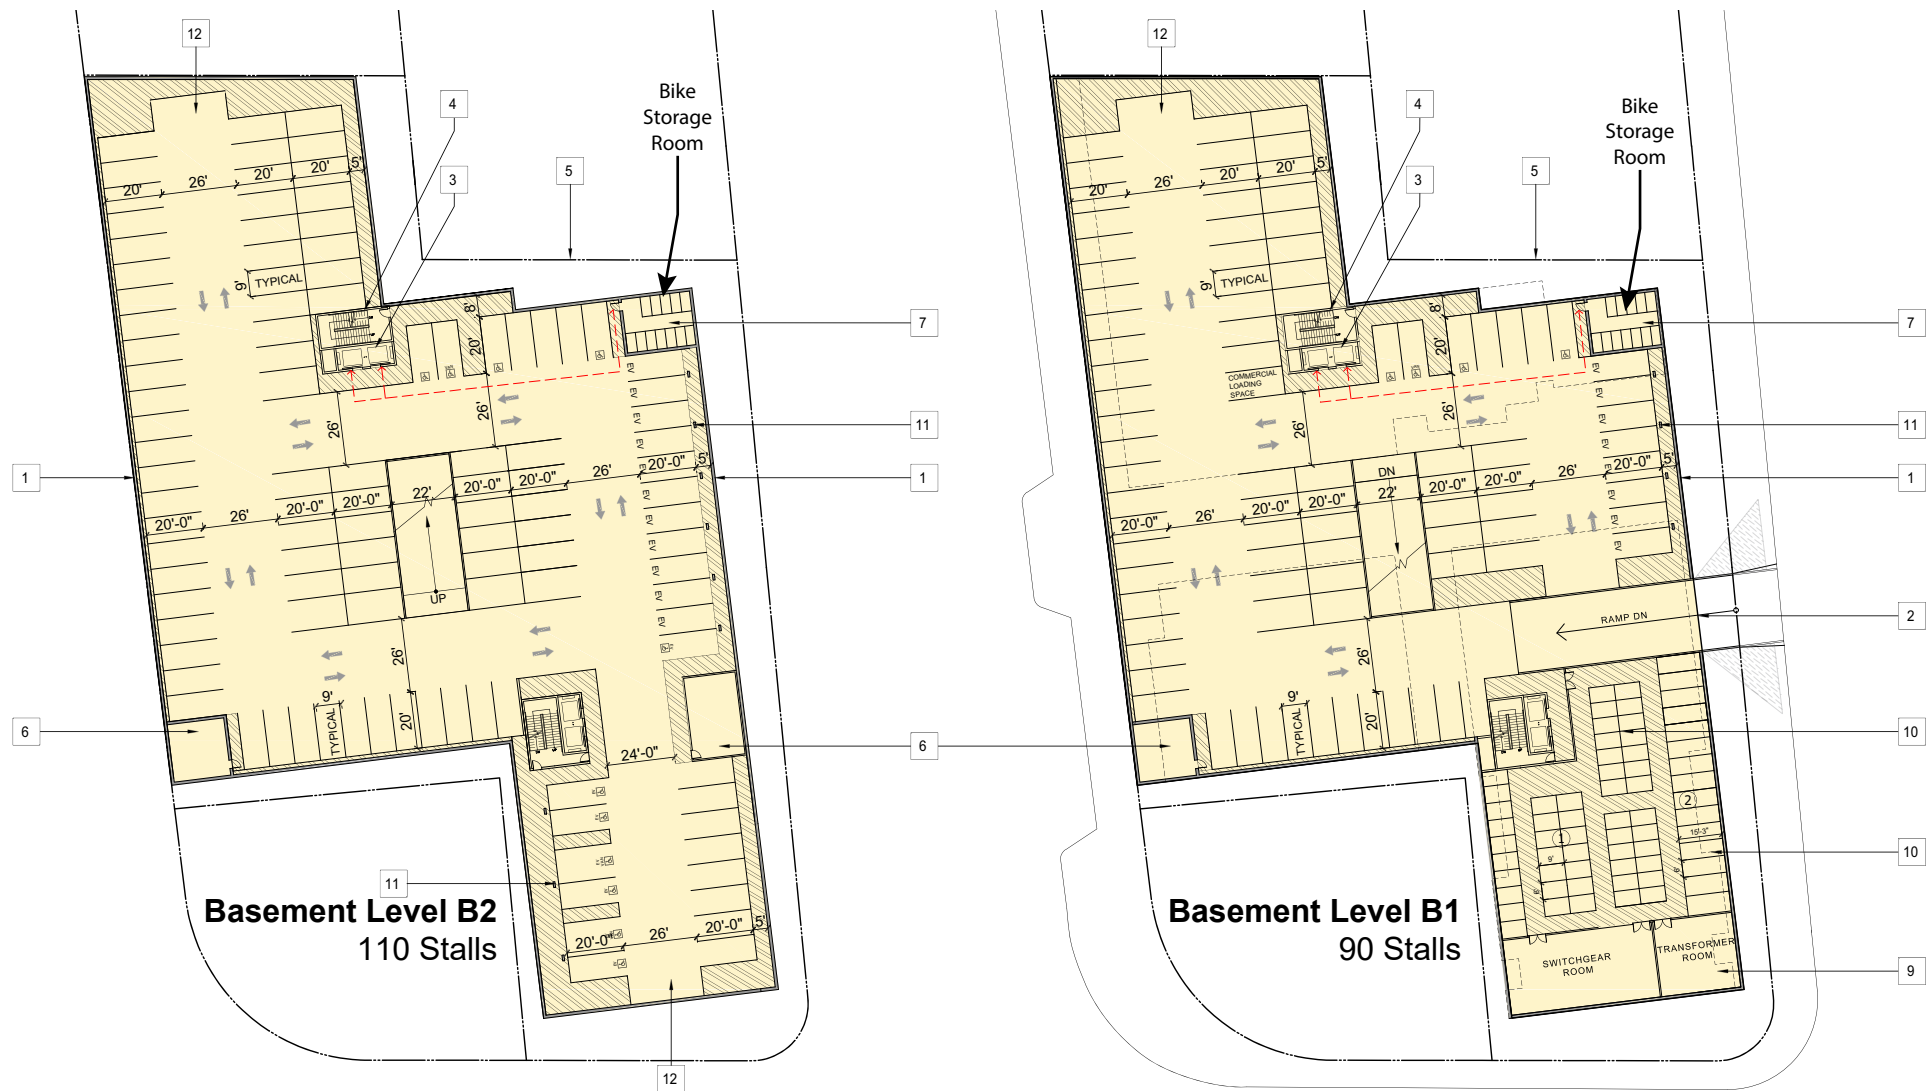
**Figure 12**  
**Parking Garage Plans**

The site plan indicates a loading zone along the project frontage on Hope Street, just south of the driveway, which would be convenient for people accessing the site using Uber/Lyft or other rideshare apps (e.g., Scoop, Bay Area Carpool). The site plan does not indicate if the loading zone would be limited to only freight loading. The loading zone should be signed for both freight and passenger loading.
