## 881 Castro Street Mixed-Use Project

### Class 32 Categorical Exemption Report

**September 2025**

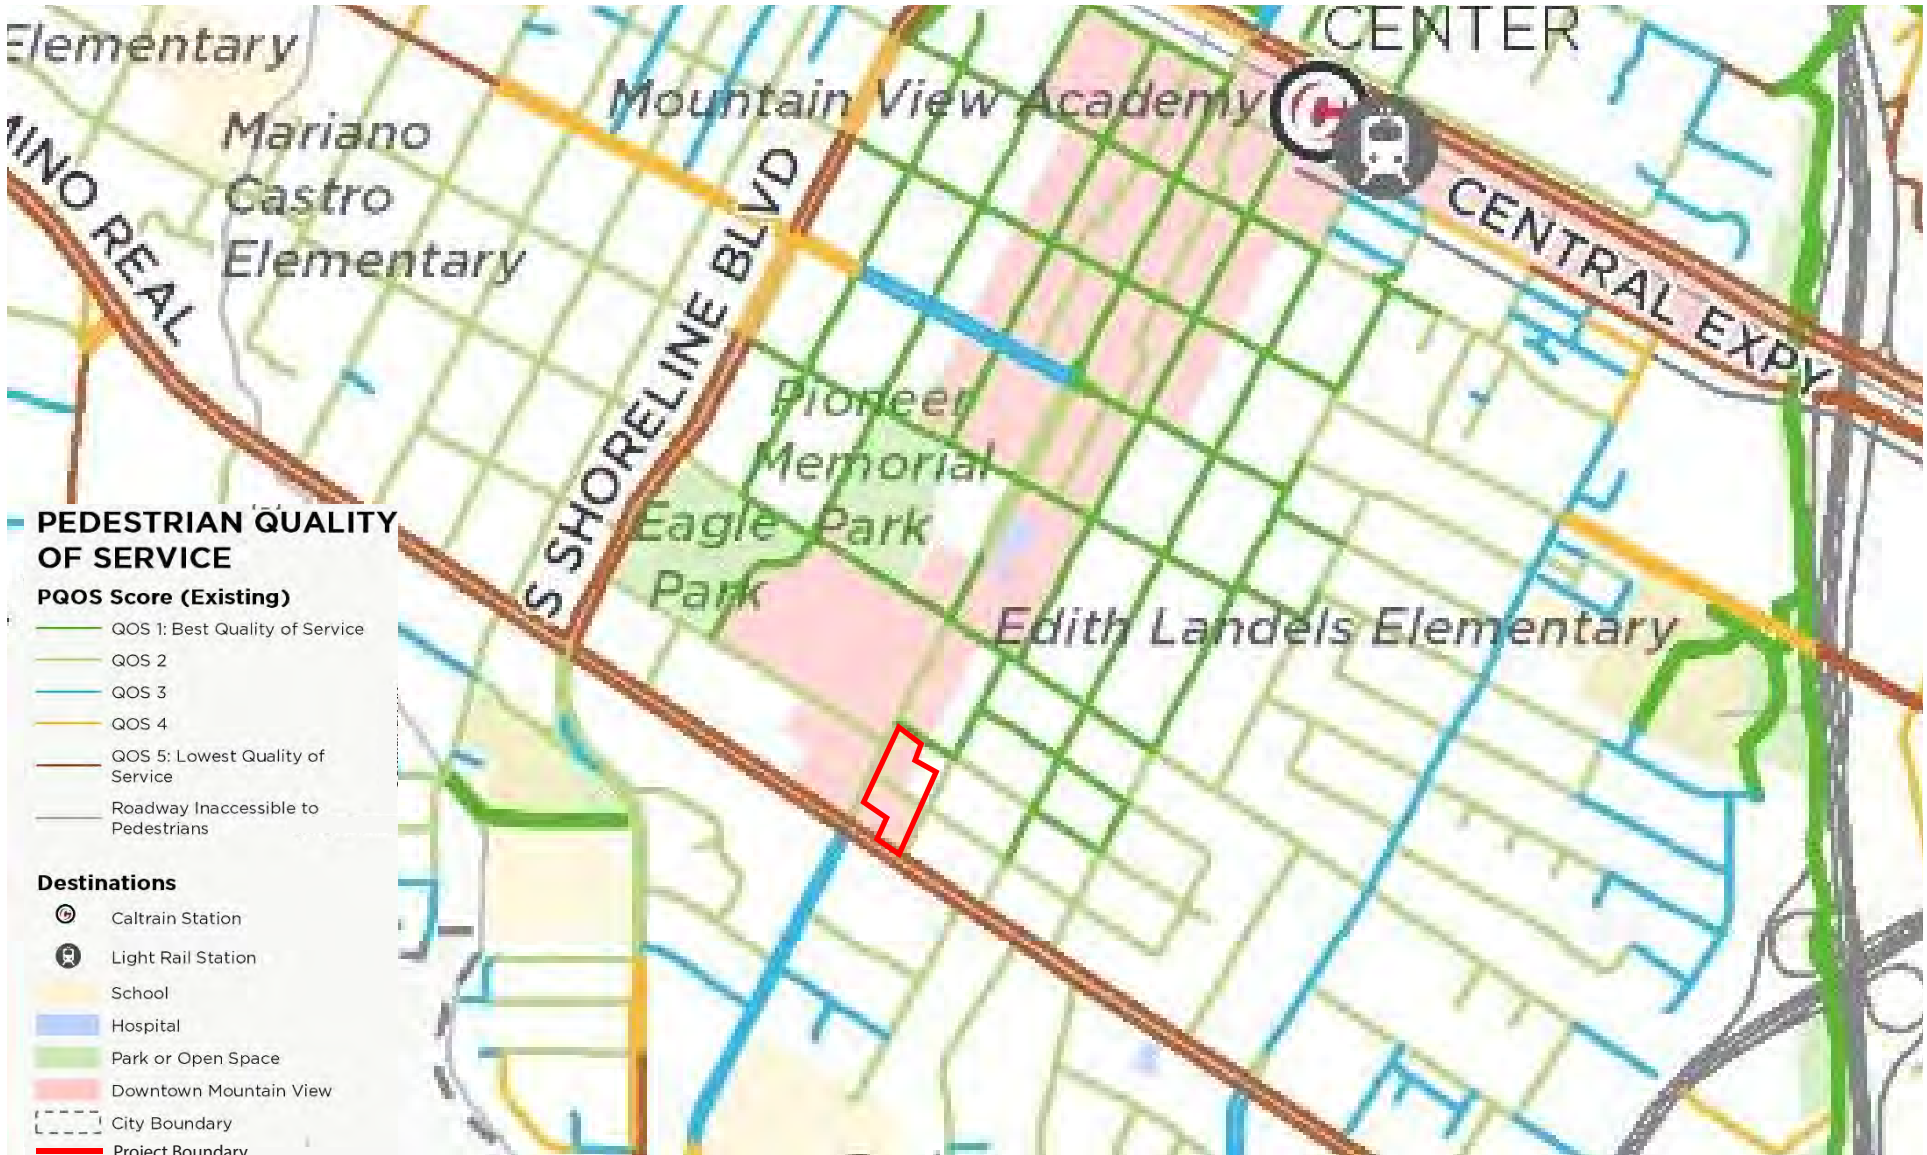
Figure 13  
Pedestrian Quality of Service (PQOS) Map

PQOS identifies the level of comfort for pedestrians on any given roadway. Mountain View's Comprehensive Modal Plan (AccessMV), published in May 2021, includes a PQOS map (see Figure 13) that shows continuity or gaps in the pedestrian facilities as indicated with a PQOS score ranging from 1 to 5. A higher PQOS score indicates a low quality of service.

According to the City's *MTA Handbook*, a project would result in an adverse effect on pedestrian operations if the project increases vehicle trips to a roadway with a pedestrian quality of service (PQOS) score of 3 or more.

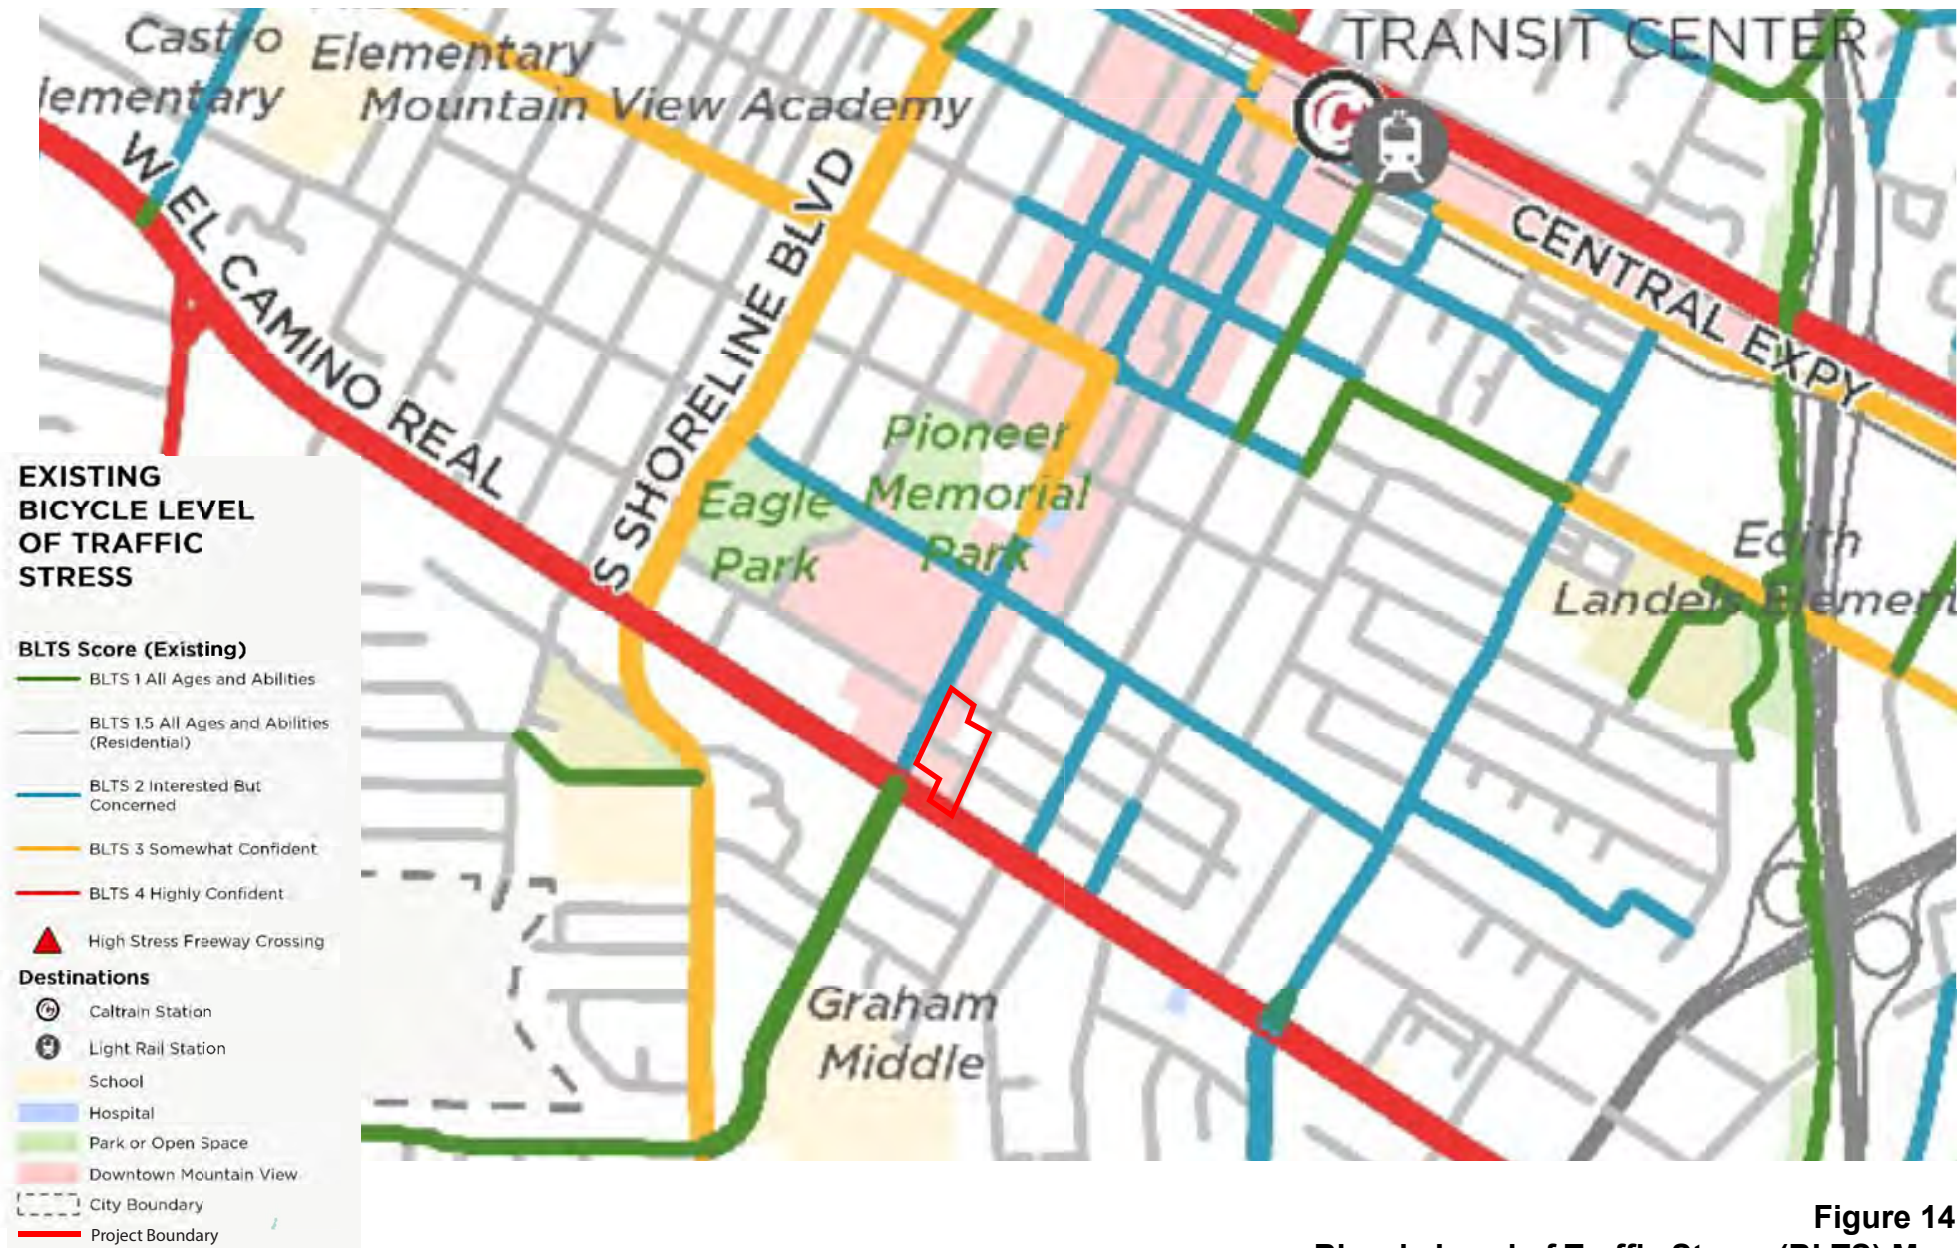
Figure 14  
Bicycle Level of Traffic Stress (BLTS) Map

The City's AccessMV report includes a BLTS map (see Figure 14) to identify the perceived comfort and safety of existing roads and bikeway facilities from the perspective of cyclists, as indicated with a BLTS score ranging from 1 to 4. A higher BLTS score indicates that the bikeway is comfortable for a more confident adult. A BLTS score of 1 is comfortable for all ages and abilities, a BLTS score of 2 is comfortable for an average adult, while a BLTS score of 4 indicates that the streets are comfortable only for highly confident riders. The metric (ranging from 1 to 4) in the AccessMV document covers the following factors:

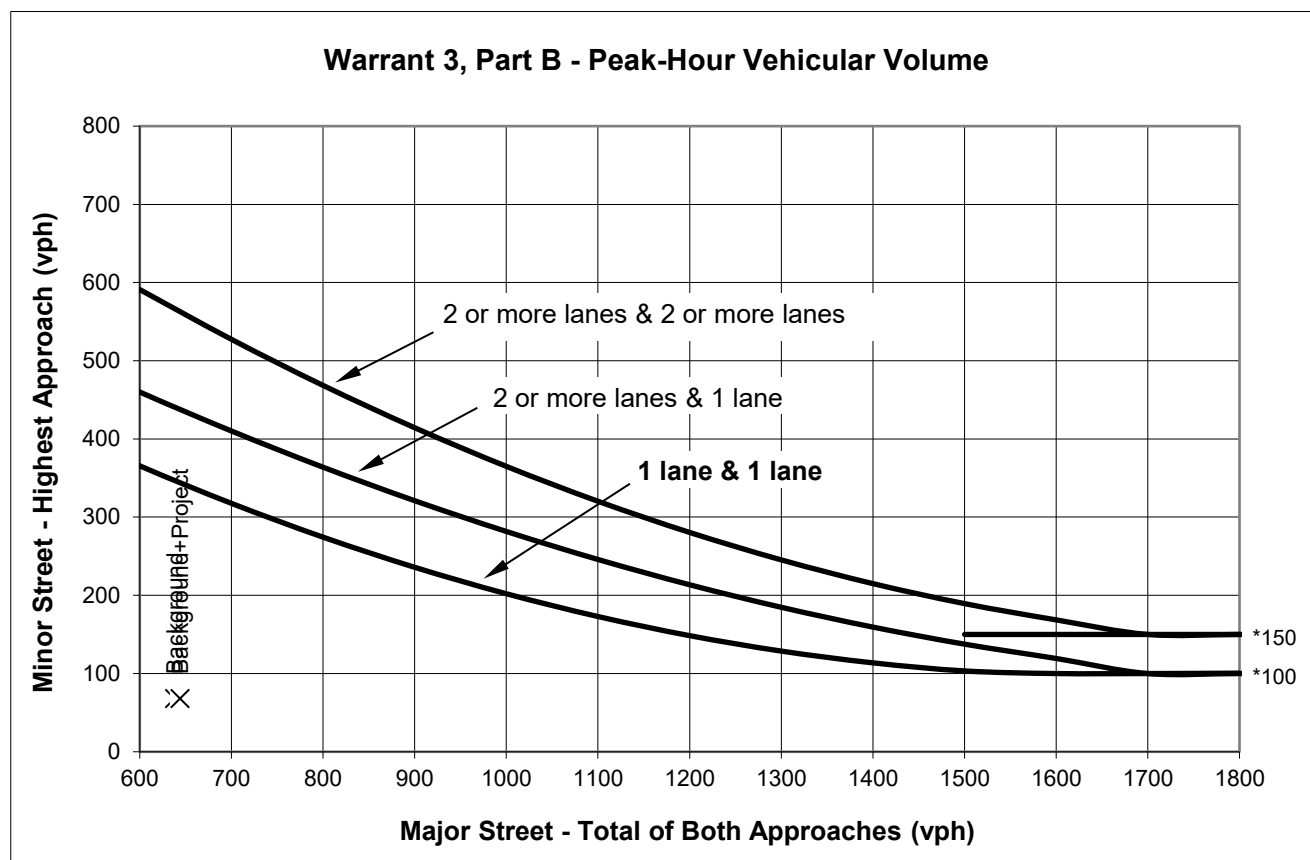
Castro St &amp; High School Way

AM PEAK PERIOD

Source: Figure 4C-3 California Manual on Uniform Traffic Control Devices for Streets and Highways (FHWA's MUTCD 2009 Edition, as amended for use in California).

\* Note: 150 vph applies as the lower threshold volume for a minor-street approach with two or more lanes and 100 vph applies as the lower threshold volume for a minor-street approach with one lane.

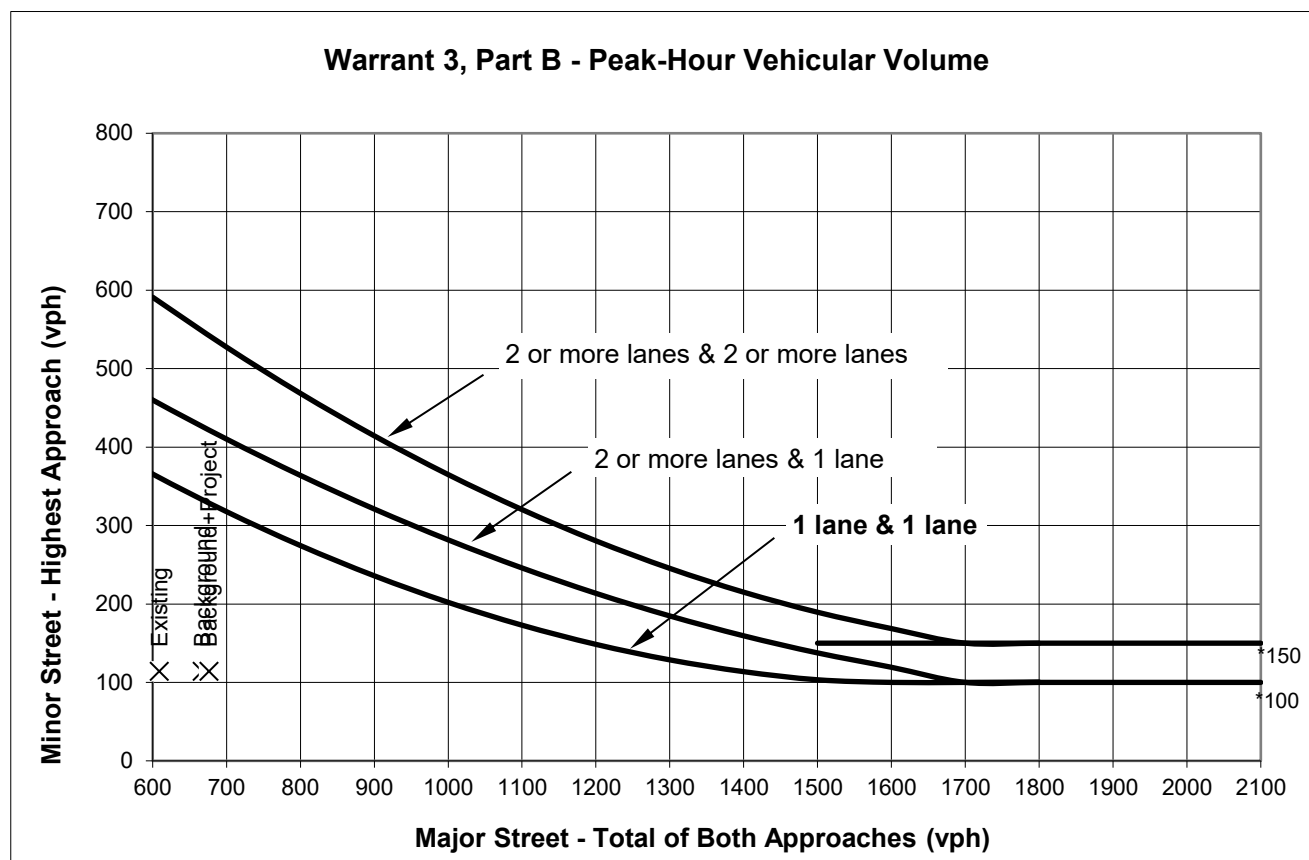
Castro St &amp; High School Way

PM PEAK HOUR

Source: Figure 4C-3 *California Manual on Uniform Traffic Control Devices for Streets and Highways (FHWA's MUTCD 2009 Edition, as amended for use in California)*.

\* Note: 150 vph applies as the lower threshold volume for a minor-street approach with two or more lanes and 100 vph applies as the lower threshold volume for a minor-street approach with one lane.

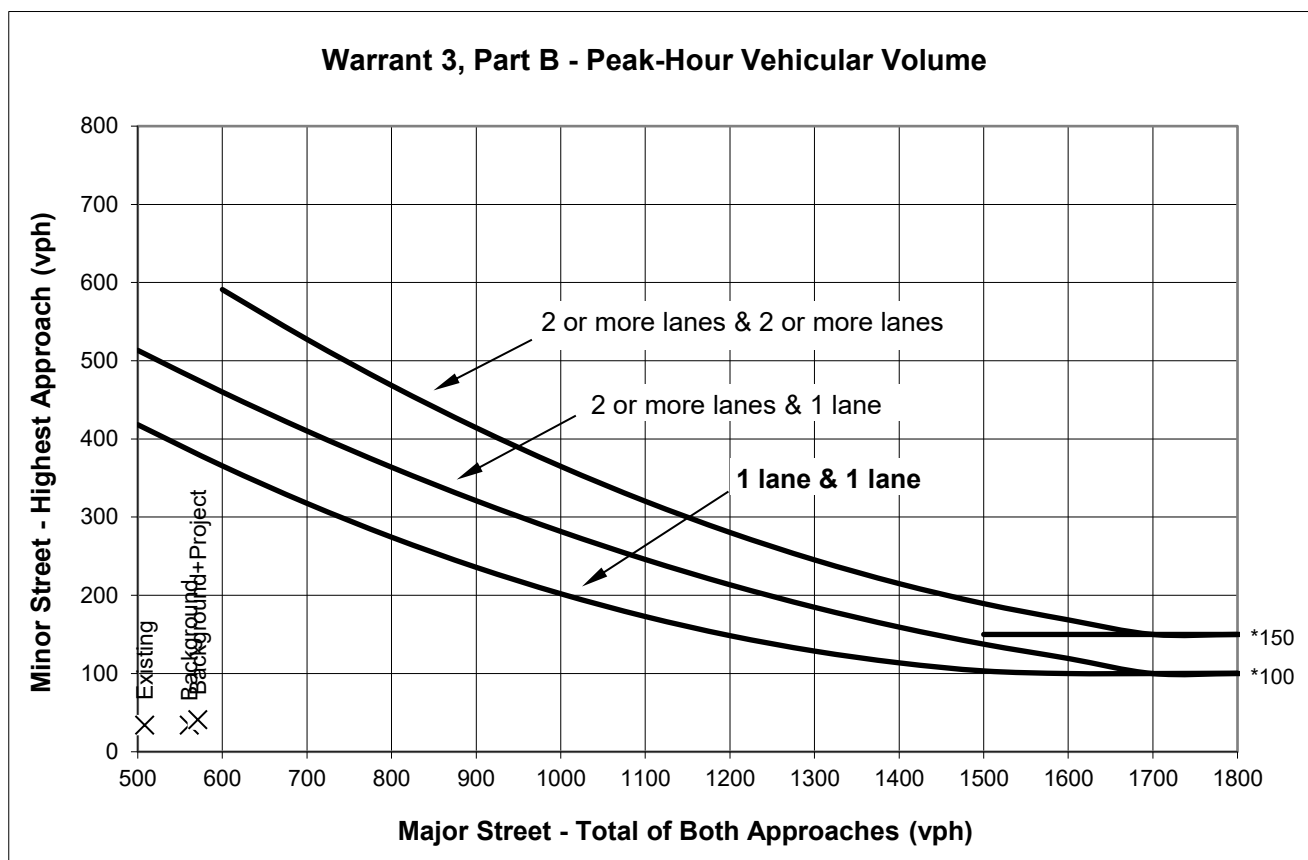
Castro St &amp; Yosemite Ave

AM PEAK PERIOD

Source: Figure 4C-3 California Manual on Uniform Traffic Control Devices for Streets and Highways (FHWA's MUTCD 2009 Edition, as amended for use in California).

\* Note: 150 vph applies as the lower threshold volume for a minor-street approach with two or more lanes and 100 vph applies as the lower threshold volume for a minor-street approach with one lane.

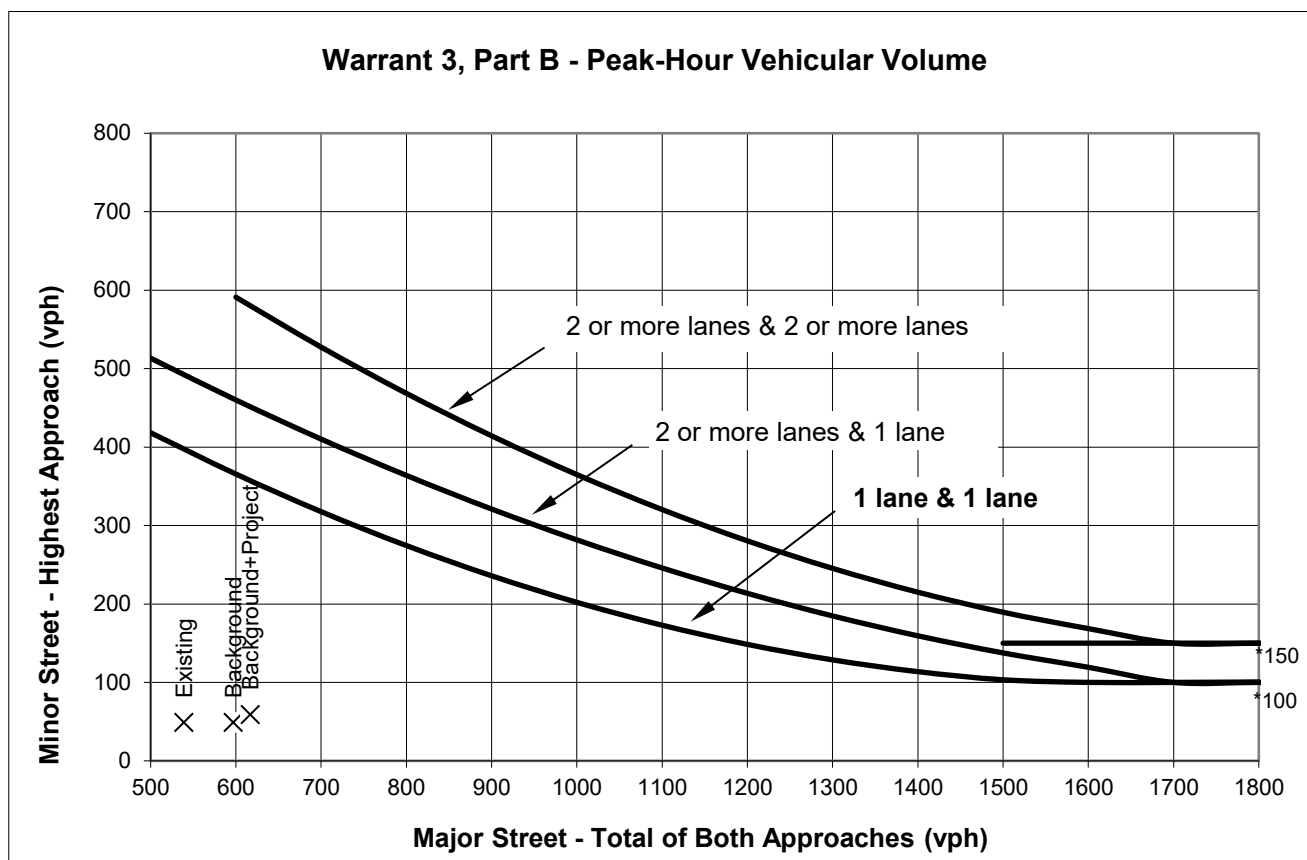
Castro St &amp; Yosemite Ave

PM PEAK HOUR

Source: Figure 4C-3 *California Manual on Uniform Traffic Control Devices for Streets and Highways (FHWA's MUTCD 2009 Edition, as amended for use in California)*.

\* Note: 150 vph applies as the lower threshold volume for a minor-street approach with two or more lanes and 100 vph applies as the lower threshold volume for a minor-street approach with one lane.

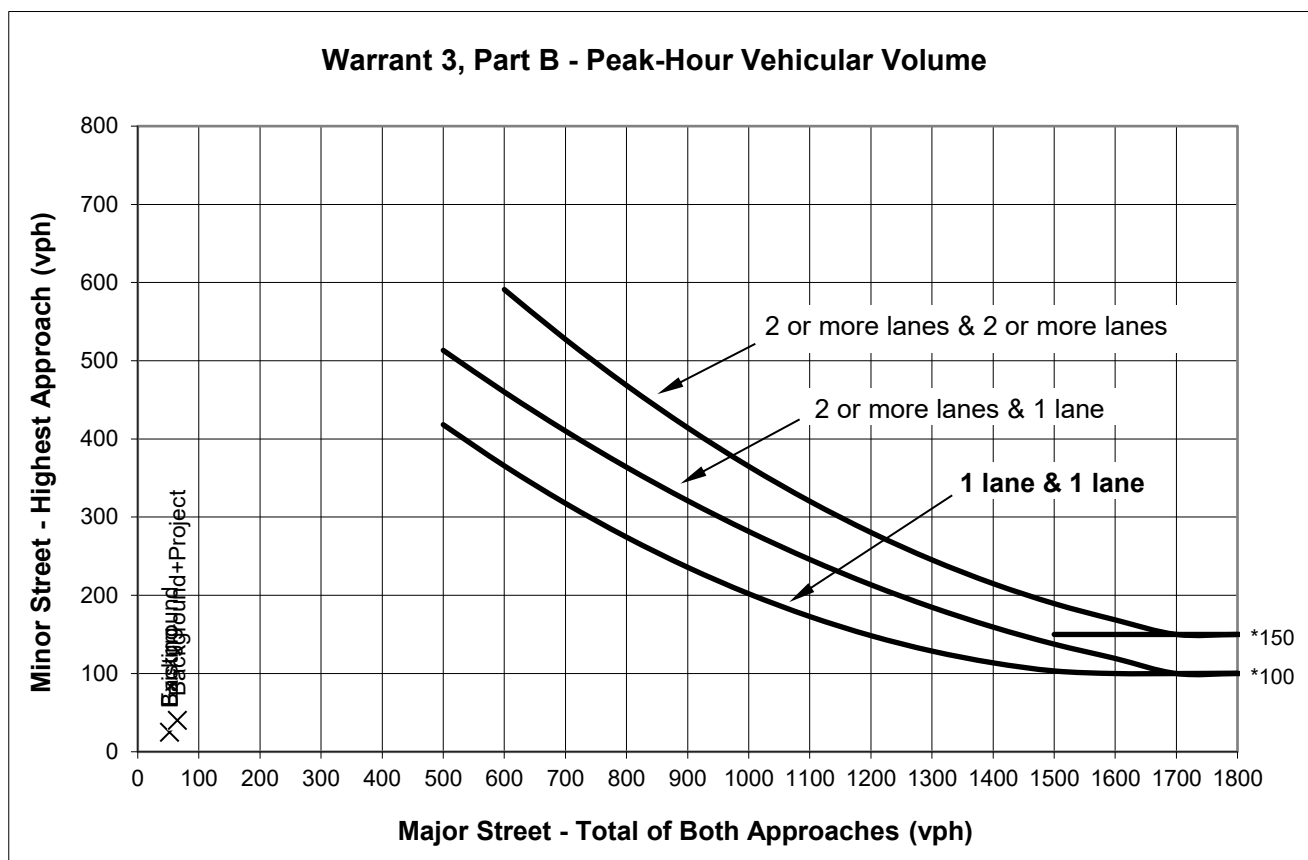
Hope St &amp; Yosemite Ave

AM PEAK PERIOD

Source: Figure 4C-3 California Manual on Uniform Traffic Control Devices for Streets and Highways (FHWA's MUTCD 2009 Edition, as amended for use in California).

\* Note: 150 vph applies as the lower threshold volume for a minor-street approach with two or more lanes and 100 vph applies as the lower threshold volume for a minor-street approach with one lane.

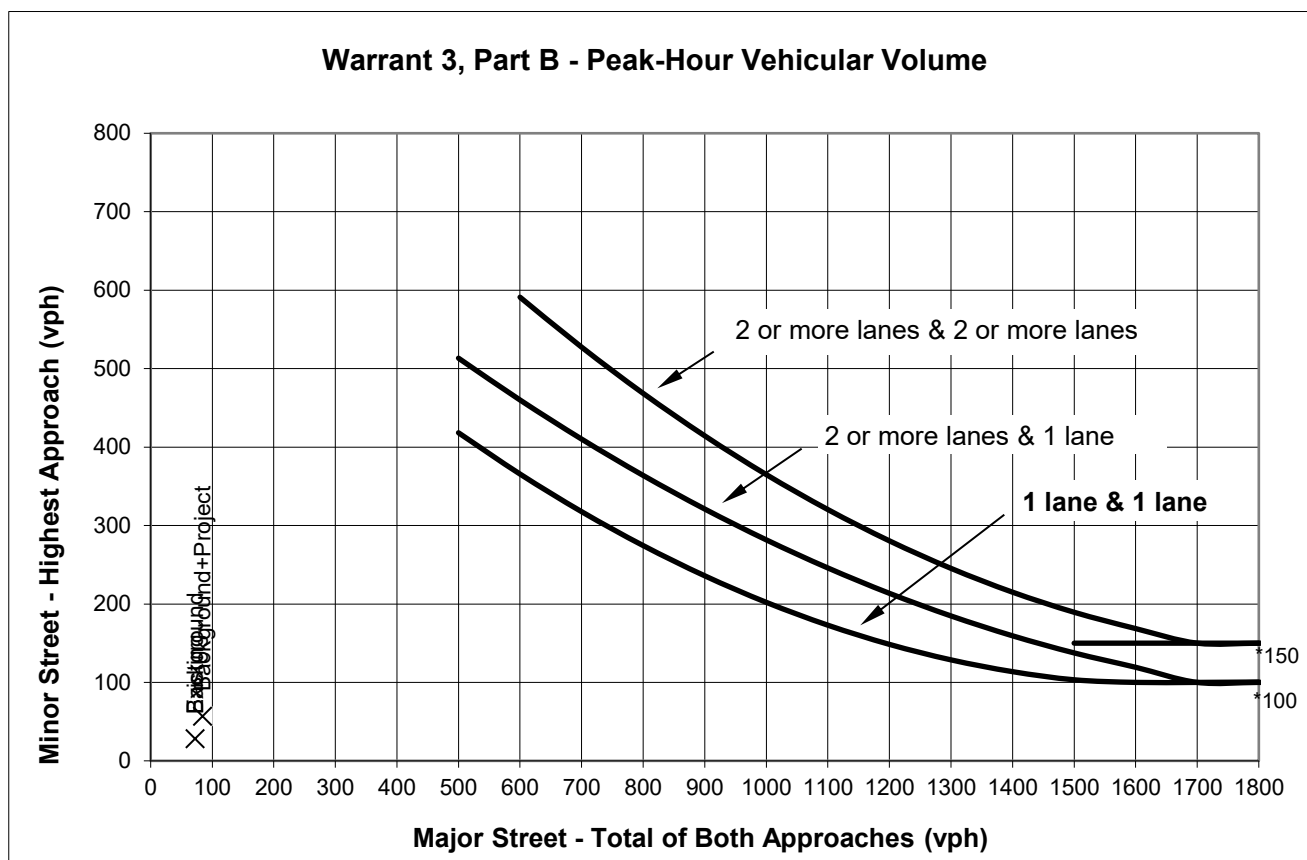
Hope St &amp; Yosemite Ave

PM PEAK HOUR

Source: Figure 4C-3 *California Manual on Uniform Traffic Control Devices for Streets and Highways (FHWA's MUTCD 2009 Edition, as amended for use in California)*.

\* Note: 150 vph applies as the lower threshold volume for a minor-street approach with two or more lanes and 100 vph applies as the lower threshold volume for a minor-street approach with one lane.

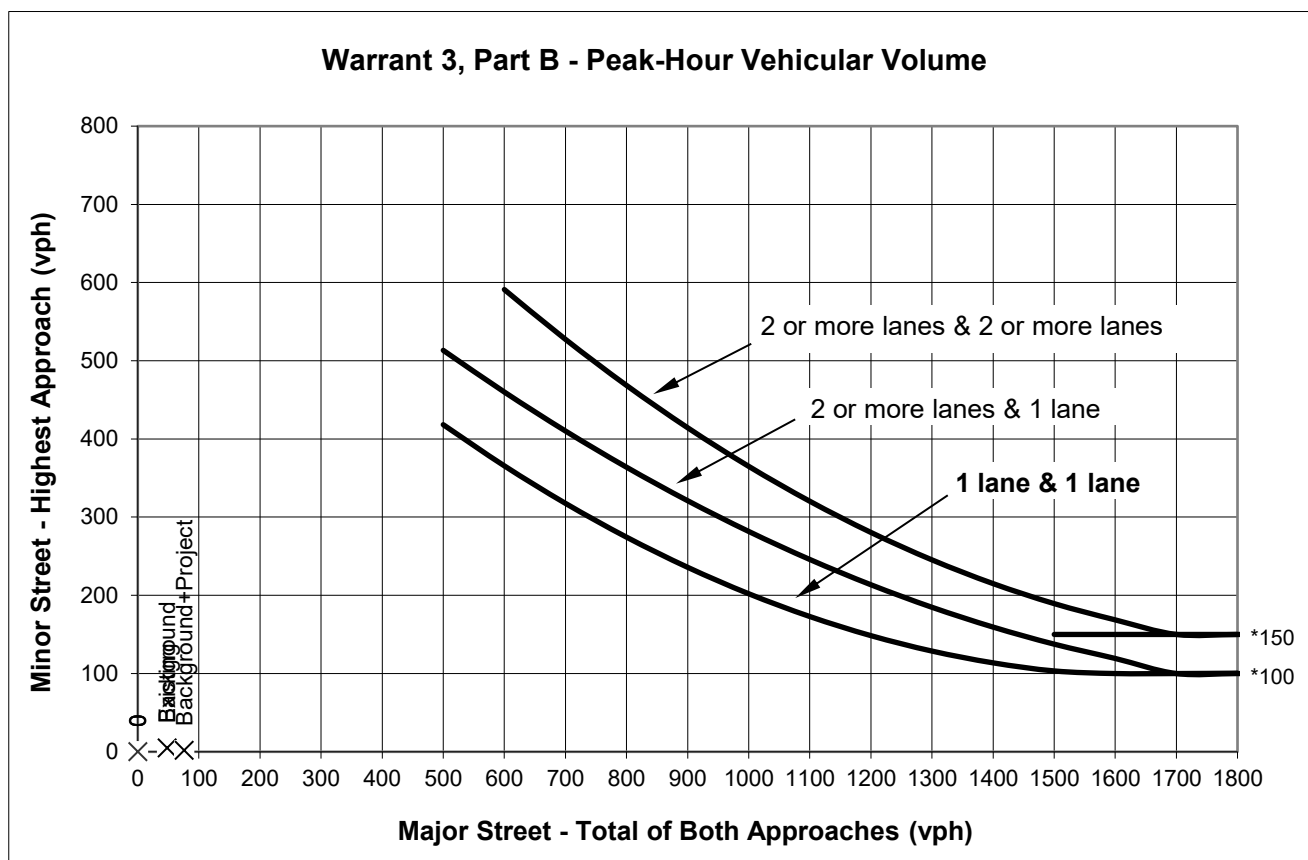
Hope St &amp; Fairmont Ave

AM PEAK PERIOD

Source: Figure 4C-3 California Manual on Uniform Traffic Control Devices for Streets and Highways (FHWA's MUTCD 2009 Edition, as amended for use in California).

\* Note: 150 vph applies as the lower threshold volume for a minor-street approach with two or more lanes and 100 vph applies as the lower threshold volume for a minor-street approach with one lane.

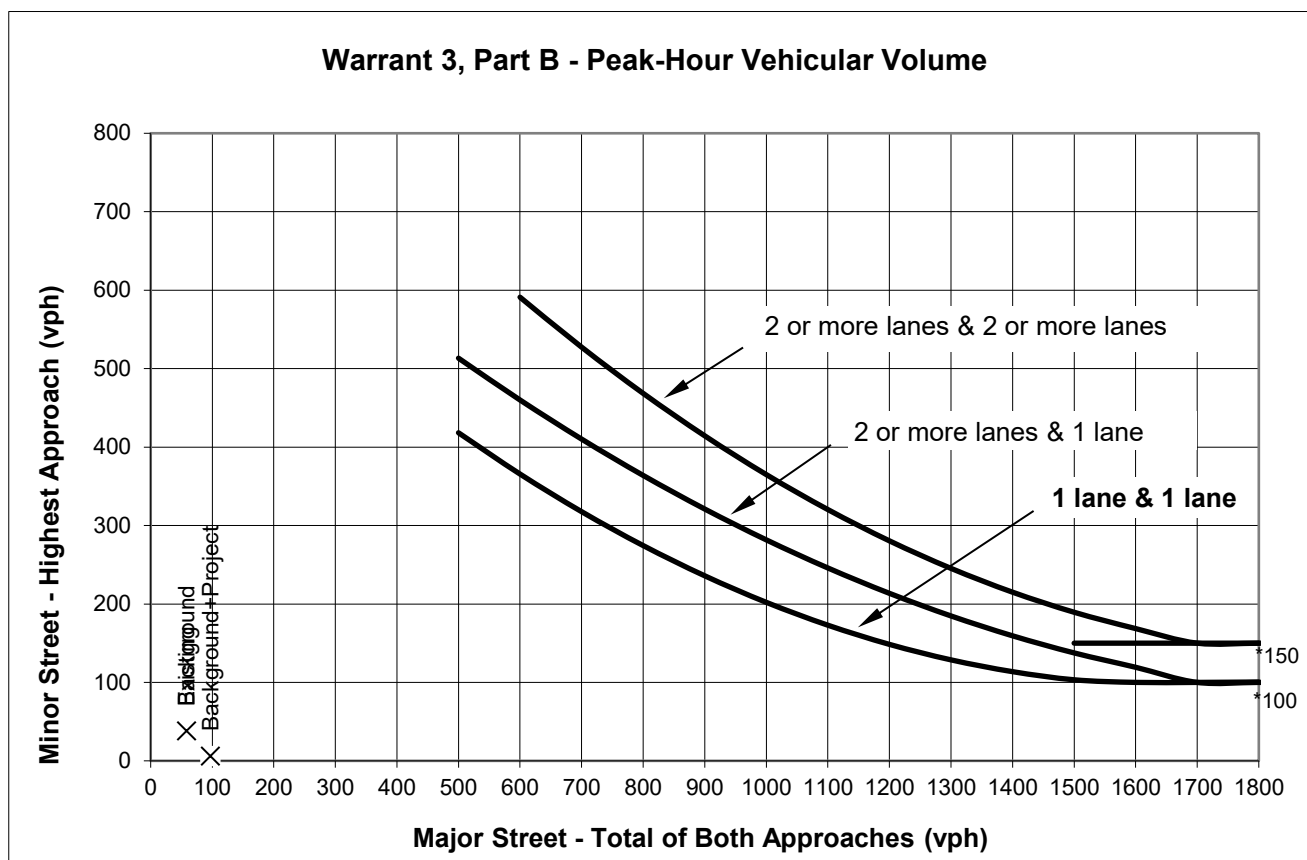
Hope St &amp; Fairmont Ave

PM PEAK HOUR

Source: Figure 4C-3 *California Manual on Uniform Traffic Control Devices for Streets and Highways (FHWA's MUTCD 2009 Edition, as amended for use in California)*.

\* Note: 150 vph applies as the lower threshold volume for a minor-street approach with two or more lanes and 100 vph applies as the lower threshold volume for a minor-street approach with one lane.

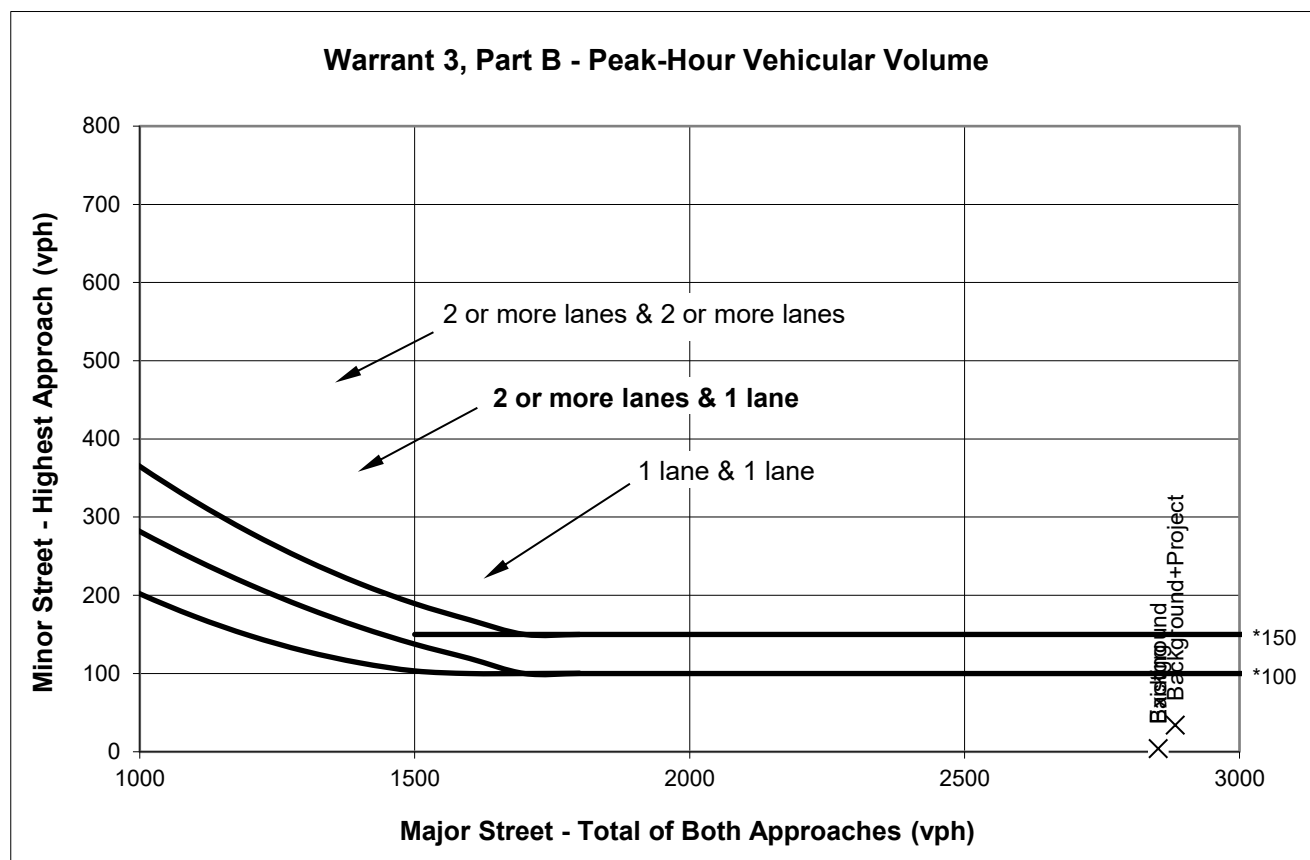
El Camino Real &amp; Hope St

AM PEAK PERIOD

Source: Figure 4C-3 California Manual on Uniform Traffic Control Devices for Streets and Highways (FHWA's MUTCD 2009 Edition, as amended for use in California).

\* Note: 150 vph applies as the lower threshold volume for a minor-street approach with two or more lanes and 100 vph applies as the lower threshold volume for a minor-street approach with one lane.

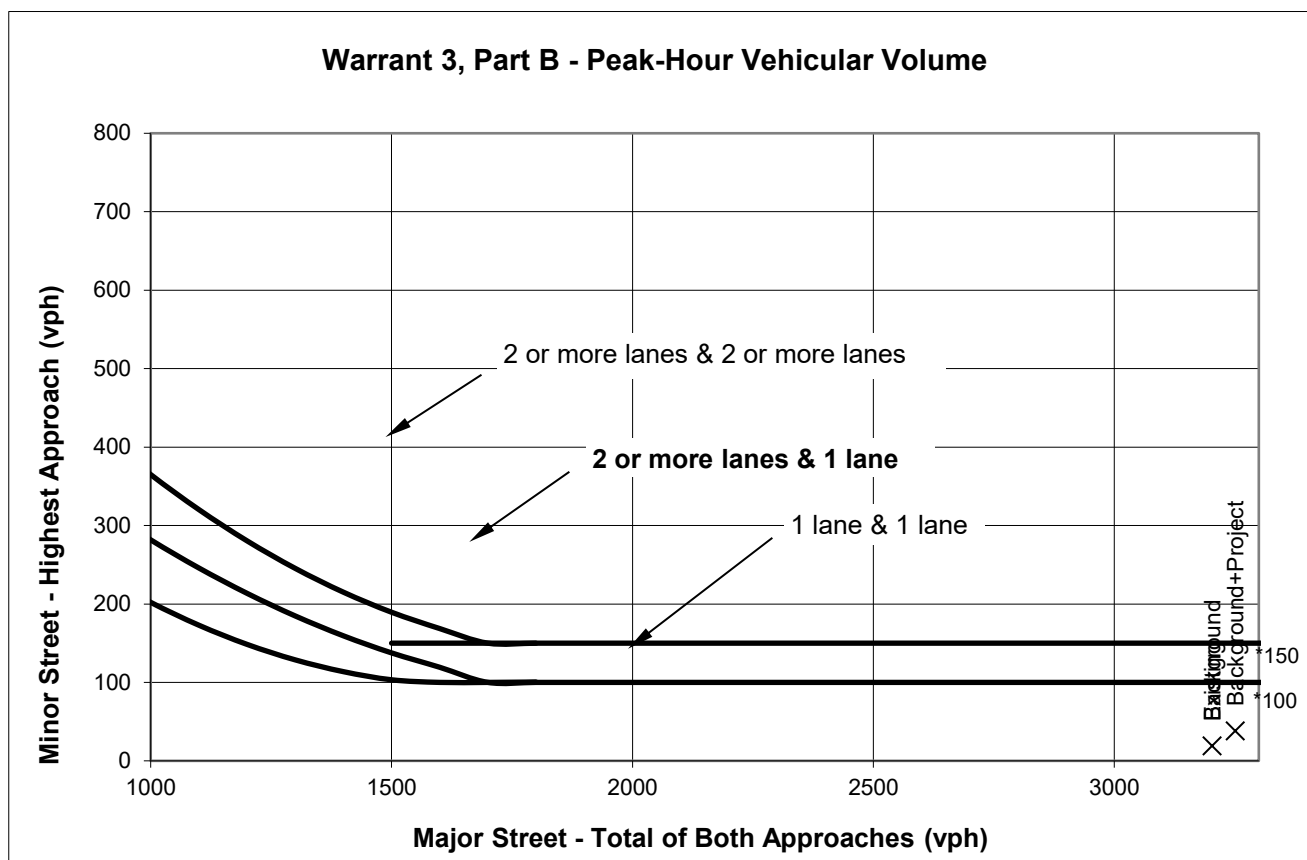
El Camino Real &amp; Hope St

PM PEAK HOUR

Source: Figure 4C-3 *California Manual on Uniform Traffic Control Devices for Streets and Highways (FHWA's MUTCD 2009 Edition, as amended for use in California)*.

\* Note: 150 vph applies as the lower threshold volume for a minor-street approach with two or more lanes and 100 vph applies as the lower threshold volume for a minor-street approach with one lane.

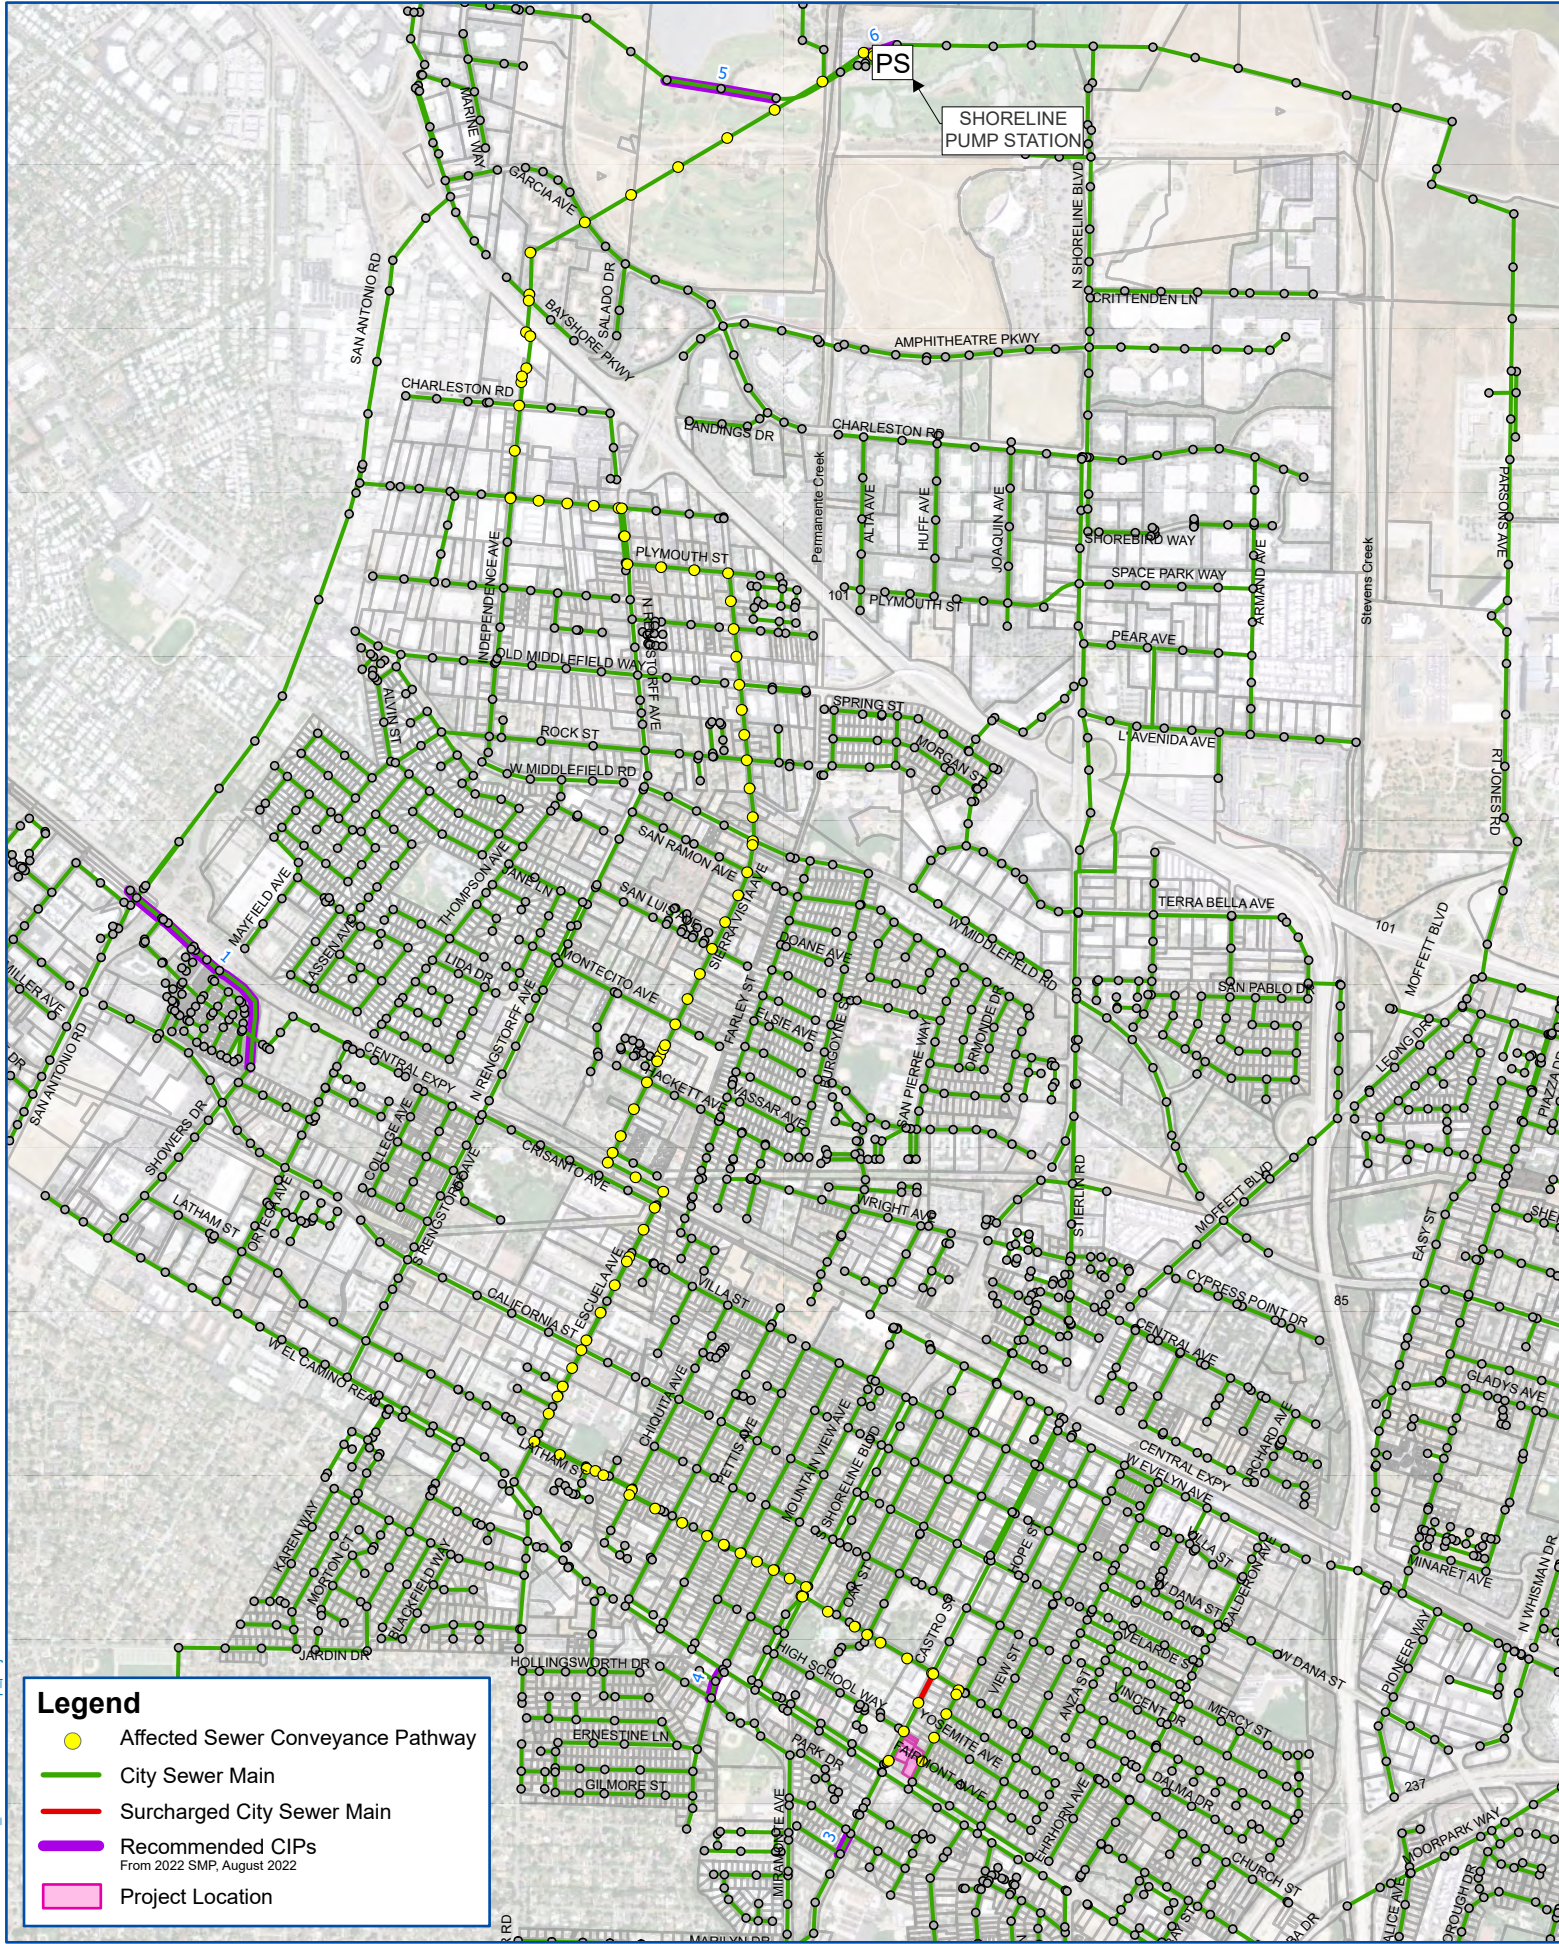
**Legend**

Affected Sewer Conveyance Pathway

There are no deficiencies along the Project conveyance pathway in the Existing Condition or in the Future Cumulative Condition. The Project does not contribute to any additional deficiencies.

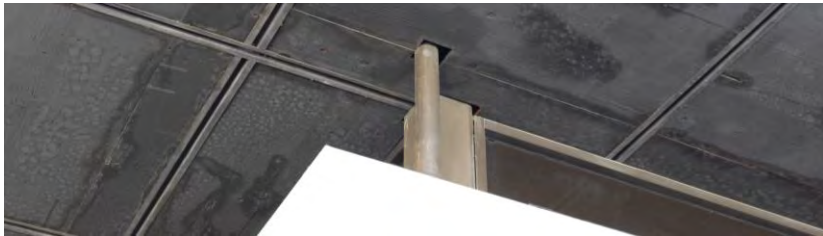
Photograph 2. Detail view of altered (enclosed) soffit and original bronze-anodized window framing that varies from the finish of the storefront windows and doors.

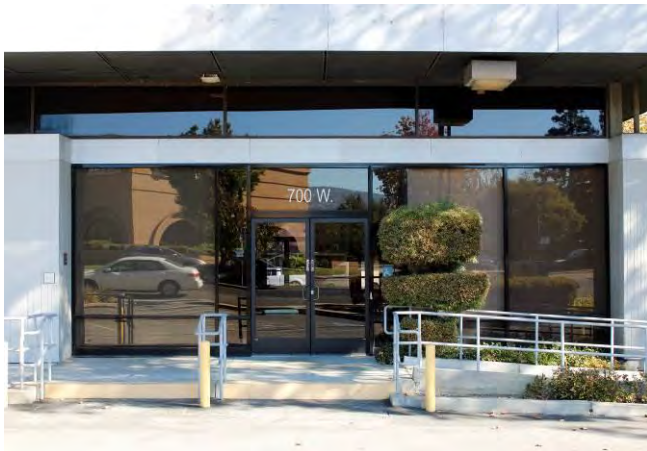
Photograph 3. Storefront and concrete ramp at main entrance, facing north

The main entrance to the building is located on the south façade, with an automatic teller machine (ATM) terminal set into the façade to the immediate west (Photograph 3). The east exterior features two banks of windows, with a windowless wall section at center (Photograph 4). The rear (north) façade contains an additional entrance, access via concrete ramp and stairs (Photograph 4). The west exterior is set alongside a drive-through lane and contains a two-lite teller's window (Photograph 6). The building appears to be in good condition.

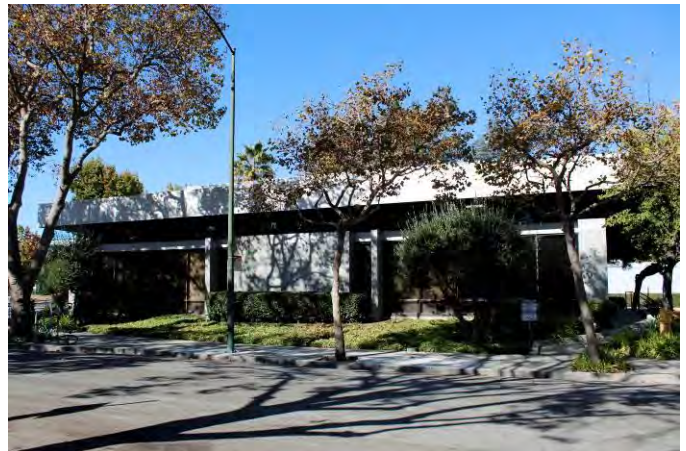
Photograph 4. East exterior viewed from Hope Street, facing southwest

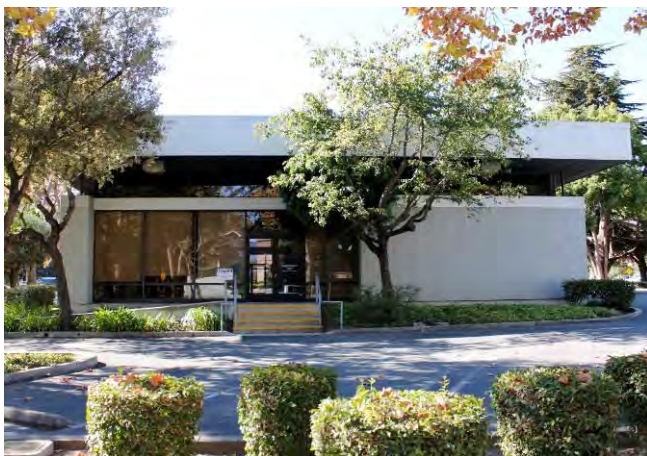
Photograph 5. Rear (north) exterior, facing south

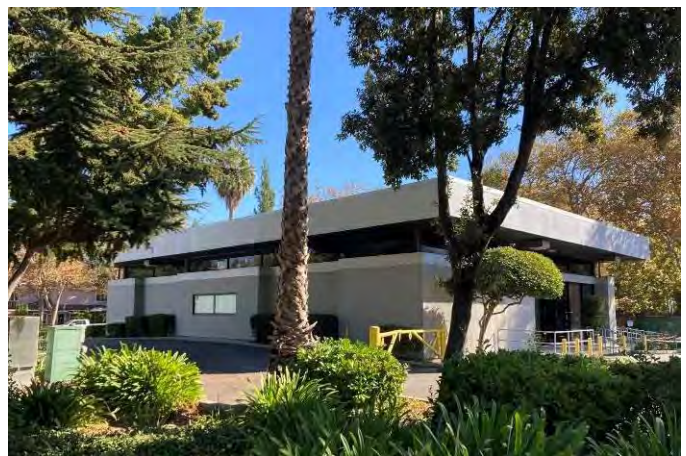
Photograph 6. West exterior with drive-thru window, facing northeast from neighboring Gateway Park

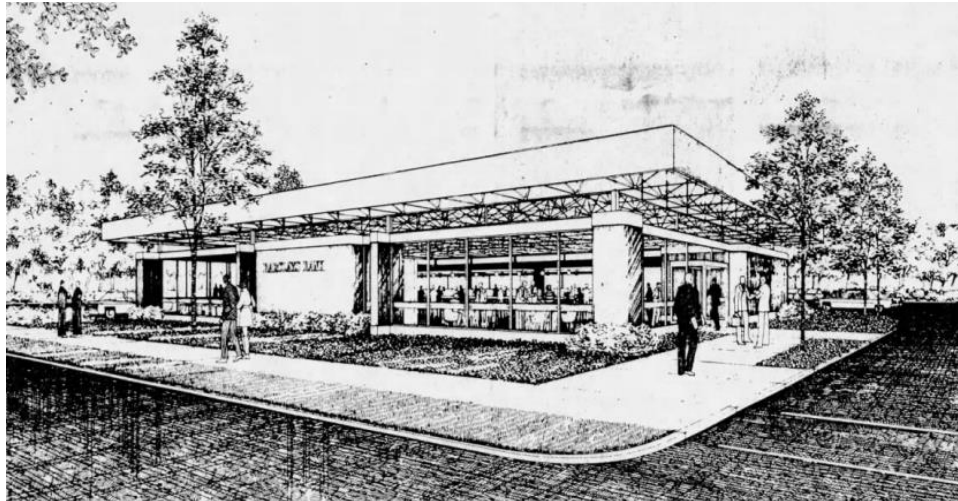
**Figure 4. Rendering of subject building, 1972 (*Peninsula Times Tribune* 1972).**

The subject building was constructed in 1972 as a branch bank location for Barclay's Bank. A rendering of the building, and an announcement of the branch's grand opening, were publicized in 1972 (*Peninsula Times Tribune* 1972, Figure 4). Based on available historical occupancy data, Barclay's continued to occupy the property until ca. 1987 (PSI 2024). Thereafter, the property became the location of several bank branches for companies including Sumitomo Bank (1995) and in the more recent past, California Bank & Trust (2001-2022) (PSI 2024a, 2024b). A comparison of existing conditions and the 1972 rendering indicates that the building's fenestration has been altered, as its original windows have been replaced with newer commercial windows systems. A circular entrance vestibule that appeared on the east side of the building in the rendering is not present. Additionally, the building no

longer features a structural framework or similar panel element beneath its overhanging roof, which appears to have been a continuous feature visible at the exterior and interior of the building. The building's current design, former ATM locations, and concrete pathways that abut the building appear to date to approximately 1994 and later, based upon review of available permit documentation on file with the City of Mountain View Building Division (hereafter, Building Division) (Building Division 2024). Beyond the rendering found in a historical newspaper, original building permit and plans related to the 1972 design were not found through research of the Building Division's records.
