## 881 Castro Street Mixed-Use Project

### Class 32 Categorical Exemption Report

**September 2025**

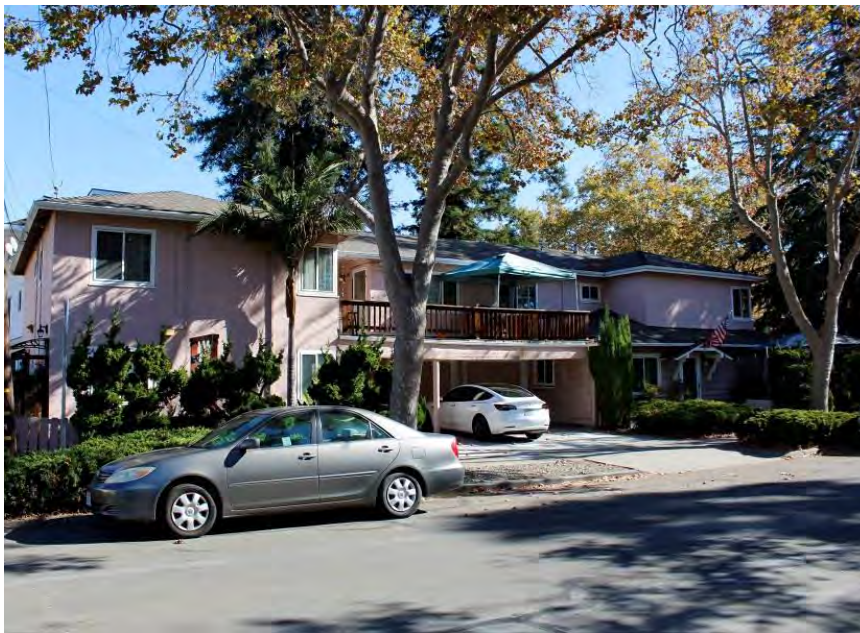
**P5a. Photograph 1.**

**P5b. Description of Photograph 1:**

Apartment building at 750 Fairmont Avenue, viewed from Fairmont Avenue, facing northeast. October 15, 2024.

Observed alterations: Windows appear to have replacement vinyl sash. Deck railing at front of building appears to be a replacement.

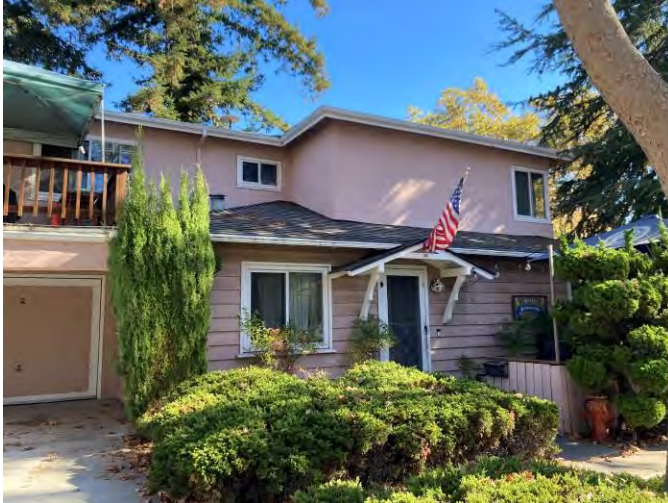
**Photograph 2 Entrance with bracketed canopy at southeast corner of building, view facing northeast**

Of the features listed above 750 Fairmont Avenue features wood-frame construction, a hip roof, casement windows (vinyl replacement), corner windows, a front portico (bracketed canopy) at one apartment entrance, and modest decorative features common to the Minimal Traditional style. The building's stucco siding is typical of both Minimal Traditional and Traditional Ranch style buildings, as is the border trim on each garage door.

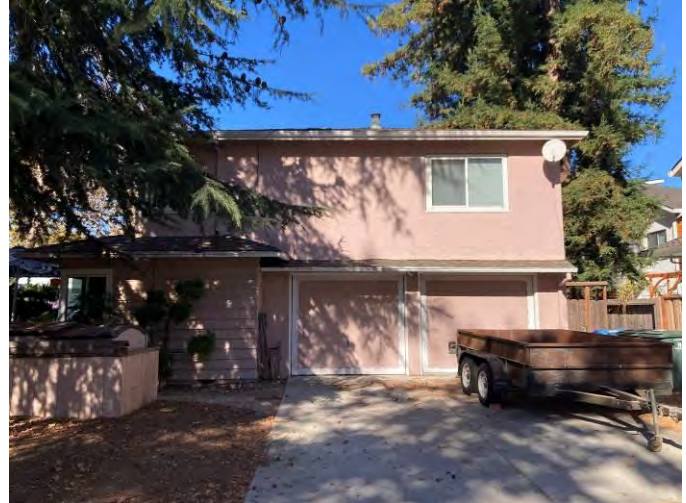
**Photograph 3 East exterior, with two garage bays at first story, facing west**

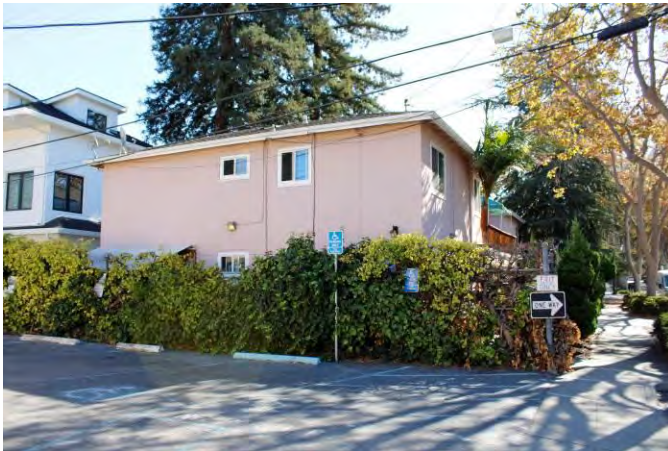
**Photograph 4 West exterior, viewed from north side of Fairmont Avenue near Castro Street, facing northeast**

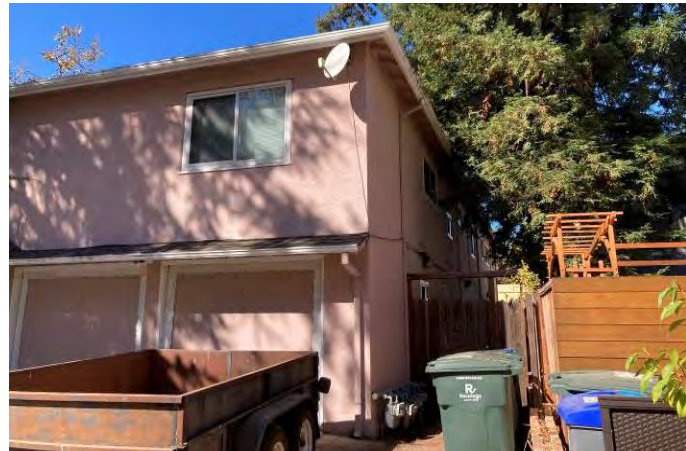
**Photograph 5 Oblique view of north exterior along the north property line, facing west-southwest**

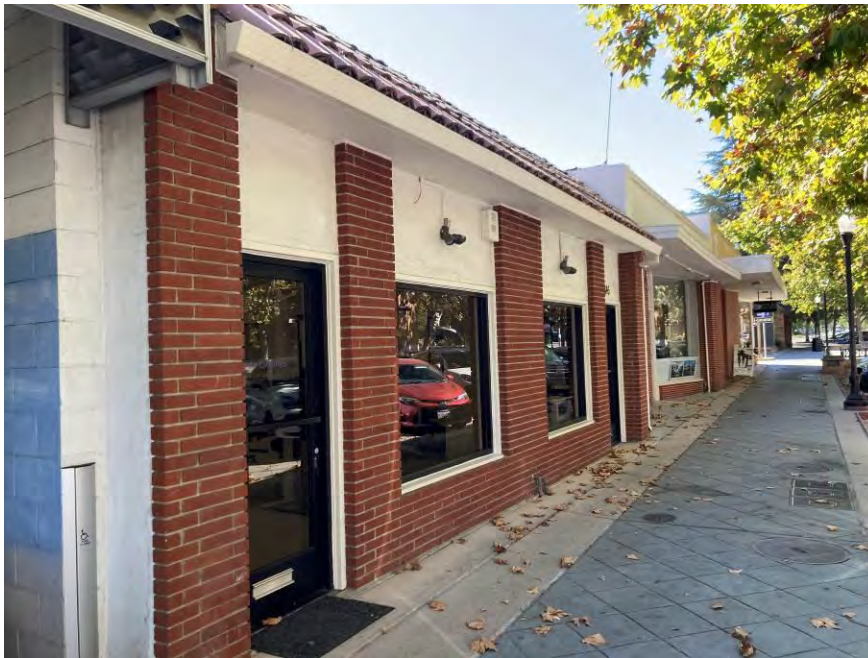
**P5a. Photograph 1.**

**P5b. Description of Photograph:** Primary (west) façade of 843 Castro Street, viewed from sidewalk on east side of Castro Street, facing south. October 15, 2024

Observed alterations: replacement storefront windows and doors, replacement vinyl windows at rear of building

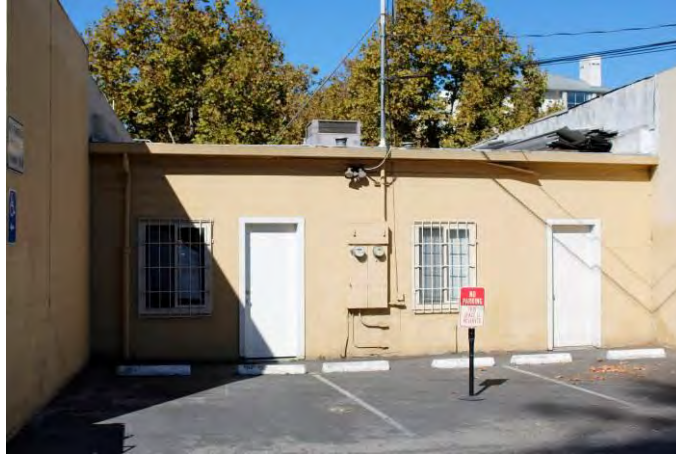
**Photograph 2. Rear (east) exterior, viewed from alley at rear of building, facing west.**

A birds-eye view from 1950-1955 showed the subject building during the first decade of its existence (Mountain View Public Library 1950-1955, Figure 4). The rear façade was similar present conditions with two entrances and related windows. The building does not appear to have featured the existing pent eave with red tiles during this period. It appears that a blade sign was mounted to the primary façade. During this period, the lot to the immediate south (present-day 871 Castro Street) was undeveloped. The existing alley behind the subject building was not present; rather, the rear areas of the individual properties were divided with fences. The alley was present by 1956, based on subsequent aerial photography (UCSB 1956). A 1965 photograph shows the subject

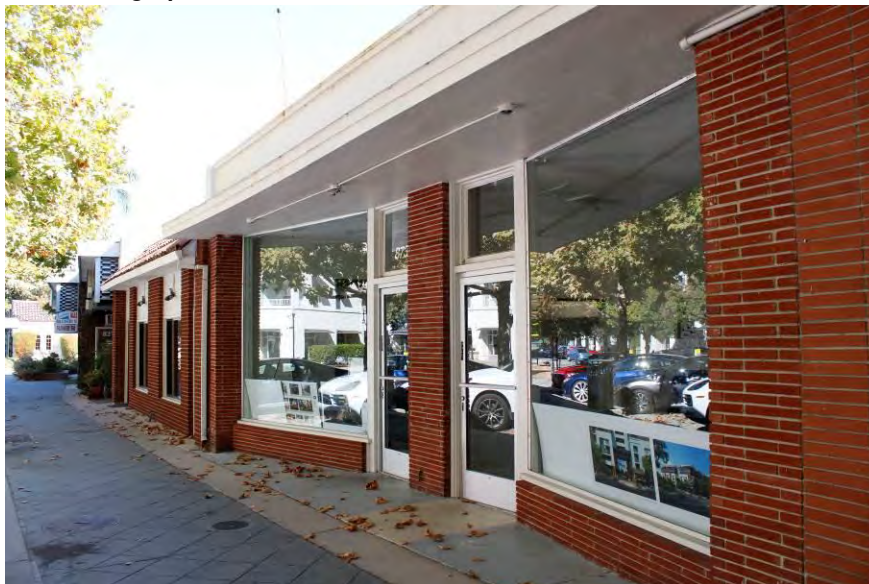
**P5a. Photograph 1.**

**P5b. Description of Photograph:** Primary (west) façade, viewed from sidewalk along east side of Castro Street, facing northeast. October 15, 2024

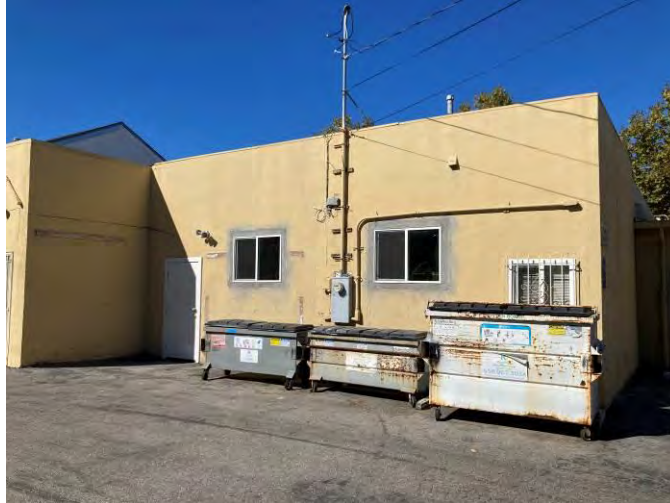
Photograph 2. Rear (east) exterior, viewed from alley behind building, facing southwest.

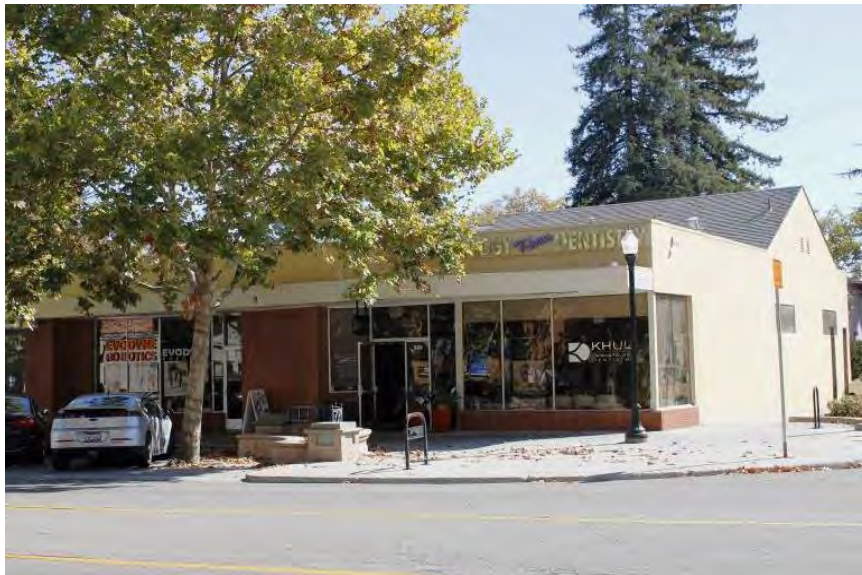
**P5a. Photograph 1**

**P5b. Description of Photograph 1:** 881

Castro Street, view from Castro Street facing northeast. October 15, 2024

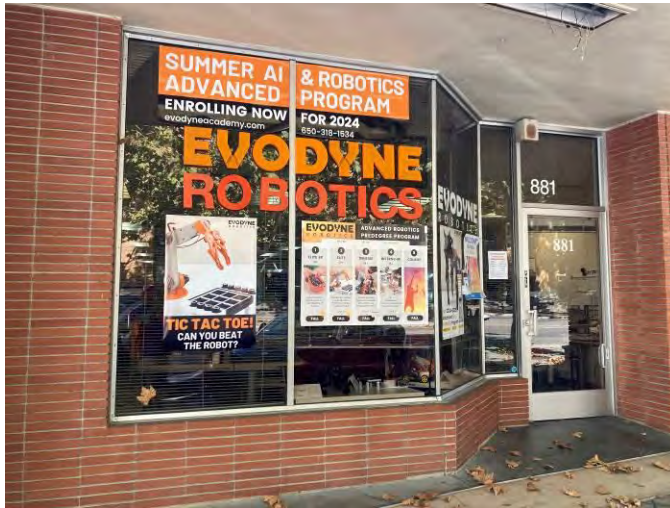
**Photograph 2. North storefront (881 address), facing east.**

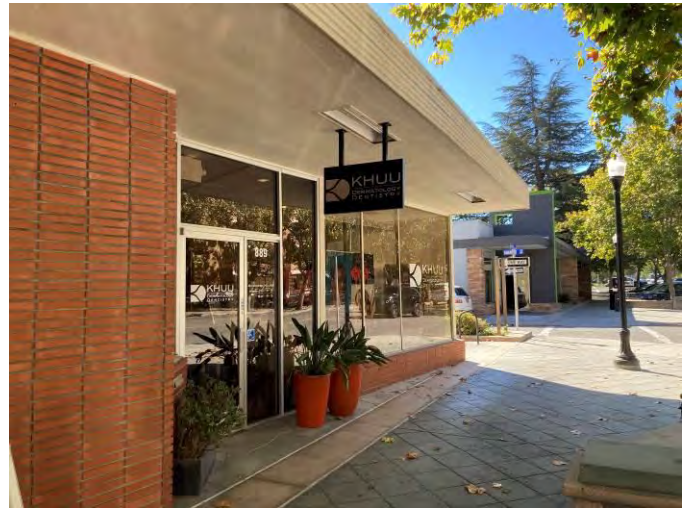
**Photograph 3. South storefront (889 address), facing south.**

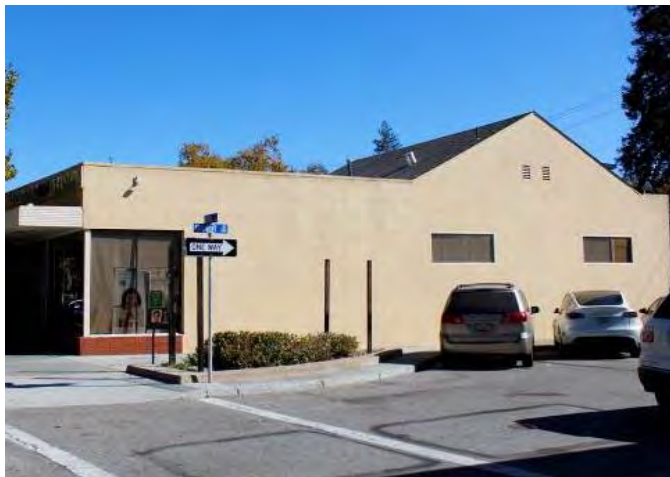
The south exterior, oriented to Fairmont Avenue, is finished with stucco and features two fixed, single-lite wood windows located in the rear (gabled) portion of the building (Photograph 4). Two louvered gable vents are visible above the windows. The rear exterior is also finished with stucco and has two similar single-lite horizontal windows, as well as a smaller vinyl-sash window at center, and another single-lite horizontal window near the north end. A rear entrance with a flush wood door and metal outer screen door with scrolled iron detailing is located at the north end (Photograph 5). The north exterior is mostly obscured from view by the abutting building at 871 Castro Street; only a short section near the northwest corner is visible and it consists of painted concrete masonry units (CMU). The building appears to be in good condition.

**Photograph 4. South exterior, viewed from Castro Street and Fairmont Avenue, facing north.**

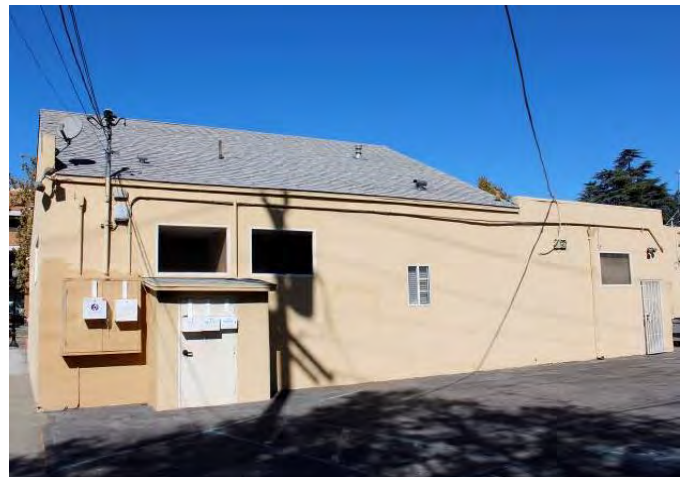
**Photograph 5. Rear exterior, viewed from alley, facing west.**

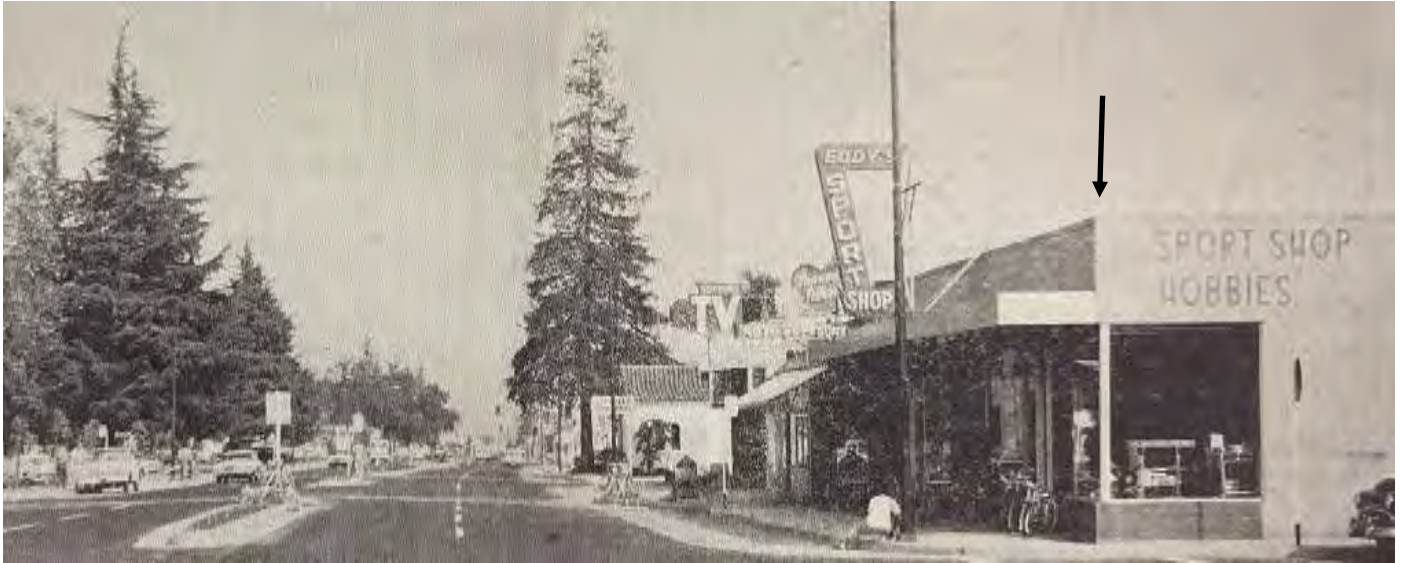
corners that were present ca. 1950-1955 (*Los Altos News-Mountain View News* 1965, Figure 5). Thus, the existing primary façade's features appear to date to ca. 1955-1965.

**Figure 5. View of Castro Street, with subject building at middle-left, 1965 (*Los Altos News-Mountain View News*, November 15, 1965)**

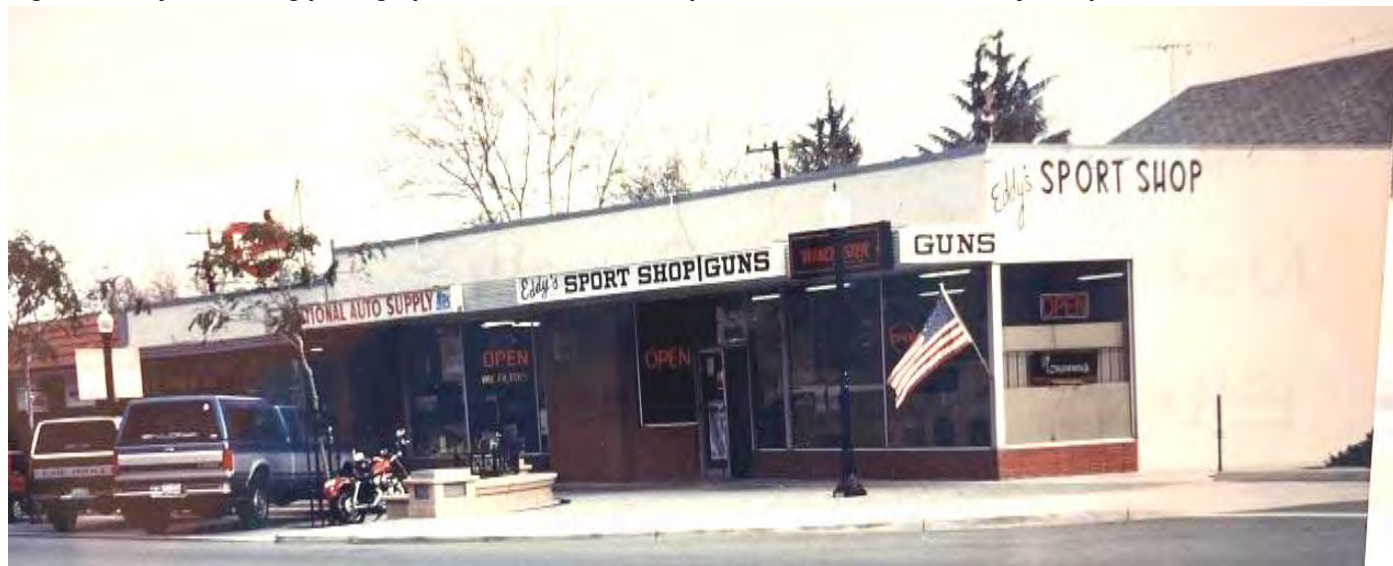
The building's form has remained similar to its ca. 1965 footprint and fenestration. By 1993, signage for Eddy's above the storefront canopy was nonextant. Signage has also been removed from the fascia of the canopy, revealing the horizontal grooves in the canopy across its length. Entrance doors appear to have been replaced after 1993, as their existing kickplates are taller than the door pictured in the 1993 photograph. The storefront windows appear to be of similar design, with variation in their mullion profiles noted in the 1993 photograph (Mountain View Public Library 1993, Figure 8).

Figure 8. Subject building photographed in December 1993 (Mountain View Public Library 1993)

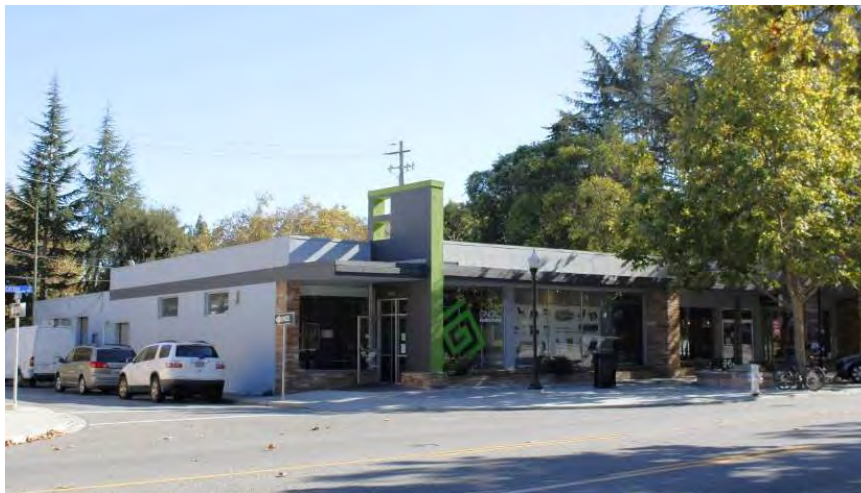
P5a. Photograph 1

P5b. Description of Photograph 1: South façade, viewed from Sonora Court, facing north. October 15, 2024

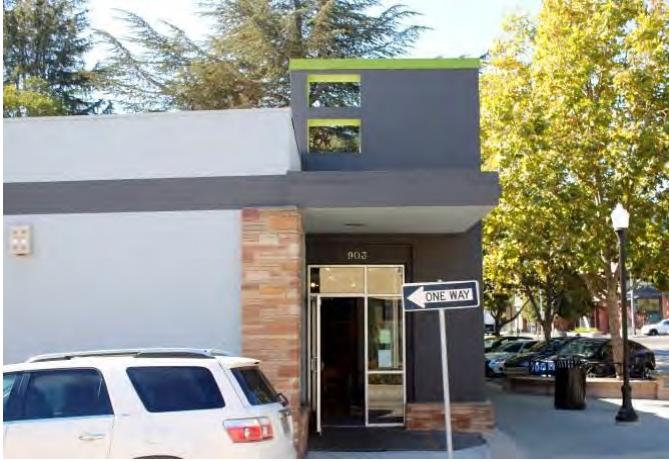
Photograph 2. Entrance at northwest corner and pilon element above canopy, facing south.

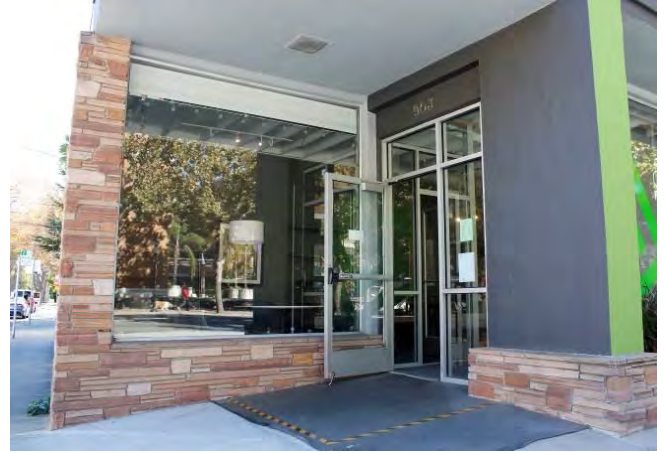
Photograph 3. Detail view of corner entrance and finishes, facing southeast.

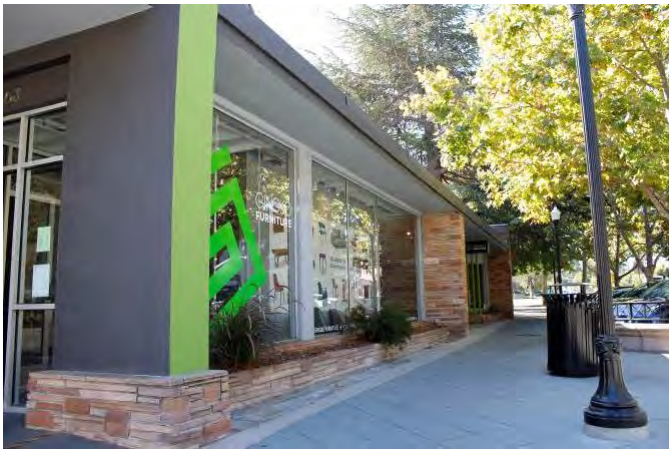
Photograph 4. Oblique view of façade, facing south.

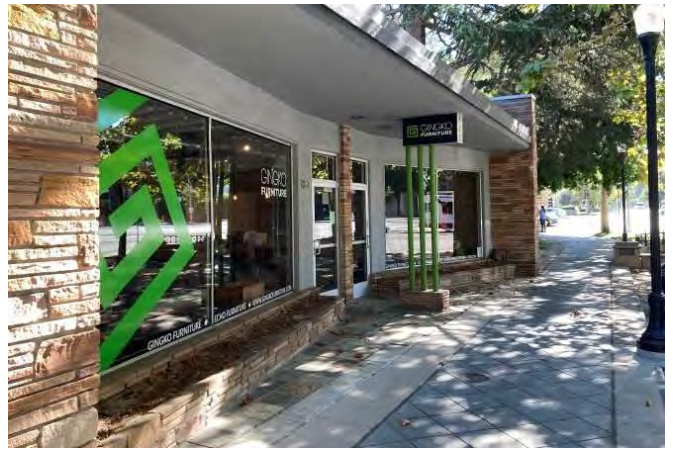
Photograph 5. Recessed entry and three-pole column beneath canopy, view facing southeast.

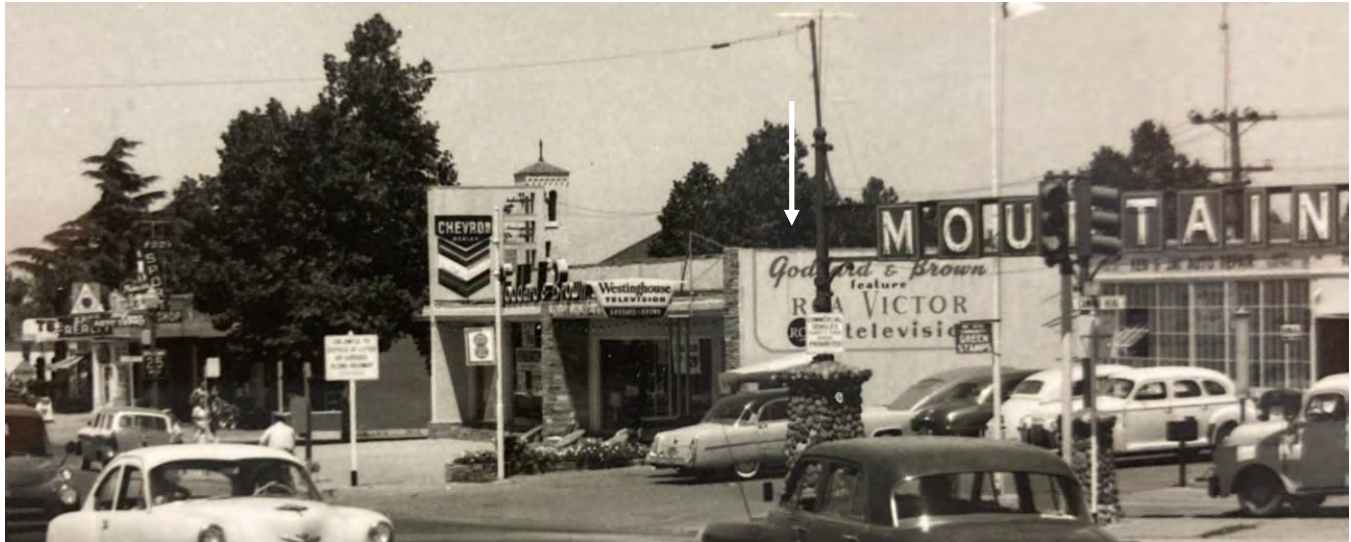
A 1957 photograph taken from the intersection of Castro Street and El Camino Real captured the subject building within two years of its original construction. The building featured painted or draped signage on its southwest corner, stone veneer cladding along portions of its primary (west) façade, signage for Goddard & Brown and Westinghouse Television along the face of its storefront canopy, and the pilon element, shown in 1957 with three rectangular openings and a slightly taller height, varying from the

existing pilon's two-opening appearance. The front of the property along Castro Street appears to have been a surface parking area. A short planting bed along the southern property line buffered the 903 Castro Street parking lot from the adjacent gas station's parking area (Mountain View Public Library 1957, Figure 4).

**Figure 4. Subject building (middle-right, identified with white arrow), pictured along Castro Street, 1957 (Mountain View Public Library 1957)**

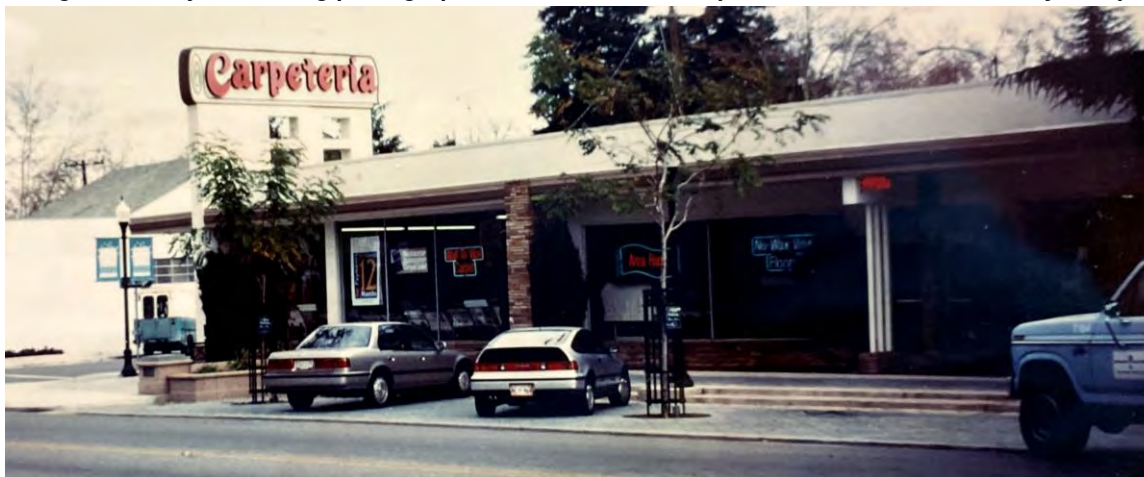
Public Library 1993, Figure 6). The Carpeteria signage appears to have required shortening of the pilon as well. Since 1993, the Carpeteria signage has been removed and the pilon's original width appears to have been restored, while it remains at a shorter height than was documented ca. 1950s.

**Figure 6. Subject building photographed in December 1993 (Mountain View Public Library 1993)**

903 Castro Street features a rectangular footprint, flat roof with storefront canopy, a vertical pilon element with some evidence of alteration (shortened), and wide primary façade with metal-framed storefronts and replacement doors. The building is clad with stucco and stone veneer along its Castro Street storefronts. Intensive research of city building records, online repositories, and historical newspapers failed to identify a builder or contractor, or architect or other design professionals associated with the building's origination (Avery Index 2024, City of Mountain View 2024c, History Center 2024e, USModernist 2024, Newspapers.com 2024).
