Public Works Department

SUBJECT: Solar Arrays—Senior Center, Mountain View Sports Pavilion, and Whisman

Sports Center, Project 24-48

Review the proposed Heritage tree mitigation for Senior Center, Mountain View Sports Pavilion, and Whisman Sports Center, Project 24-48, and forward a recommendation to the City Council to approve the mitigation of one Heritage tree at a 2:1 tree replacement ratio, with the planting of two 24" box trees for the Senior Center site.

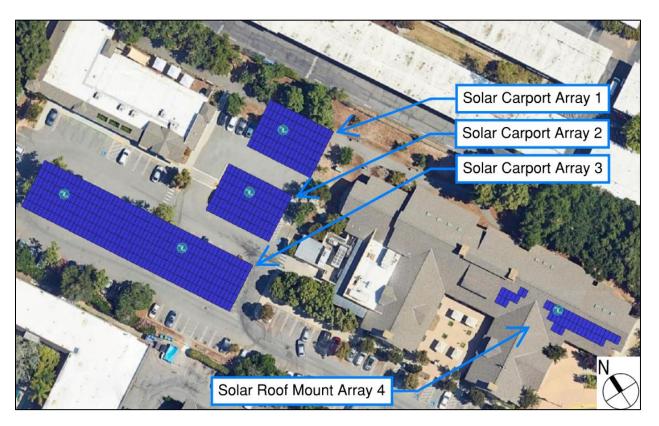
Figure 1: Senior Center Solar Arrays Preliminary Locations

The preliminary conceptual design included installation of solar arrays on the Senior Center's rooftop and new carports in the parking lot (Figure 1). Staff's preliminary analysis estimated up to seven non-Heritage trees would need to be removed and advised Council at the June 25, 2024 meeting that the project mitigation measures would be at a 1:1 tree replacement ratio with 24" box native species trees, either on- or off-site.

The design for the Senior Center solar arrays was finalized in August 2025, and a permit has been issued by the City's Building Division. During the design phase, higher-efficiency solar panels were incorporated on the solar carports, which reduced the total number of panels necessary to generate the required energy production. This reduced the solar arrays from 586 panels on the preliminary design to 558 on the final design.

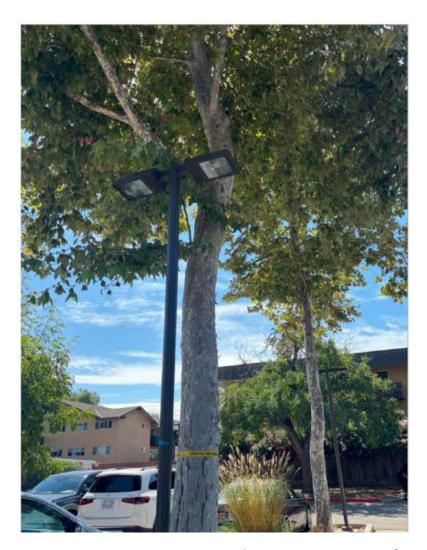
Figure 2: Impacted Heritage Tree—Sycamore (*Plantanus x hispanica*/London Plane)

Syserco's subconsultant, Bionic Landscape Architecture, and the City arborist evaluated the project layout and identified a total of 13 trees within the project site that will require removal. The trees recommended for removal consist of 12 non-Heritage trees and one Heritage tree (see Figures 2 and 3). The Heritage tree is a Western sycamore.

trees are located within the footprint of the solar carport. Of these six trees, one was identified as a Heritage tree. This tree was initially classified as non-Heritage during the preliminary tree impact assessment but was later confirmed to meet the Heritage criteria.

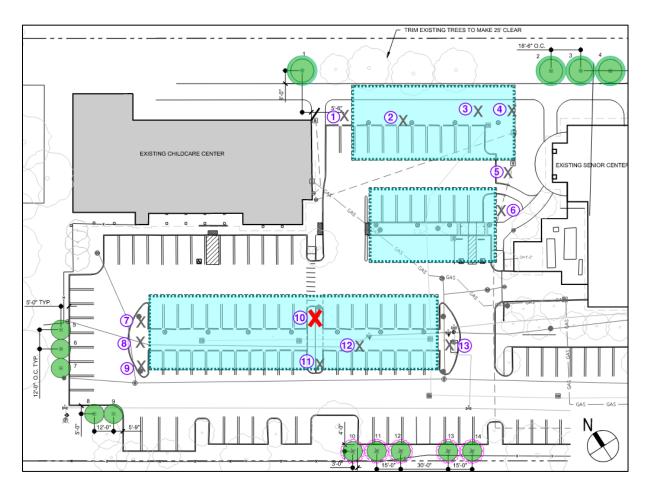
Figure 3: Senior Center Removal and New Tree Location Plan

The assessment included the location and species of existing trees (Figure 3) and mitigation recommendations. The circled blue numbers corresponded to the tree numbers in Table 2.

Staff recommends mitigation for the Heritage tree at a 2:1 tree replacement ratio with 24" box tree and replacing the 12 non-Heritage trees at a 1:1 ratio with 24" box trees. This results in 14 new trees, as shown in Figure 3. There is suitable and available space to plant all proposed replacement trees within the project limits (see Figure 3). The tree canopy coverage within the project limits is projected to exceed the current coverage within five to seven years. Three of the trees proposed to be removed are non-California native tree species, and nine of the 14 mitigation trees are California native tree species. Five of the mitigation trees recommended are non-California native tree species and were selected as more appropriate to the location due to conflicts with existing infrastructure and limited grow space.

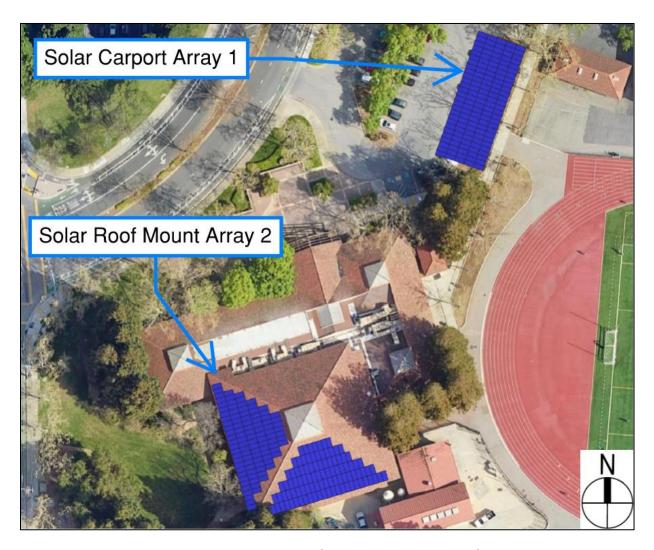
Figure 4: Mountain View Sports Pavilion Sports Center—Preliminary Design

The Mountain View Sports Pavilion includes rooftop solar arrays and a solar carport (Figure 4). On June 25, 2024, the City Council was informed of the planned removal of five non-Heritage trees for the carport portion of the solar arrays and of the proposed on-site tree mitigation at a 1:1 replacement ratio with 24" box native-species trees. Transplant is not recommended for these trees for similar reasons stated above regarding the Senior Center trees—essentially, unfavorable candidates for transplant and likelihood of not surviving transplant.

City staff conducted a field review of the proposed Mountain View Sports Pavillion solar array preliminary design with Syserco. As noted to the City Council in the June 2024 report, five

non-Heritage trees would be impacted by being underneath the carport solar arrays. After finalizing the design, three additional non-Heritage trees adjacent to the solar arrays will cause significant shading, thereby reducing energy production as well as branch conflicts with the array. In total, eight non-Heritage trees will be removed.

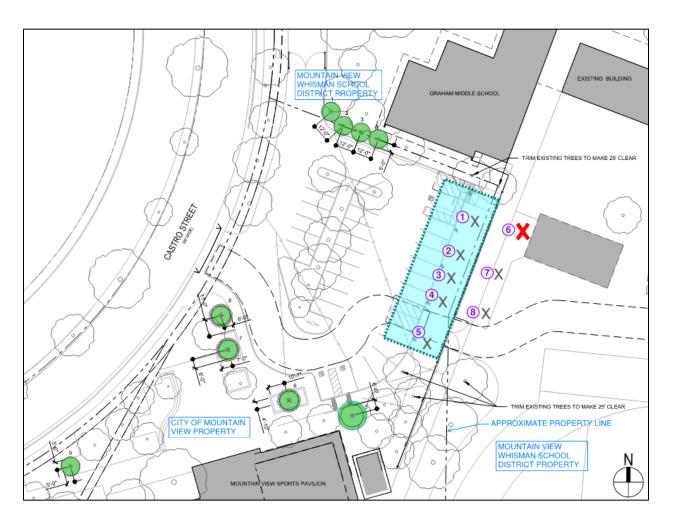
Figure 5: Mountain View Sports Pavilion New Tree Locations

The blue circled numbers in Figure 5 below correspond to the tree number in Table 4.

The School District has agreed with a plan to plant nine 24" box trees on site as part of the voluntary mitigation measures (Table 5). There is suitable and available space to plant all proposed replacement trees within the project limits (see Figure 5). The tree canopy coverage within the project limits is projected to exceed the current coverage within five to seven years. All eight trees proposed to be removed are non-California native tree species, and all nine mitigation trees are California native tree species.
